National Register of Historic Places Inventory—Nomination Form

historic Delta Historic District

HISTORIC DISTRICT MAP

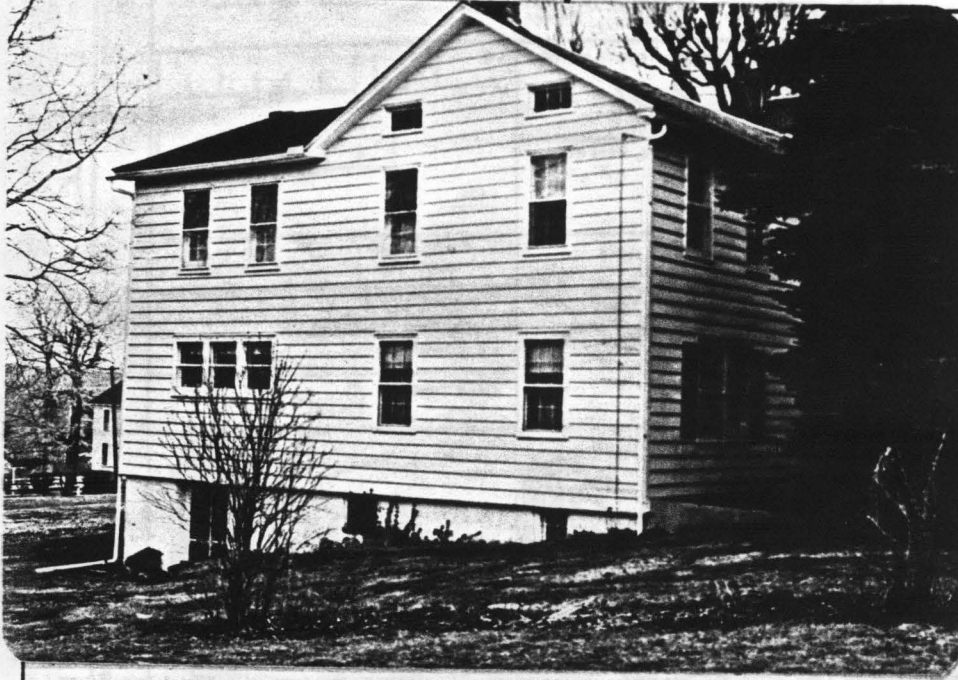
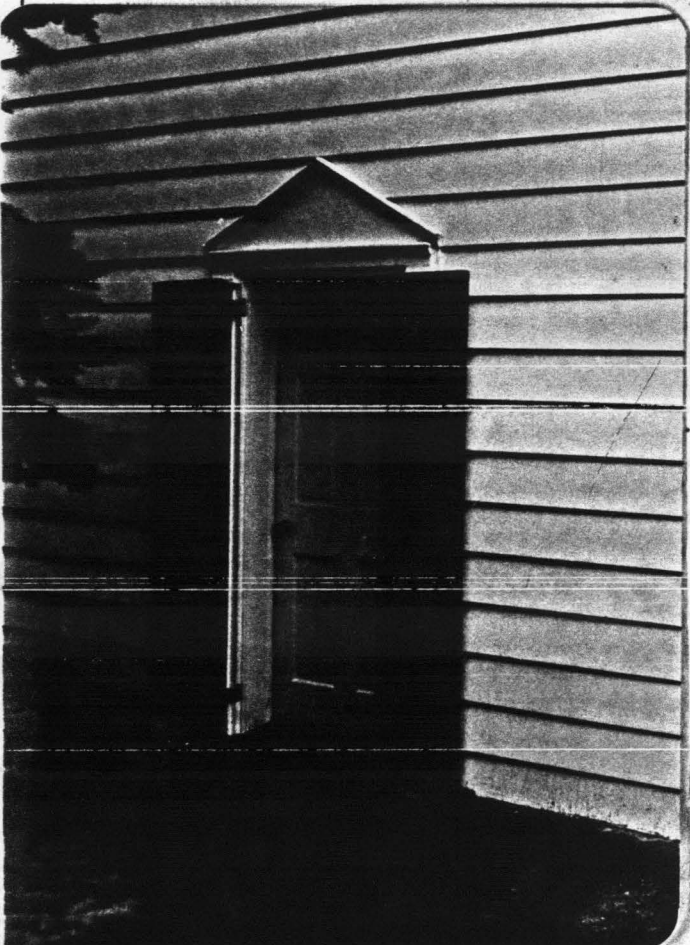
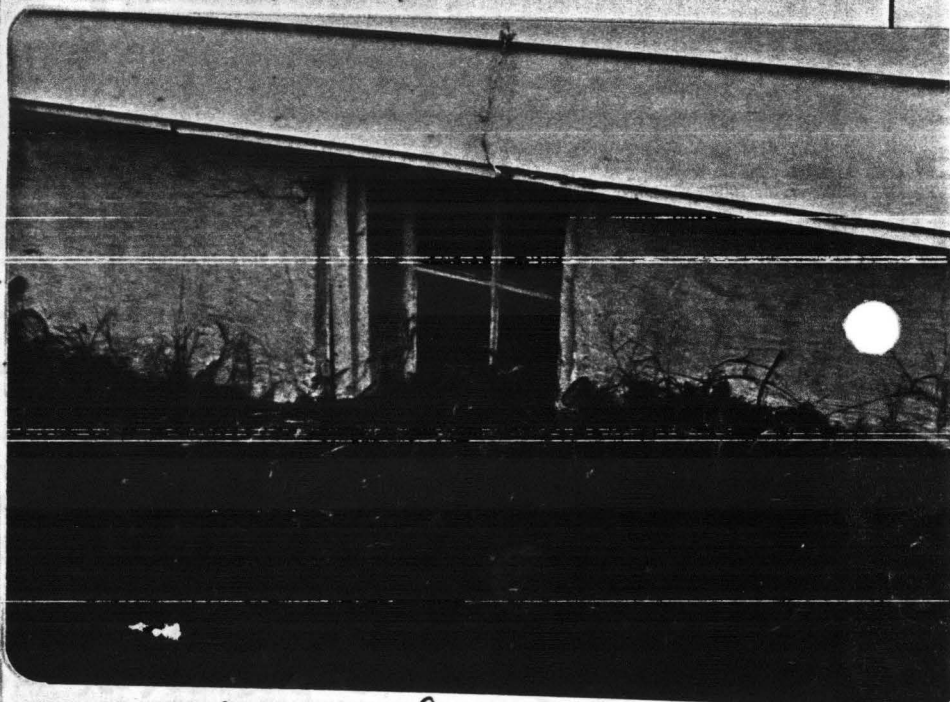
Horizontal barring of foundation windows is rather uncommon

Pedimented door treatment is

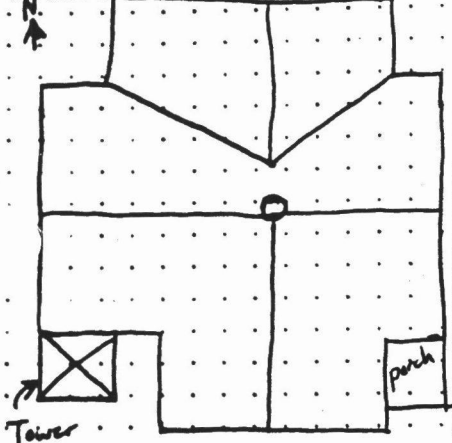
#1

18. primary building mat./construction
 coursed slate foundation;
 bricks, common bond

Combines numerous Victorian elements: Gothic, Queen Anne, and Romanesque Revival
 high banked foundation of coursed slate, no quoins; basic cross gable
 plan, 3 bays each gable; gable pediments decorated in shingling, plain
 fascia along gable peak, pediment bottoms closed with moulding; windows
 are basically tripartite lancets, flanking windows are a Palladian variation;
 bays are delimited by corbelled buttresses with metal caps decorated
 with rosettes; square tower with hipped roof is vaguely Romanesque, especially

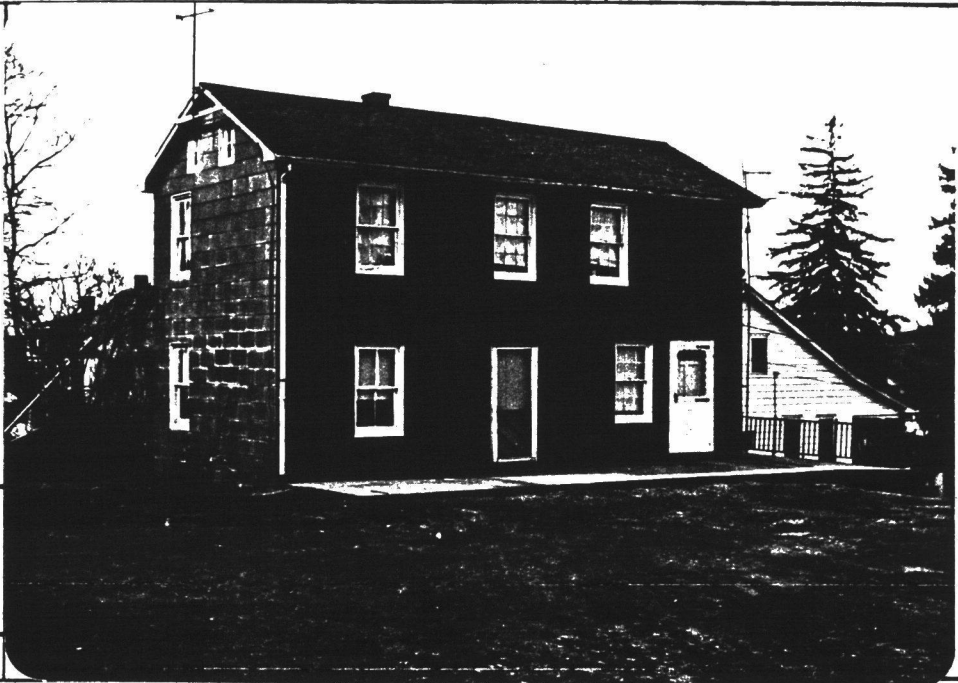
23

2 1/2 story, rectangular, I-house, narrow proportions of the Gothic influence; was probably 2 over 2 bays originally with addition built into N. gable; despite its proportions, the roof pitch is not steep; plain box cornice, returns are implied by the inward angle of the gable fascia bay frames - narrow, slightly milled; sashes 6/6 with a few replaced as 2/2 doorways have no transom lights; pediment windows - pair of 4-pane casements in S. gable; S gable eaves have single cross piece spanning above
 (continue on back if necessary)

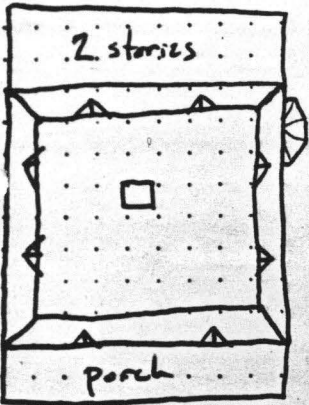
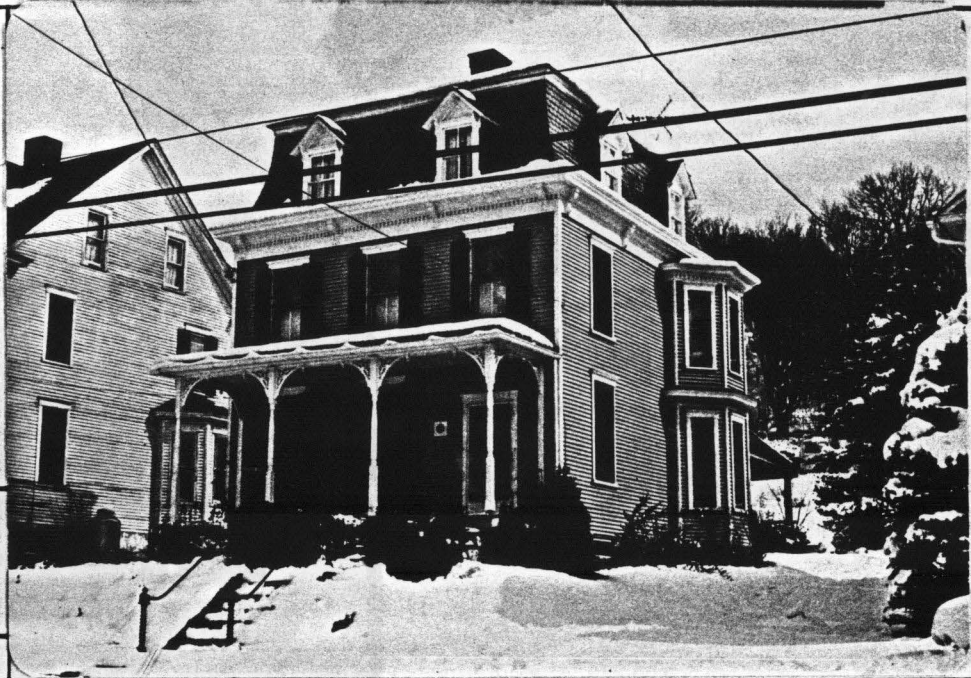
#10

3 story, classically proportioned mansard-roofed Italianate; 3 over 3 bays with rear addition; central chimney with corbelled coursing; slate mansard with hexagonal decorative coursing bands, geometric figures of red slates, central star with two flanking diamonds; pairs of small pedimented dormers in each roof-line, rounded tripartite motif in each pediment ; crown moulding at length of roof top; very deep cornice + frieze, plain with central dentilled motif, widely spaced decorative consoles, this extends

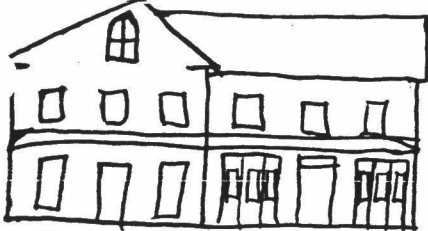
2 1/2 story rectangular with 3 bay wide L-shaped addition at E. gable end; structure is functionally 3/3 + 3/3; slate roof; corbelled double-end chimneys; mottled cornice and returns, returns also at facade pediment; facade pediment window-centered 2/2 sash with rounded peak (Italianate/Gothic) bay frames - plain, wide bowel, deep lintel which touches bottom of cornice, sawn appliques on fascia of lintel; sashes 2/2; doorway of rect. section has single-light transom, doorway flanked by two added bay (continue on back if necessary)

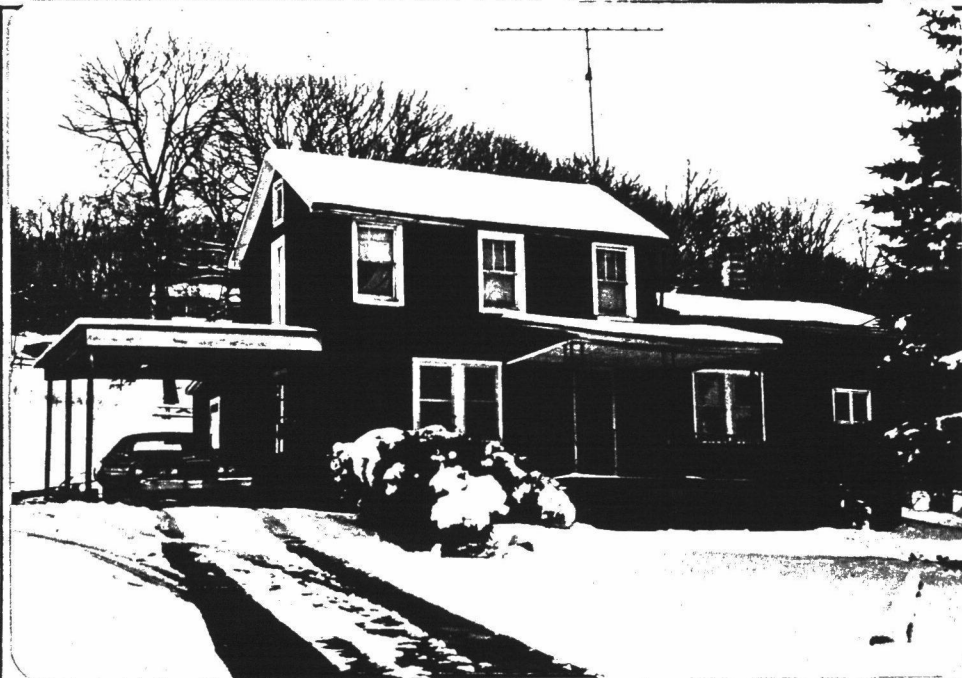
17

2 1/2 story, rectangular I-house with 1 1/2 story addition on W. gable; originally 3 over 3 bays; plain box cornice, shaped fascia board at gables; imply cornice returns; plain, wide bay frames;

3/4 sashes, vertically divided - rather unusual; doorway has no transom; pediment windows - centred 6 pane casement, each gable end

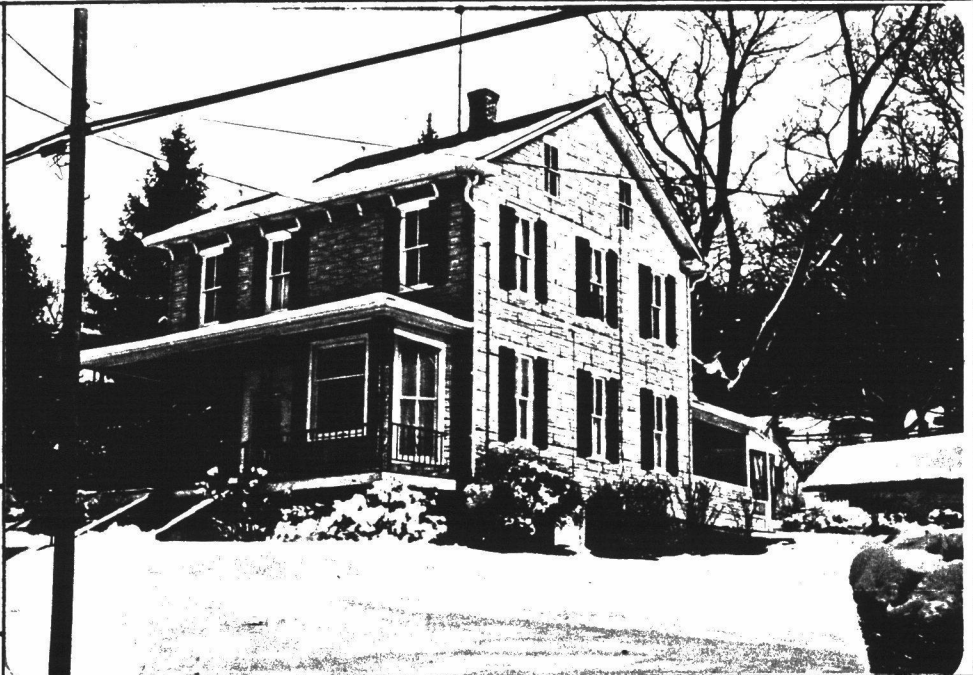
24. photo notation
#18

2 1/2 stories, rectangular with rear addition; originally 2 over 2 or 2 over 3 bays, 3 bays deep; slate roof; centre chimney; moulded cornice + returns; frieze hidden by siding, brackets in Gothic triangular configuration; brackets touch lintels, spaced to meet lintels at their outer edges - N.B. - unevenly spaced brackets in centre of facade; bay frames plain, wide board with small lip; sashes 2/2; window bays slightly elongated; pediment windows - pair of large 2/2 sashes

27. history, significance and/or background
each gable end; unusual treatment of bay added to E. gable but not unique in Delta

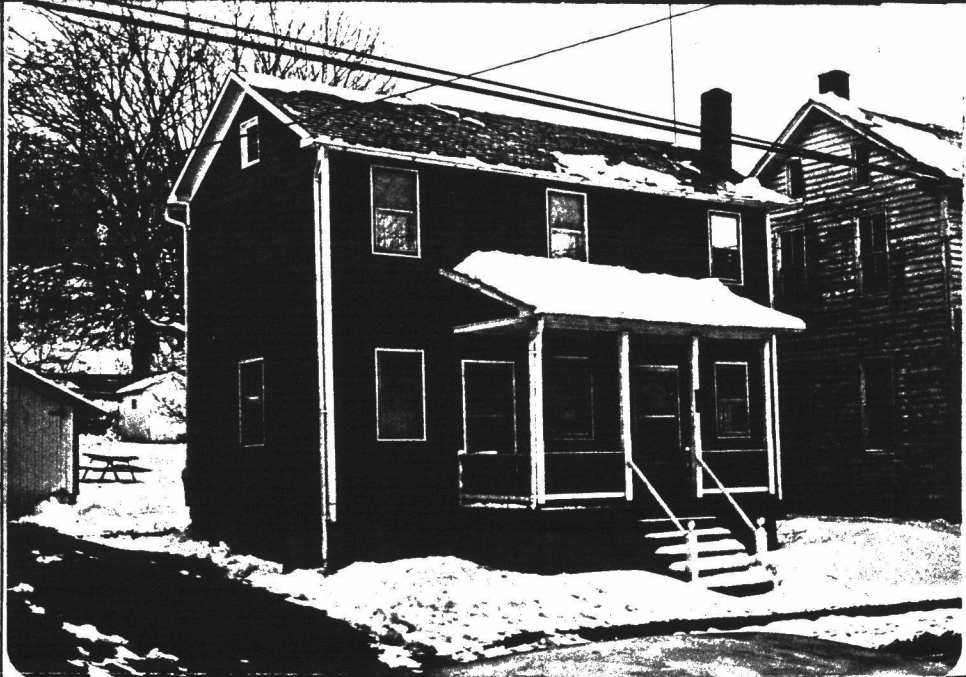
2 1/2 story, rectangular frame I house was originally 2 over 3 bays. House extended via lower 2 bay addition to the west. Original single end chimney replaced with cinder block masonry. Slate roof has plain box cornice and small returns. Original 6 over 6 sash windows have been replaced by lower 1 with narrow, beaded frames + storm windows. Each gable eave has wide frieze board and a central 4 pane casement window. Original structure covered with wide alpineboard siding and medium width corner boards. Coursed slate foundation is covered with concrete. One story, 3 bay, shed roofed porch across central portion of facade has implied cornice returns and is supported by chamfered wooden posts and enclosed by a decorative sawn balustrade. Porch foundation has open lattice work on front and concrete covered slate on sides.

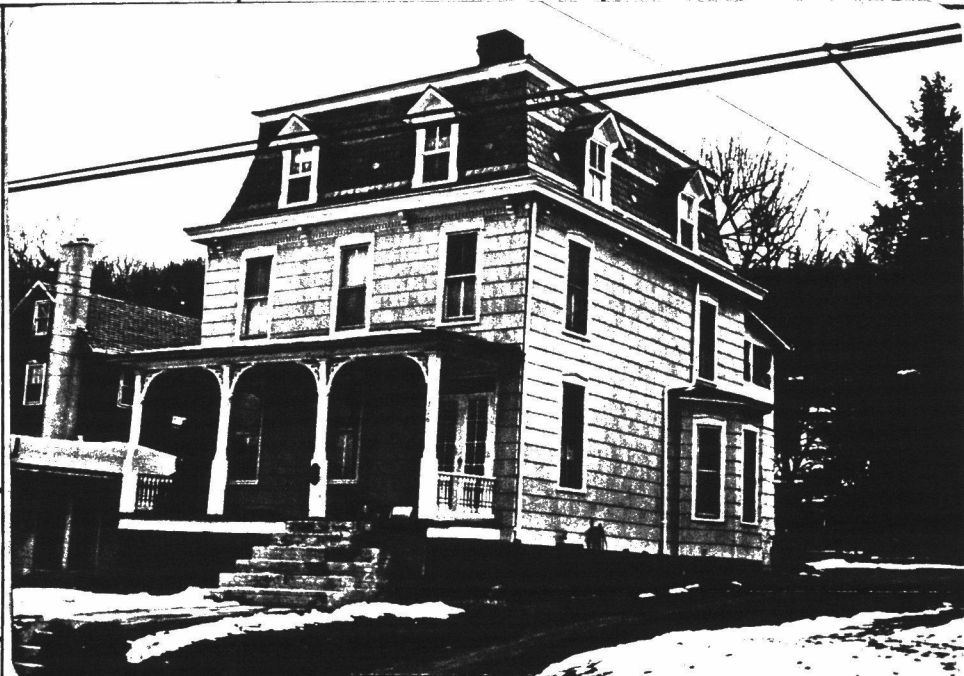
#24

3 story, squared rectangle, Italianate influences; mansard roof, slate roof, decorative courses and motifs in red + yellow slates; moulded cornice (runs 3/4 around structure) dentilled motif under, rather small, widely spaced brackets complete entablature decorations; pedimental dormers in pairs - have bracket supports, sashes 2/2, sawn applique in pediment; bay frames - wide, edged outline in 1/4 round moulding, shallow-pinked lintels with sawn appliques in fascia; bay openings

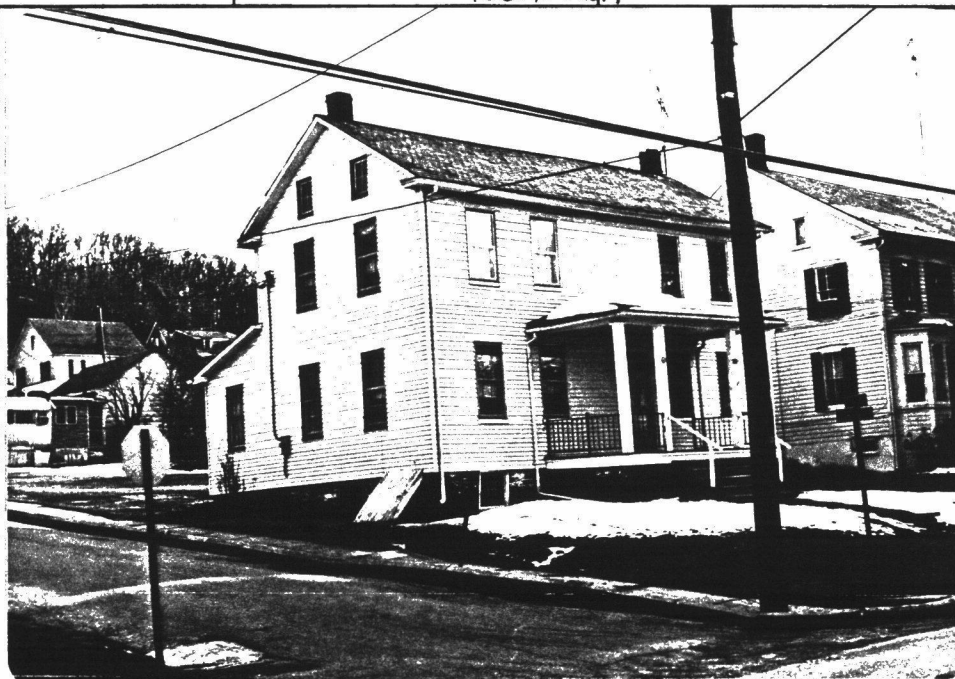
#38

2 1/2 stories, rectangular, with rear addition; slate roof with snow stops removed; double-end corbelled chimneys; milled cornice + returns; bay frames - plain, narrow; sashes 6/8; downspouts placed in center of structure, E door sided over; remaining downspout has

2-light transom, door - Italianate round panel; pair of 6-panel casement windows in foundation facade; pediment windows - 4 panel casements in pairs, each gable end; rear porch addition has

cornice returns; porch foundations have well shingled slate quoins

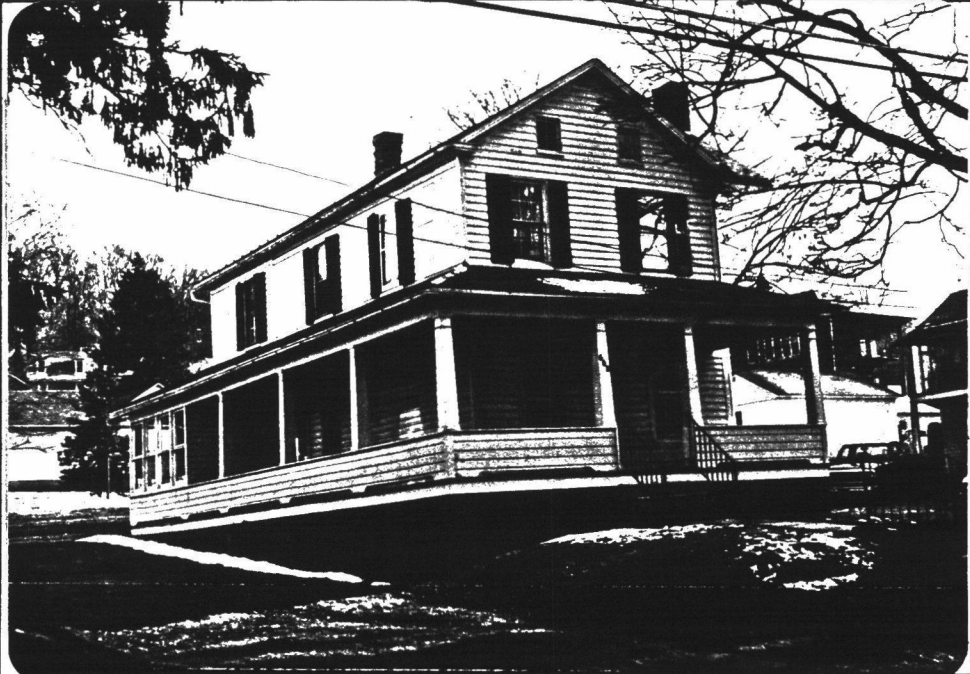
#41

2 1/2 story, rectangular gable end to street;
 slate roof; ^{with snowbirds} tall chimney, central rear interior;
 shallow board-shaped cornice + returns, frieze
 under; bay frames - plain, narrow, bead on inside
 of frame; 6/8 sashes; narrow doorway - 3-light
 transom; lower story windows - plain, wide
 frame, 4 sashes; W. long wall has 2 story added
 bay window, top story has chamfered roofline with returns - ashlar slate
 foundation, chimney obviously modern;

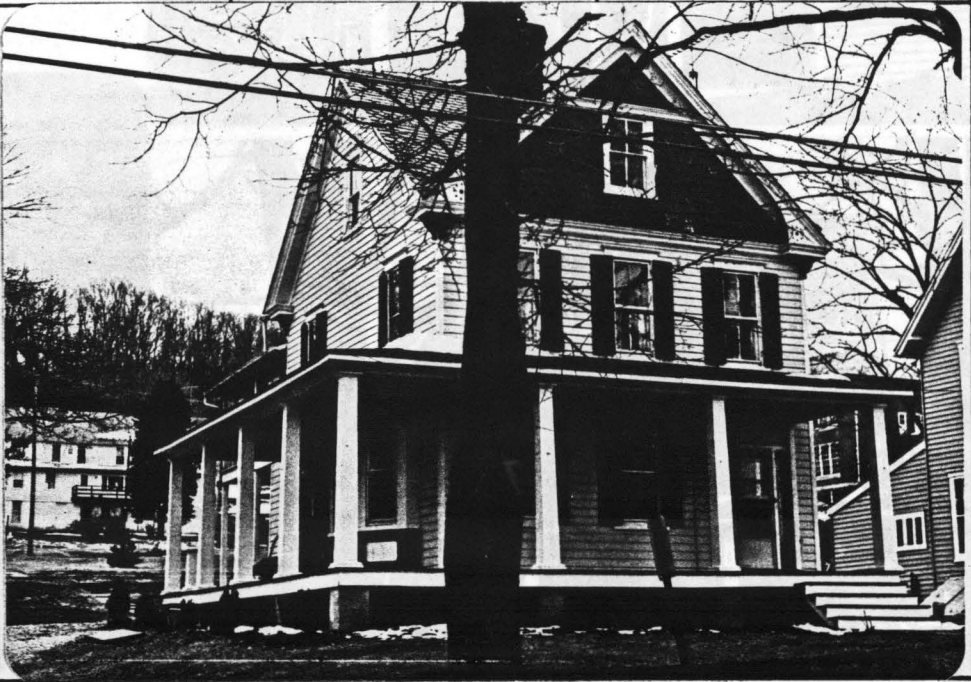
<p>X - LIGHTNING RODS WITH WHITE MILK GLASS GLOBES</p>		2. municipality DELTA BOROUGH	
24. photo notation #12

<p>2 1/2 stories, rectangular, cross gables with T-shaped addition in rear, 3 over 3 bays; slate roof with decorative courses of hexagonal tiles; corbelled central chimney; equality of dimensions of the gables allows this structure to function visually as if it simply had its gable end to the street in the Greek Revival fashion; moulded cornice + interesting treatment of returns and brackets; facade and pediment decorated in U-shaped fish scales (Queen Anne), vergeboard at eaves flairs downward to the</p>		4. survey code 133.7.42

27. history, significance and/or background back edge of the return, has circular drilled designs at the flared bottom; (reminiscent of the major axis outlines of an English crutchcase), pediment window has small cornice moulding crossing the lintel top; bay frames - wide, plain with small lintel cap; sashes 3/4; doorway has long single pane side lights, wooden moulded piece at transom, all is recessed; 1 story bay window		29. prepared by: T. Schaefer		30. date 3/81

28. sources of information on E. gable, top is chambered with decorative brackets + pendants; pediment windows - large central 3/4 sash, each gable end; structure curved in deep bevelled Germanic siding, narrow corner boards; porch roof has cornice returns		(continue on back if necessary)		(continue on back if necessary)

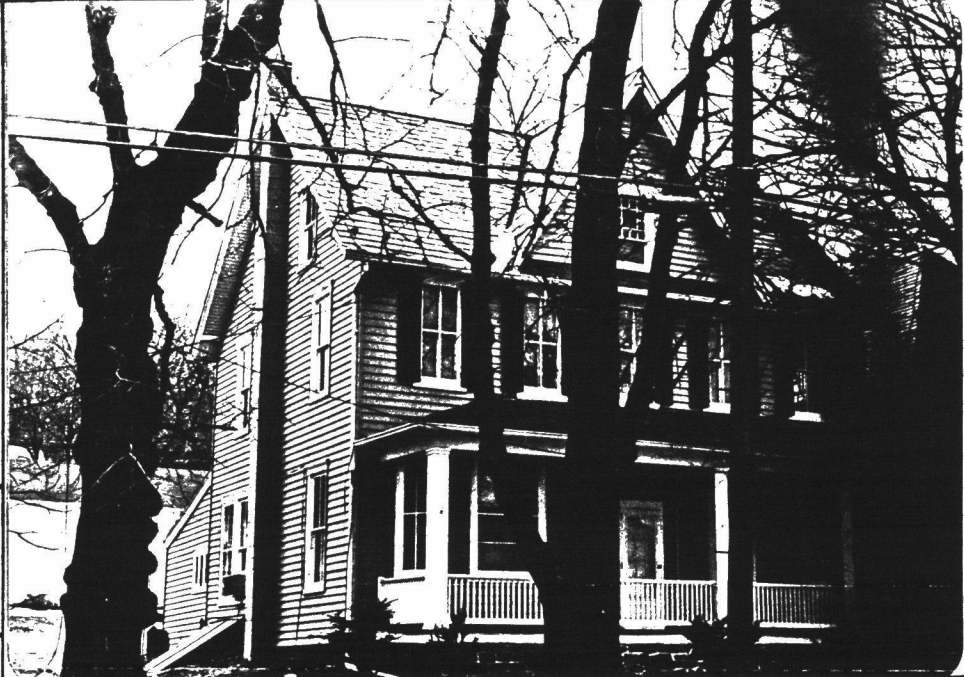
#43

2 1/2 stories, rectangular, tall proportions, sharply pitched V-dormer, originally 5 over 5 bays with central doorway; slate roof, snow birds intact, original single-end chimney removed; dormer details hidden by siding, sashed window is one over one over one large single pane, dormer pediment closed by small pediment; bay frames plain, wide boards with small corbelled lintel cap; sashes 2/2; lower story facade windows are elongated to floor; doorway over hood

transom and side lights, replaced with glass blocks; one story bay window added to facade, short side angles, wide facade plane; hip-roofed porch supported by plain piers; pediment windows - ~~large~~ pair of large 2/2 sashes, each gable end

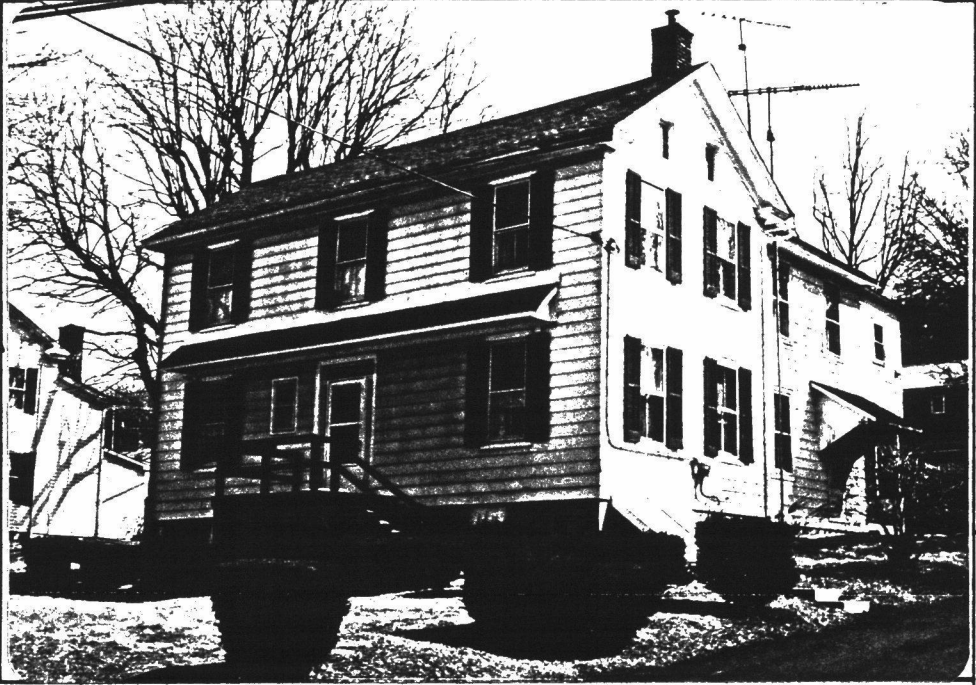
2 1/2 stories, rectangular with rear addition, 3 over 3 bays with central doorway; originally had slate roof; single-end chimney; it should be noted that the facade bays are very widely spaced the long-wall of this structure is proportionally unusual;

moulded cornice + returns; moulded verge at gable ends with wide frieze and band of moulding under; bay frames - plain board with moulded outline of outside edge; 3/2 sashes; doorway has 2-light transom, narrow 2-panel
 (continue on back if necessary)

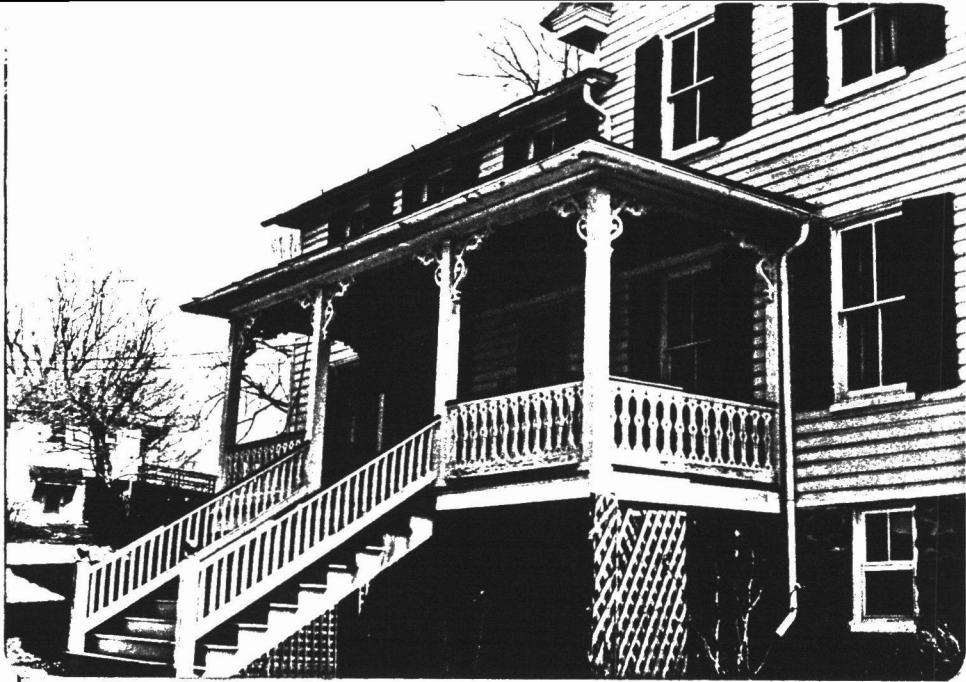
133-7.69

N.B. [→] steep line of the
balkhead is a fairly
common feature in Delta

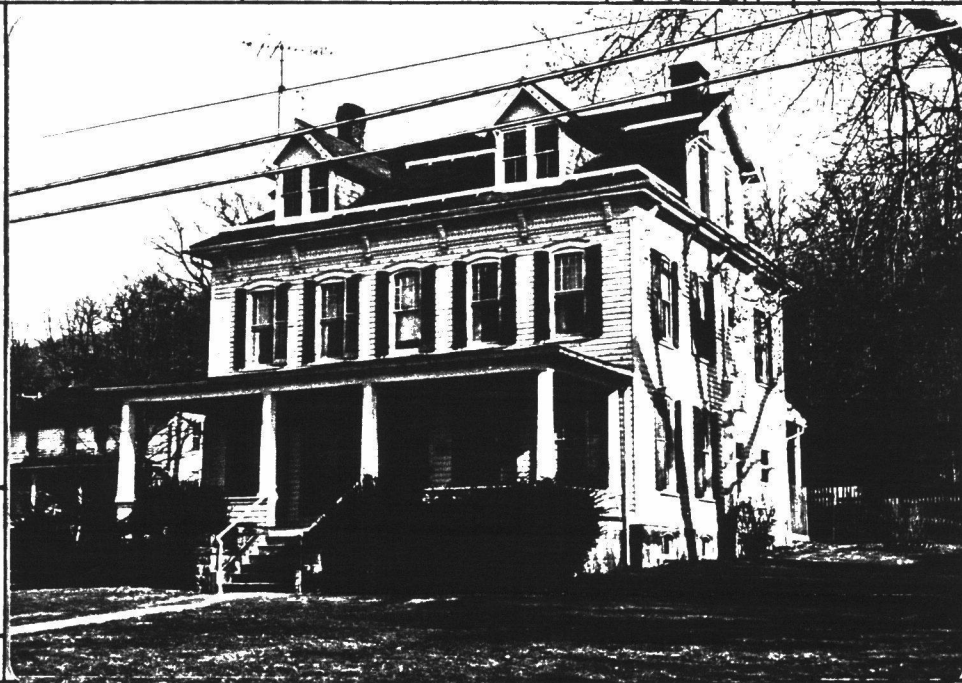
3 stories, squared rectangle, hipped roof with gables and dormers; 5 over 5 bays, central doorway; slate roof, snow boards intact; tall, corbelled double-end chimneys; gable dormers decorated with fish scaling pediment in fill is vertical boarding, perforated verge-board at eaves; sashes $\frac{Q.A.}{2}$ - (Queen Anne small panes over regular 2-pane lower sash) - dormers in frame have same

basic treatment; deep entablature running $\frac{3}{4}$ of structure - features shallow corbels and incised floral motifs, consoles extend beyond bottom of entablature - not on
