National Register of Historic Places Registration Form

historic name Strickler Family Farmhouse other names/site number County Farm

street & number 1205 Williams Road not for publication N/A city, town York (Springettsbury Township) vicinity N/A state Pennsylvania code PA county York code 133 zip code 17402

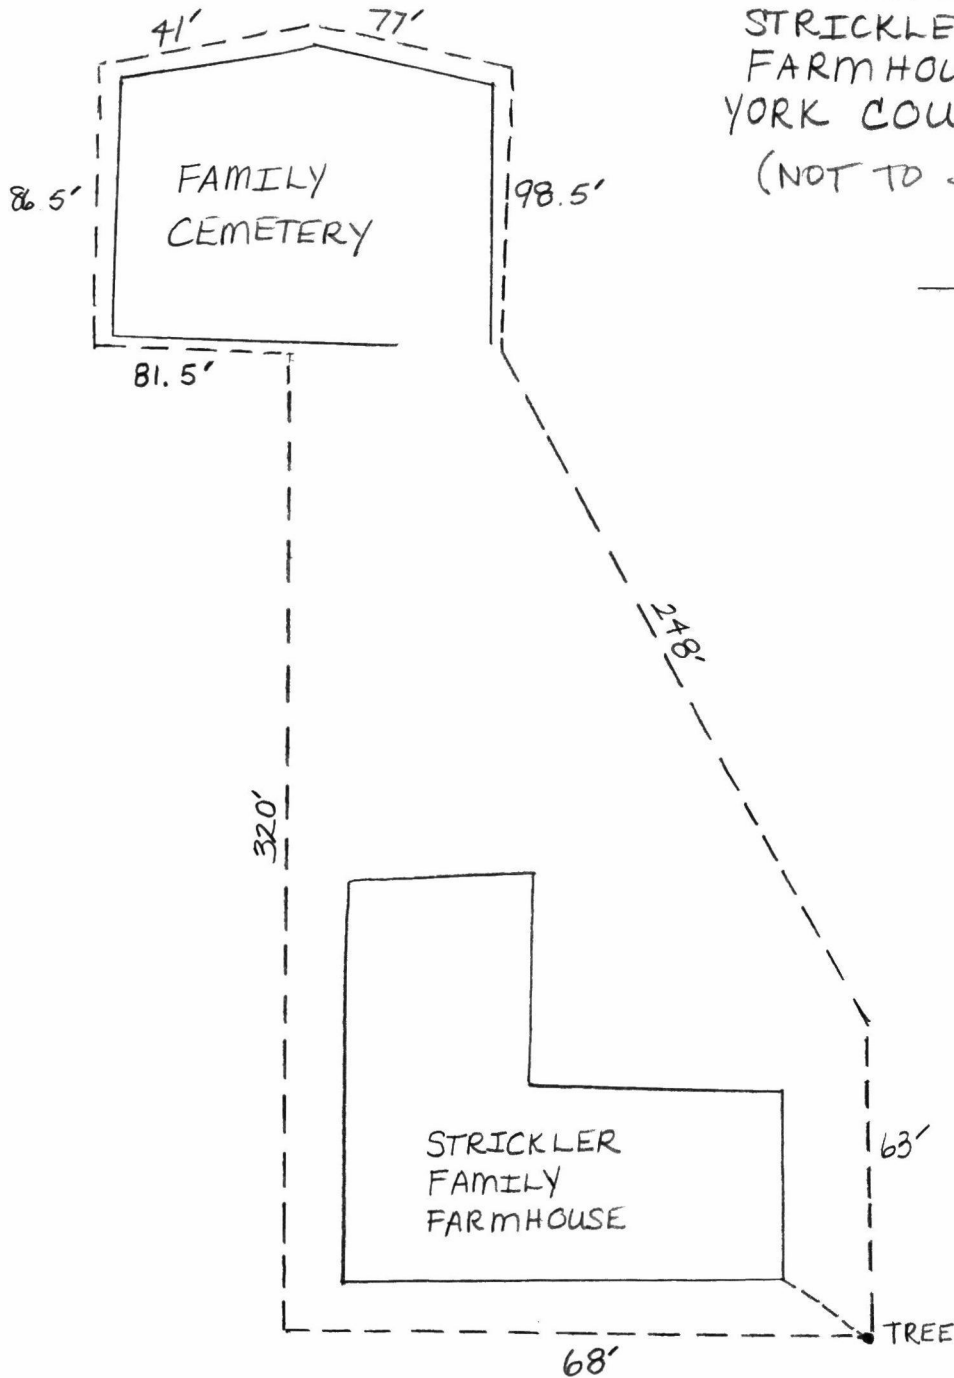
Strickler Family Farmhouse
Sketch Map- Boundaries

SKETCH MAP SHOWING
BOUNDARIES FOR THE
STRICKLER FAMILY
FARMHOUSE
YORK COUNTY
(NOT TO SCALE)

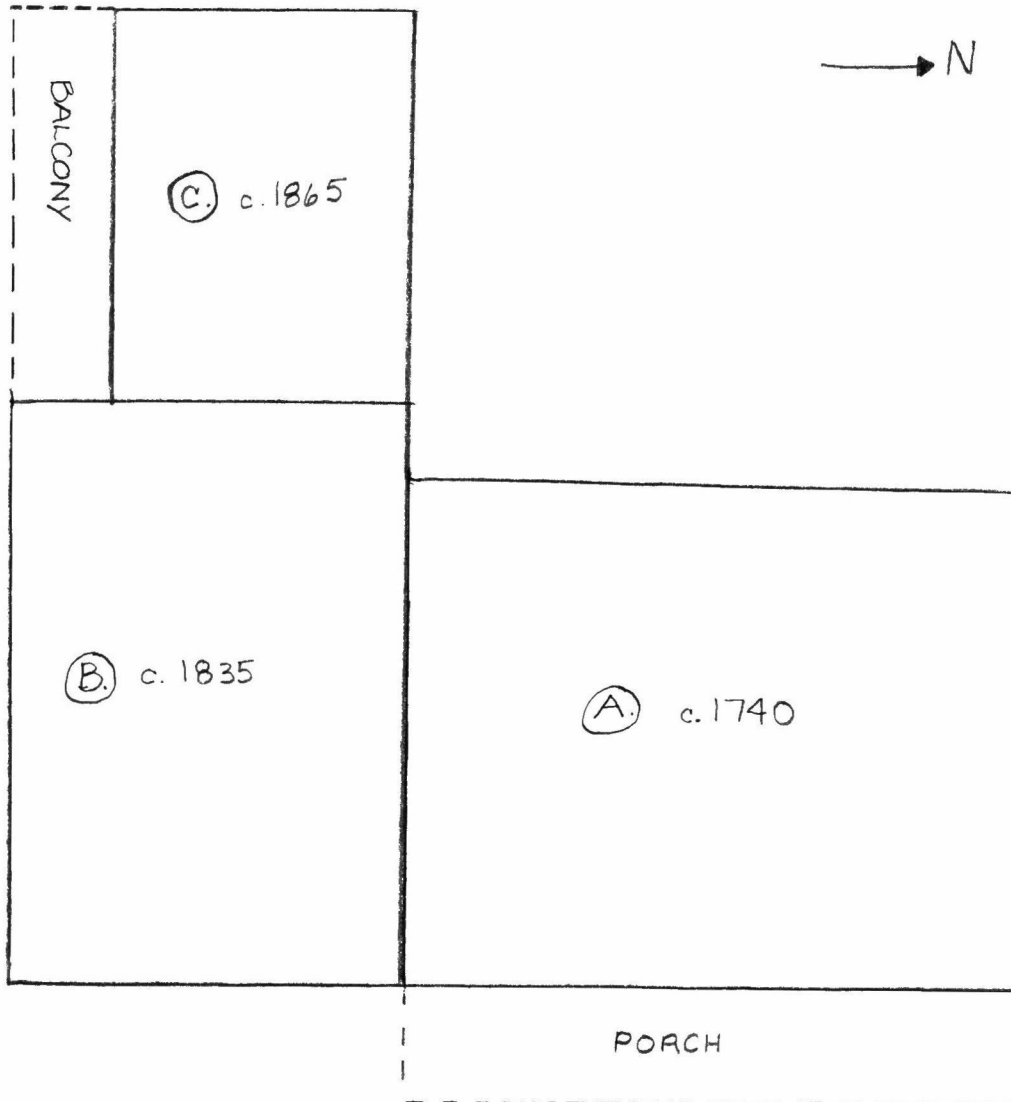
Strickler Family Farmhouse
Sketch Map- Site Plan

STRICKLER FAMILY FARMHOUSE
YORK COUNTY
SITE PLAN

The Strickler Family Farmhouse is located at 1205 Williams Road in Springettsbury Township, York County, Pennsylvania. The farmhouse is located on a larger parcel of land owned by the County of York. This larger parcel contains county offices, a retirement home, and the county prison. The farmhouse itself sits in the center of the larger parcel, but it is separated by a fence which surrounds the prison and a small branch of the Kreutz Creek. The house is surrounded by two barns of later construction, and the family cemetery where generations of Stricklers are buried. The Strickler Family Farmhouse was built in three successive stages. The main house (A), constructed of limestone, was built c. 1740 and shows a mid-18th century Germanic influence. In the mid-19th century two brick additions were added. The first (B), extending from the south facade of the main house, is a 2 1/2 story brick Georgian wing built c. 1835. A 2 story brick ell (C) extends from the west elevation of the brick wing. The original stone farmhouse, its accompanying additions, and the family cemetery have remained nearly intact over a 250 year period.

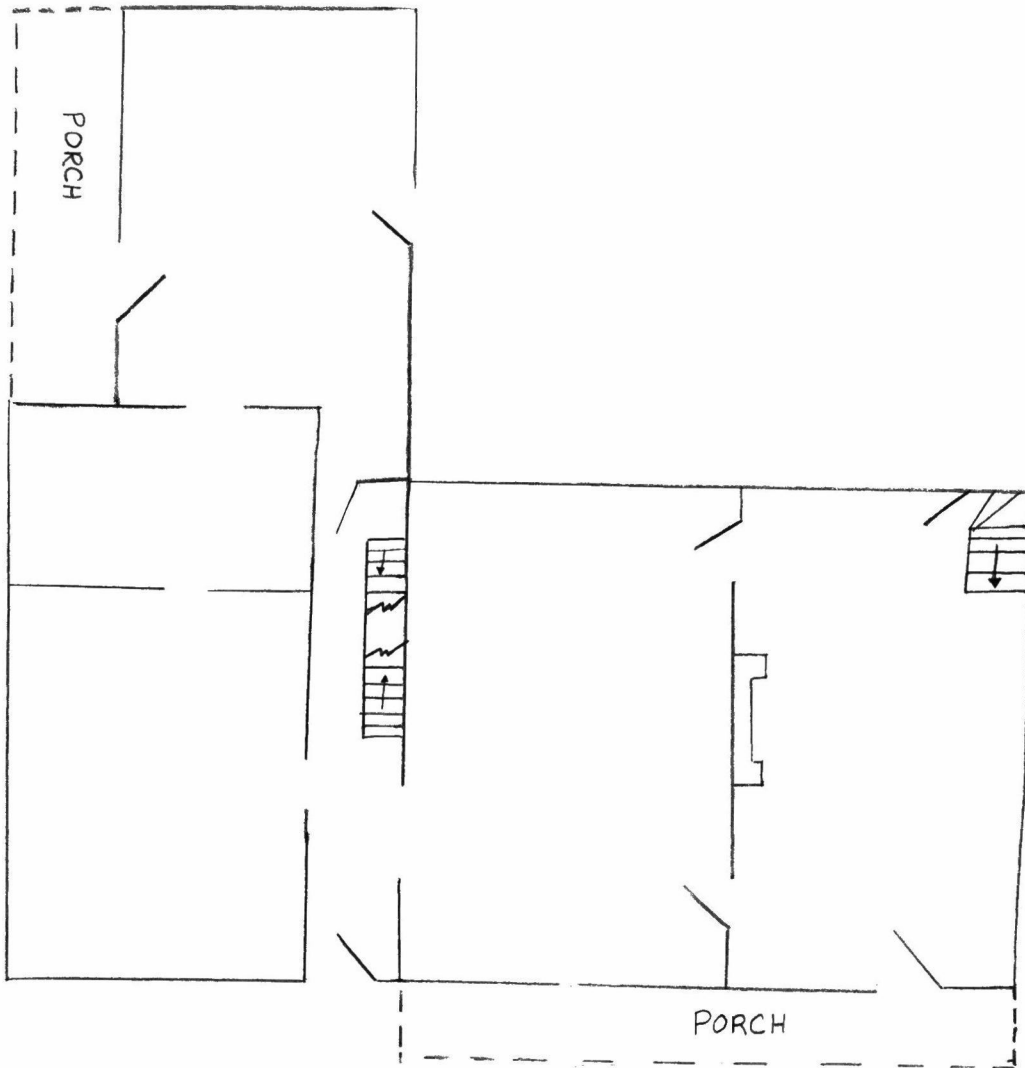
Strickler Family Farmhouse
Floor Plan- First Story

STRICKLER FAMILY FARMHOUSE
YORK COUNTY
FLOOR PLAN
FIRST STORY

The interior features a typical Pennsylvania German floor plan. The first story consists of two rooms (north and south) divided by a stone partition wall with a central chimney and a cooking fireplace which opens into the north room. The fireplace contains an arched opening (now bricked in) which would almost certainly have been connected to a decorated warming stove in the south room. On the hinged side of the sliding panel exterior door, there are a series of large pintels which suggest there was originally a board and batten door hung on strap hinges. Two doors, one on each side of the fireplace, lead into the south room. The east door has four panels and is held in place by strap hinges. The west door is taller and narrower than the east door and its hardware suggests a late 19th century installation date. It is a batten door with a small square four-light opening in the top half. In the northwest corner of this room is an enclosed stairway which leads to the second floor. At the entrance to the stairway is a batten door with a hand wrought thumb latch. The ceilings are covered with what appears to be original plaster.

The interior floor plan of the brick wing (B) and the brick ell (C) features a side hallway on the north side of the wing, two rooms on the south side of the wing and one large room in the ell. All exterior doors in the wing and the ell have three horizontal panels on the top, two vertical panels on the bottom and box locks. All doors are topped by three-light transoms. The exterior door on the east perimeter wall of the wing leads to a side hall where a staircase with a turned baluster extends all the way to the attic. The staircase also features applied decorative pendants on the ceiling of the first story. The entire first story contains original trim, chair rail, and baseboards. Of particular interest are the plain corner blocks and complex trim built of dimension lumber in the brick wing's two rooms and hallway. The large room in the ell features an exterior door on both the north and south perimeter walls. At some point the room was used as a kitchen, and it still contains a sink, counter top, and upper cupboards on the west perimeter wall.

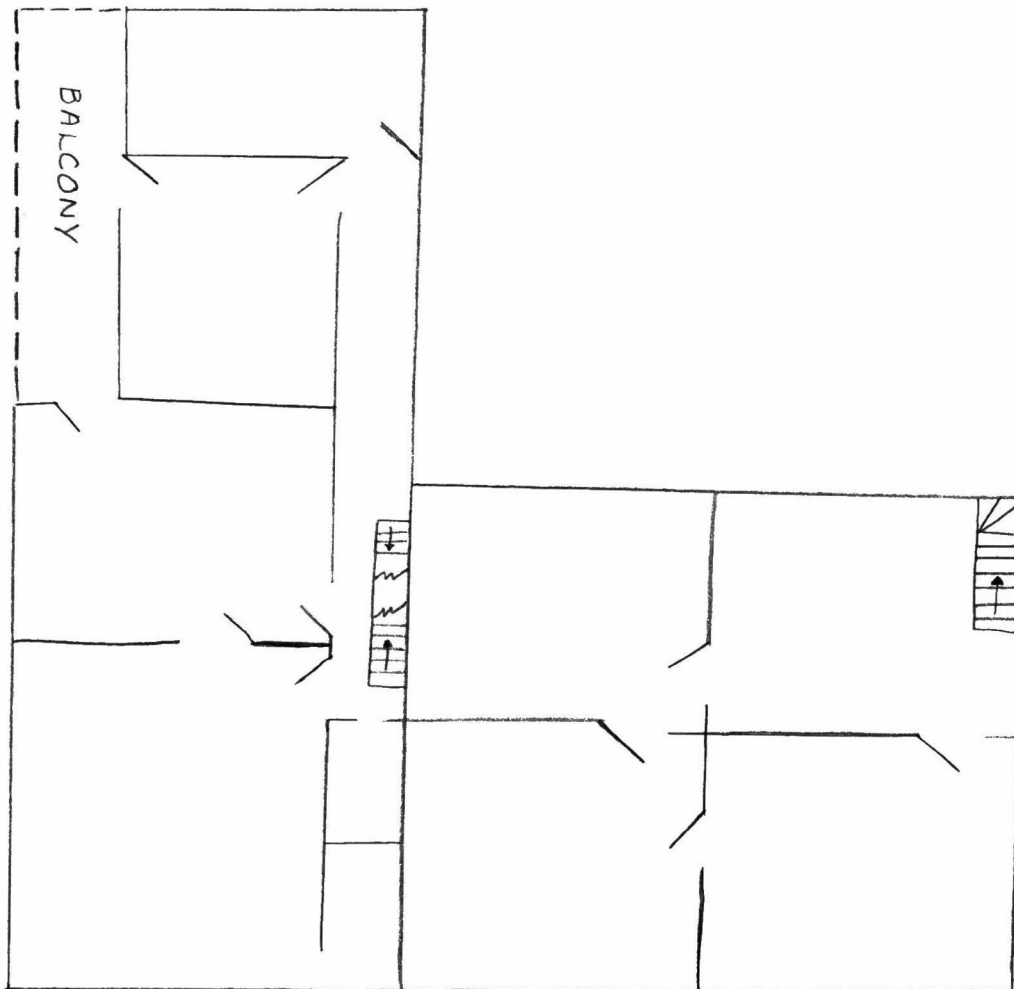
Strickler Family Farmhouse
Floor Plan- Second Story

STRICKLER FAMILY FARMHOUSE
YORK COUNTY
FLOOR PLAN
SECOND STORY

On the second story, there are four rooms divided by board partition walls. The partition wall which extends from the east perimeter wall to the west perimeter wall appears to be original, while the north to south perimeter wall is a later addition.

The second story floor plan includes two rooms on the south side of the wing accessed by a hallway on the north side. There are two rooms in the ell, one on the southeast side and one extending across the rear of the ell. The ell also contains a balcony which can be accessed from the southeast room of the ell and the southwest room of the wing. The second story contains the same plain corner block dimension lumber trim of the first story. Most of the plaster and trim appears to be original.
