National Register of Historic Places Registration Form

historic name Zeigler, John Farm House
other names/site number N/A

street & number 1281 Mountain Road
city, town York Springs (Latimore Twp.)
state PA code PA county Adams code 001 zip code 17372

The John Zeigler Farm House is a 2½ story, 3 bay brick farm house of early 19th century Federal style with modified Georgian plan. Built in 1817, it has exceptional integrity and has recently been restored. Surrounded by farm field, the Zeigler Farm House also retains its agricultural context.

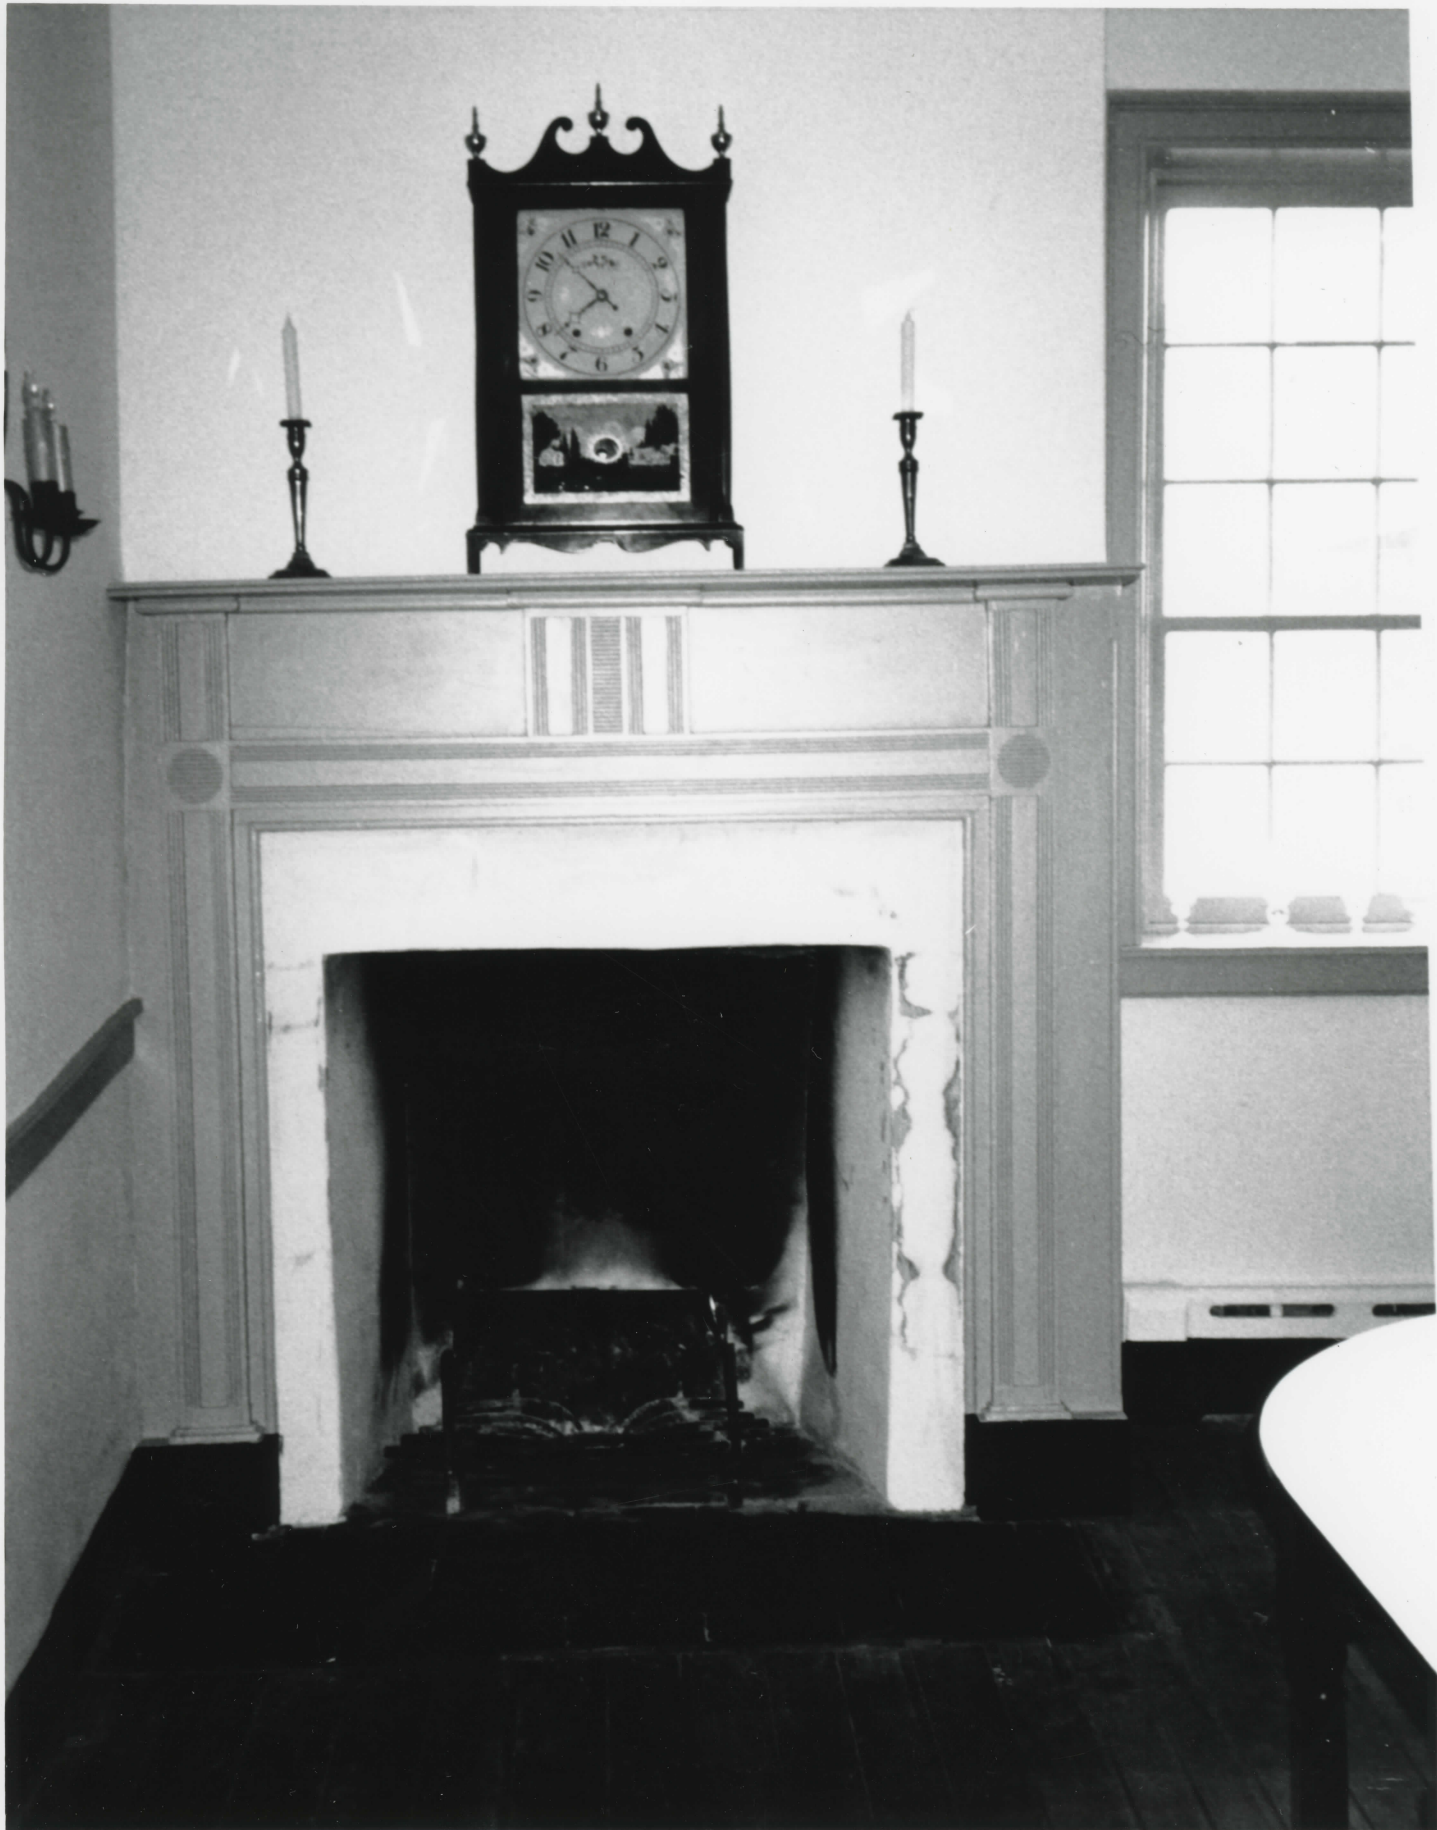
Rear parlor toward west

The rear parlor, less ornate than the front parlor, retains its original woodwork. The fireplace mantel is geometric with reeded detailing. An original exterior door in the northeast corner leads into the room. Peg rails are on the southern and eastern walls. An enclosed staircase, c. 1900, was removed from the northeast corner during restoration.

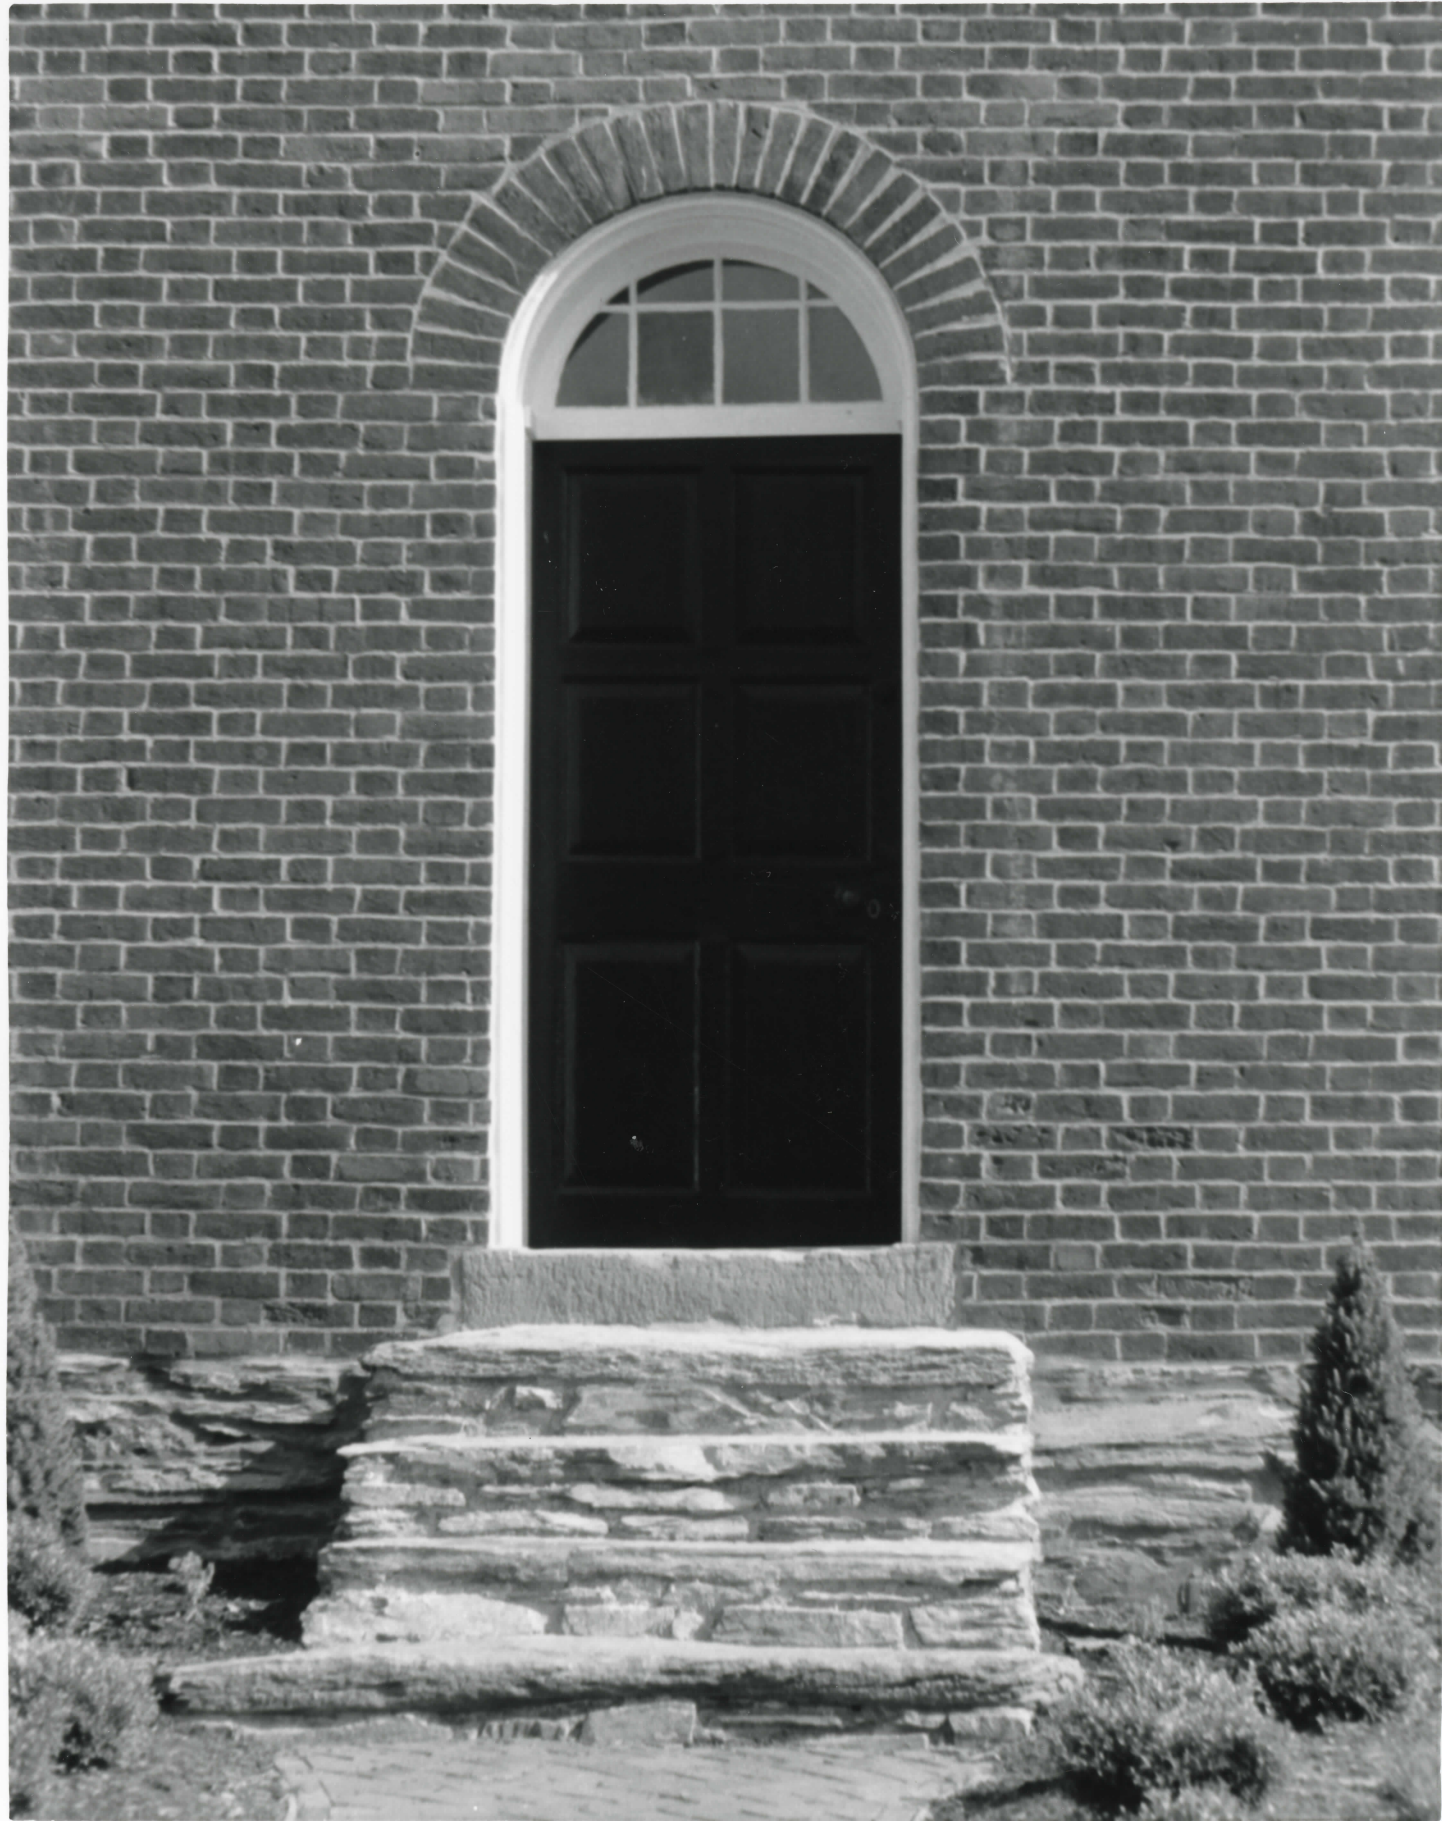
2

South Facade - front door

The Zeigler Farm House is comprised of a main block and a rear ell. The main block has a fieldstone foundation. The south facade is 3 bay, 2½ story with flemish bond red brick. The main door, on the east of the facade, is six panel wood semi-circular fan light topped by a brick arch. The windows are wooden, 9/6 with flat brick arches above. All window sashes in the house are reproductions of an original found in the attic. (Original windows had much earlier been replaced.) All shutters are original. All brick was cleaned and repointed during restoration according to Sec. of Interior guidelines.
