National Register of Historic Places
Registration Form

historic name Boyer-Mertz Farm

other names/site number Angstadt Farm

Agriculture in Berks County: 1700-1945

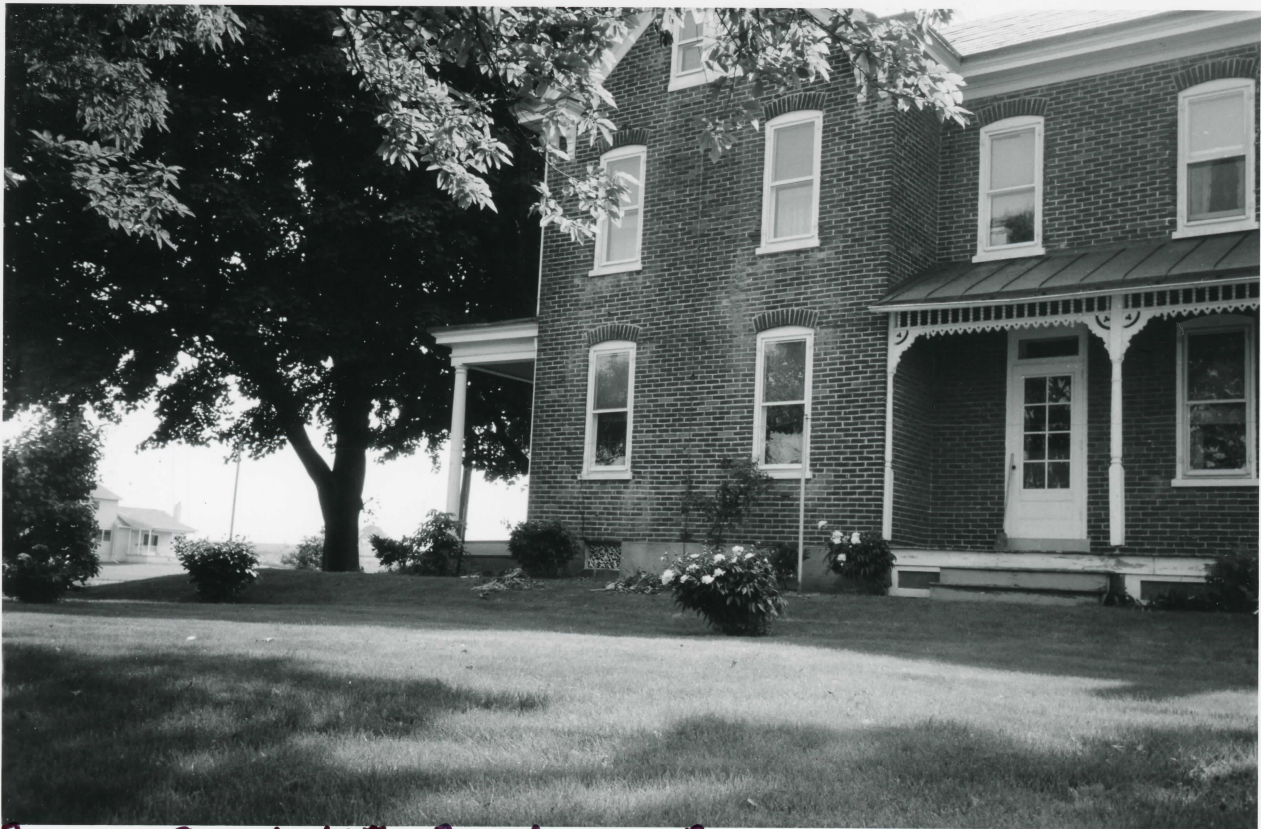
#1

The 1905 brick farmhouse has a cross gabled roof and incorporates high style features of the Late Victorian period. The two-and-one-half story house features a Colonial Revival front porch supported by four Doric columns in front and a fluted pilaster on each rear corner. The double door with transom above is in a center projection and there are two double windows on either side of the door.

There is bracketed trim on the molded cornice and cornice returns. The frame arched lintels above the windows and doors have gougework trim. The second floor front has five windows, four with paneled shutters, and there is a small arched window in the peaked gable. Jigsaw trim is featured on the west side two tiered porch. The windows on the east side porch have paneled shutters as do the two windows on the one story wash room extension to the rear (built as an original part of the house). All windows have 1/1 window sash and like the doors have brick arches above the lintels. The east side has two basement window openings covered with very decorative wrought iron grilles with pineapple finials while the two steel window grilles on the west side are quite plain. There is an exterior chimney on the main rear block of the house for the kitchen stove and one on the west cross gable.

Boyer - Angstadt Farm Berks Co., Pa.
East Elevation 1905 Farmhouse

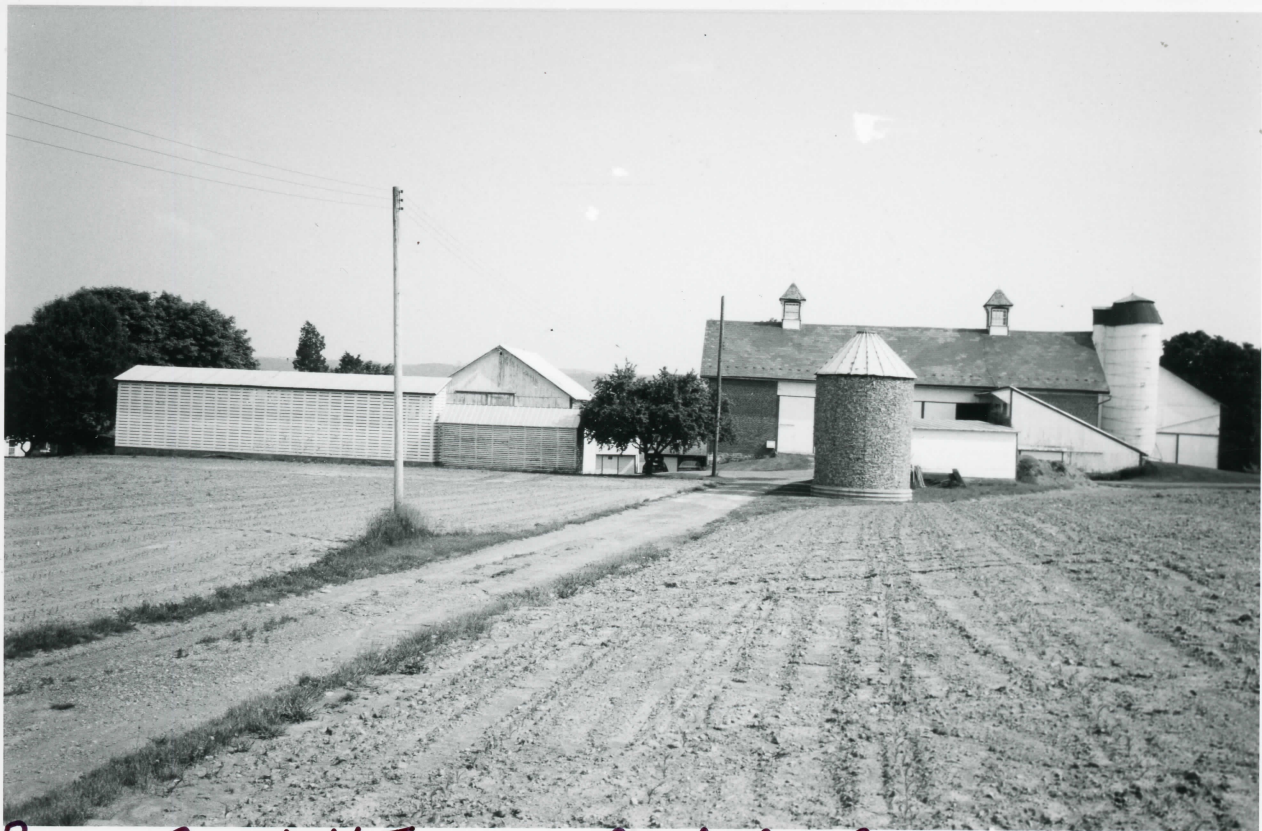
The gabled brick end barn with a tin roof has a a datestone which reads - 1871 Benneville and Mary Boyer. The stone foundation has a peiler eck. The forebay of the barn has been enclosed in order to add more light and room in the stable area for dairy cattle. The barn has five bents and the roof has a wooden hay track with metal carriage and standard truss system (Ensminger). Entrance to the threshing floor is on the bank end, and the granaries located in the forebay area are intact. A hay barn addition was added to the front and west side of the building. The rear addition at the northwest end of the barn was the former horsepower room. Shaft, pulleys, and wheels for the horsepower are intact but not in place. The west side of the power room is built into the bank which contains a large cistern for barn use. The barn has two cupolas on the roof for ventilation and light. Hex signs are painted on the south end of the barn, there is a wood silo on the west side no longer in use.

Wagonshed/corn crib - frame, two story has a gable tin roof with a frame addition to the east side. The large hex sign on the exterior duplicates those on the barn.

Buggy shed - one story, frame vertical sided, tin shed roof had been used to store buggies and is now used as a tractor shed.

Bayer-Angstadt Farm. Berks Co., Pa. #2
North side of barn showing corn crib, Wagon shed, Buggy shed

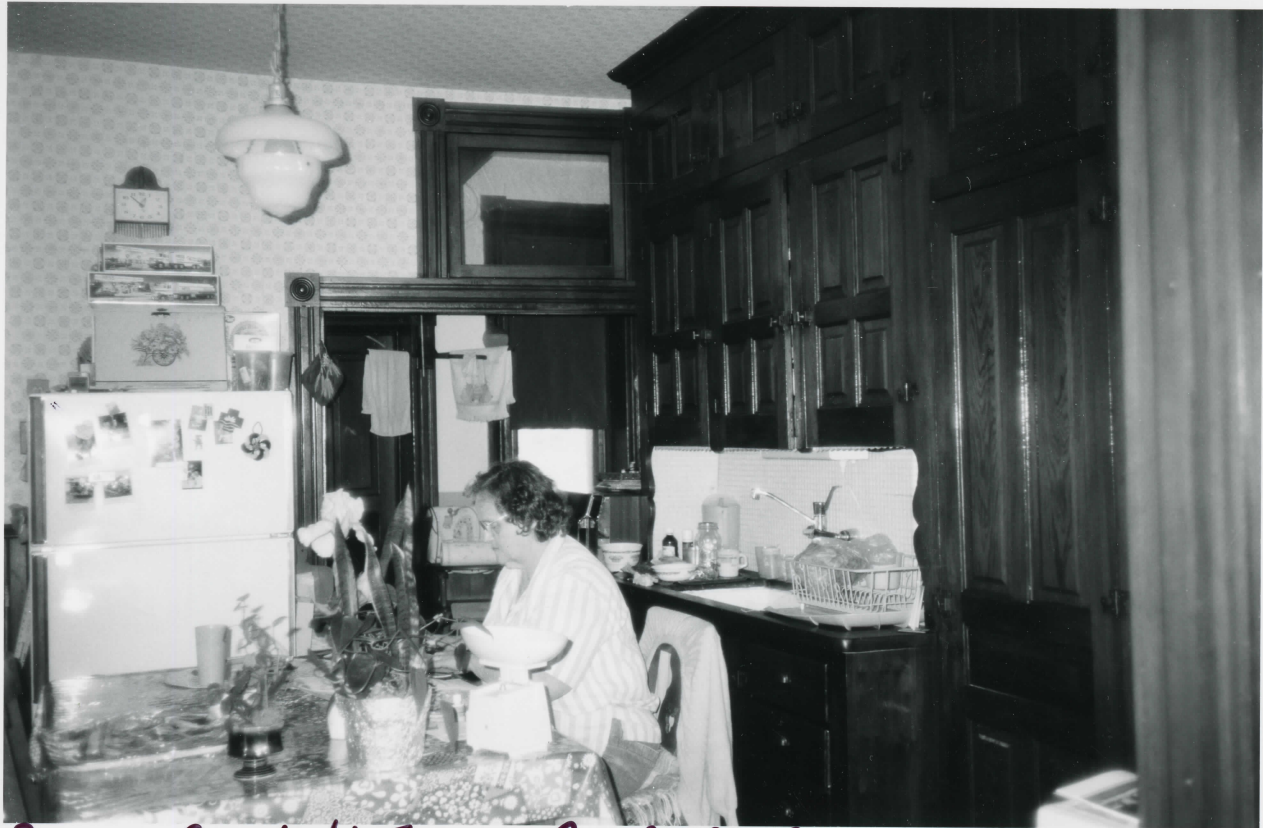
Bauer - Angstadt Farm Berks Co. Pa. 7/Emur 1905 Kitchen #3

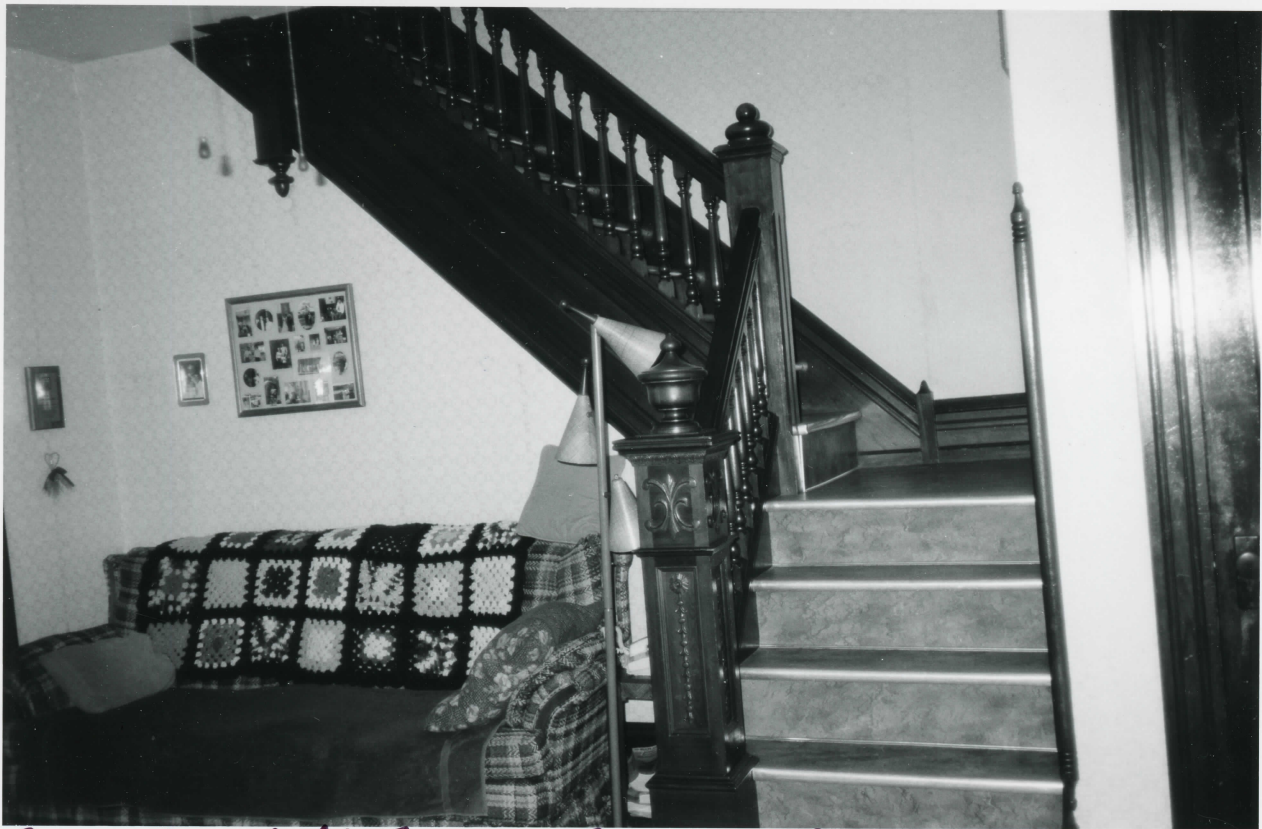
#4

The interior of the house, like the outside, is little altered. The trim is unpainted cherry wood throughout. The open stair in the living room has square newel posts with acorn motifs and turned balusters. The built-in-cabinets in the kitchen are also cherry. The molded surrounds on windows and doors feature rosettes within squares on each side of the lintels. The small room to the rear of the kitchen has a raised brick hearth with an inset iron kettle, which the present owner states was used to heat wash water.

Bayer Angstadt Farm Berks Co., Pa.
Parlor - 1905 house east view

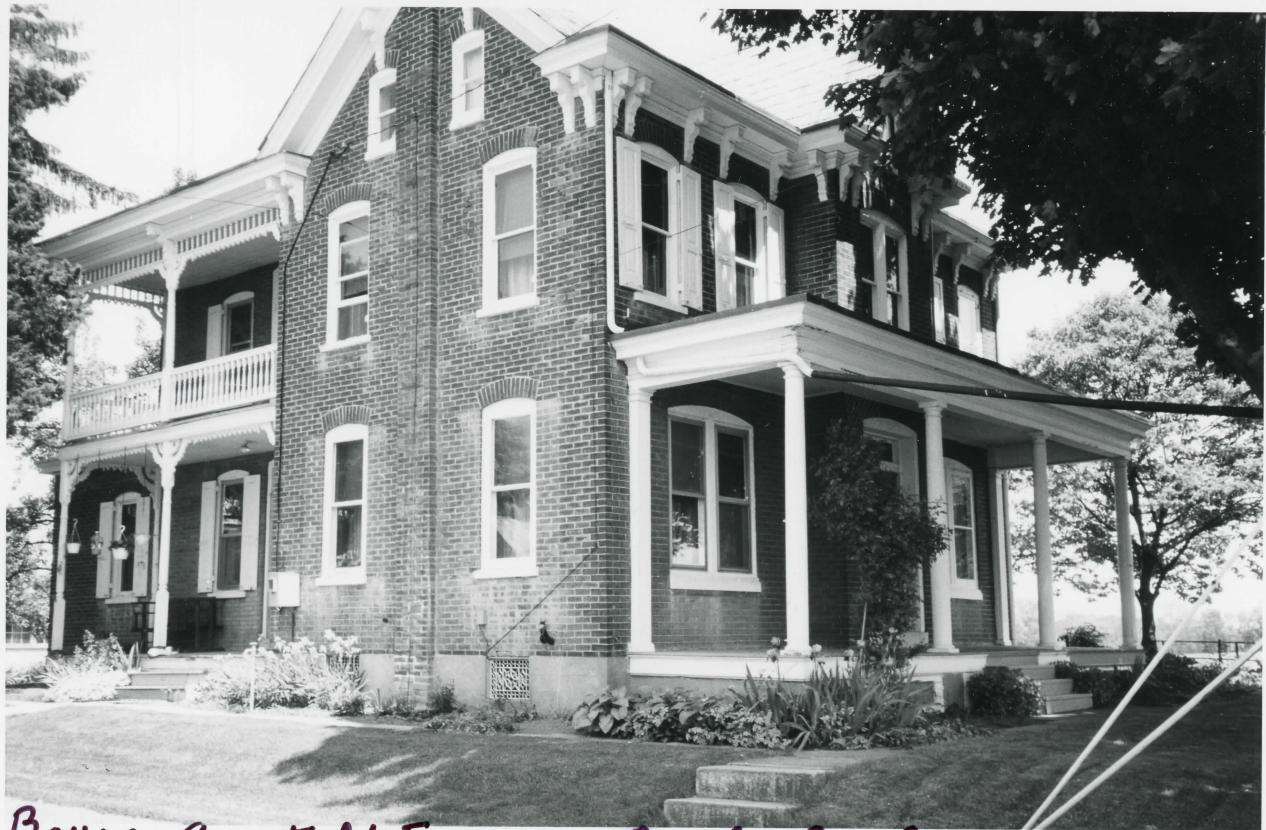
#5

Boyer - Angstadt Farm Berks Co., Pa.
Front and West Elevation of house (1905)

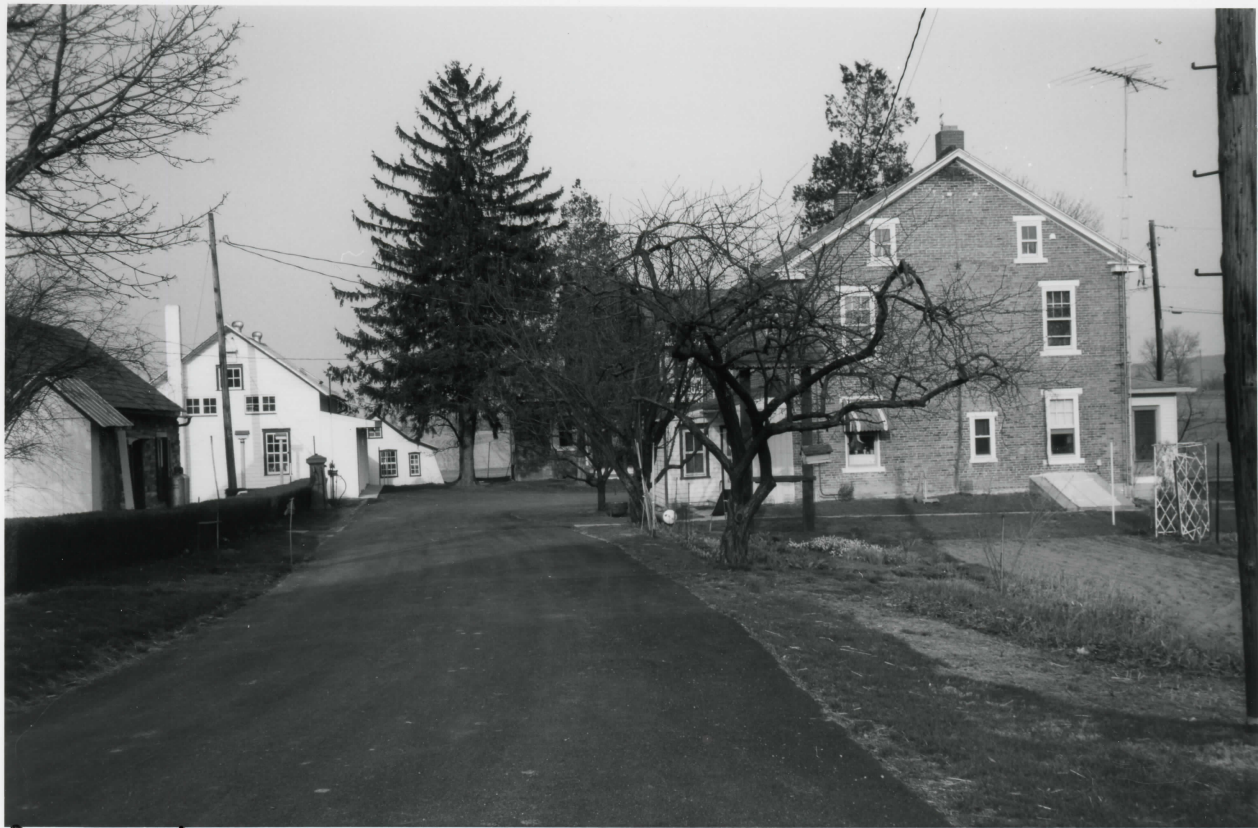
#6

The brick two-and-one-half story vernacular house, is believed to have been built the same time as the barn ca.1871. It had been the original farmhouse but since the building of the 1905 farmhouse it now serves as the tenant house. It has four bays with a slate gable roof. The porches on the front and rear have been enclosed. The windows have 6/6 window sash although some have large pane replacements. There are interior chimneys on each gable end. The asbestos siding on the east side of the house was added later. The trim on the outside is plain frame.

The one-and-one-half story stone summer kitchen ca. 1850 retains some of the original 6/6 windows and has a side entrance on the front or south of the building, and a later German sided addition. It is not known when the stone portion was moved from the west side of the tenant house, although a photograph taken earlier in the century records the building at its present location.

Carriage shop - two story was enlarged and garage doors added to house the family's cars. It is frame German sided with 6/6 window sash and a tin gable roof. The interior contains the weights and pulleys that are used to raise and lower the stairway to the second floor. The building was originally used to manufacture buggies. Later the Angstadts used the second floor to house chickens and at present it is a garage.

Privy - frame, tin gabled roof.

Tenant house (West), privy, summer kitchen, carriage shop

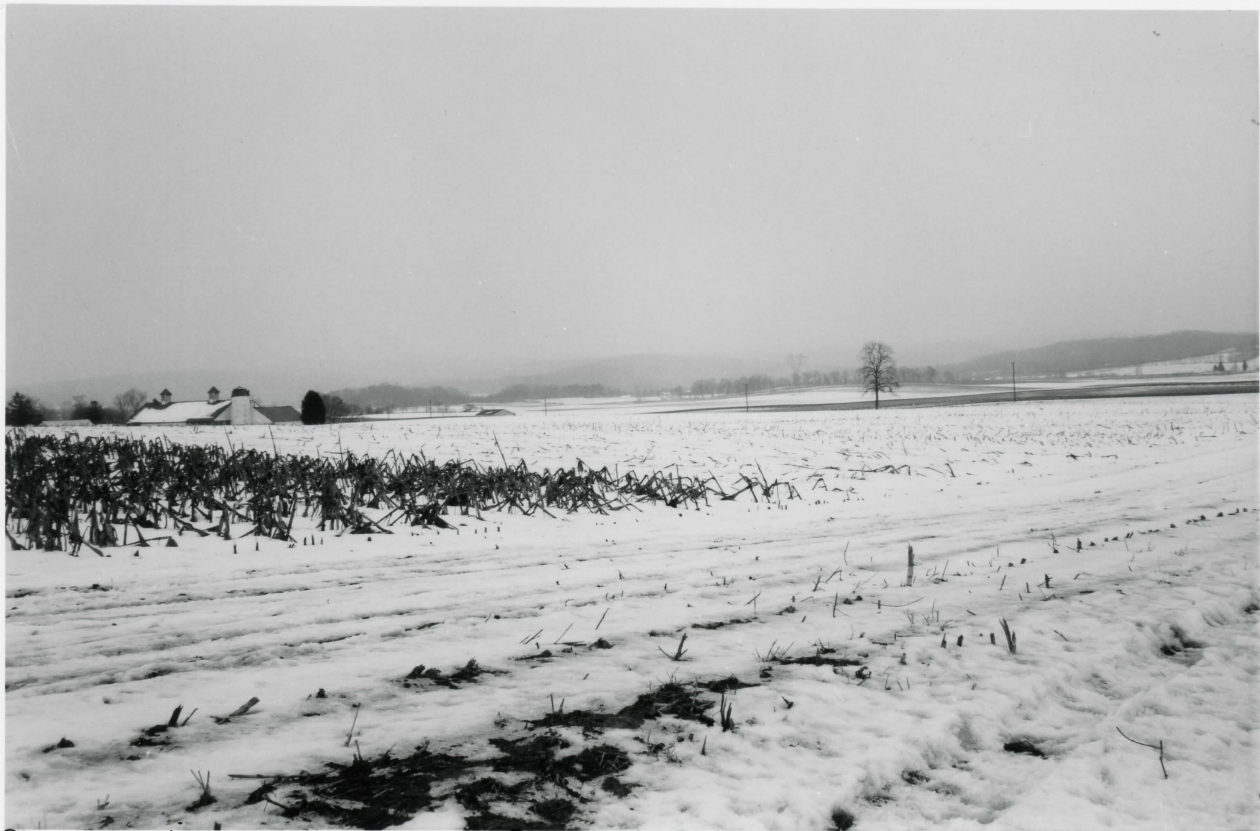
#7

Fields and view of barn
