National Register of Historic Places  
Registration Form

historic name MILLER, CHRISTIAN, HOUSE  
other names/site number \_\_\_\_\_

street & number 233 West Mahoning Street  not for publication  
city, town Punxsutawney  vicinity  
state PA code PA county Jefferson code 065 zip code 15857

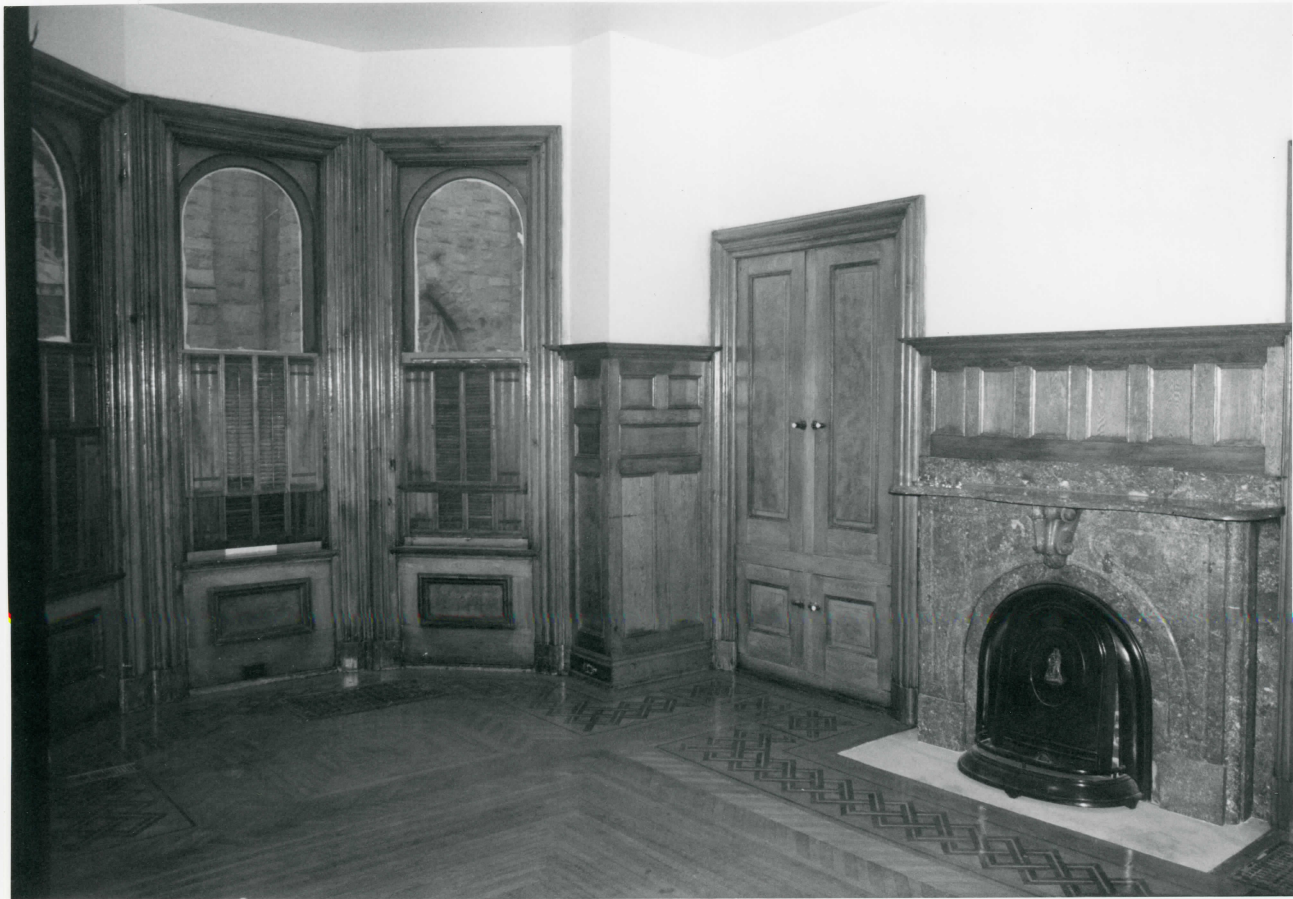
Diningroom, showing bay window, wainscot,  
parquetry, mantle.

The two principal rooms are a front parlor and the diningroom, located back-to-back to the right of the hallway. The parlor is distinguished by its woodwork, including parquet flooring and a plate rail located at a height corresponding with the meeting rails of the windows. A mantelpiece of white marble is also found in this room. The diningroom contains plate rail-height paneled wainscoting of golden oak, a parquet floor, a marble mantelpiece, and a built-in china cupboard. This room also contains a bay window, pierced by three round-arched windows and accented by paneled window aprons.
