**NATIONAL REGISTER OF HISTORIC PLACES
REGISTRATION FORM**

historic name Singsaas Lutheran Church
other names/site number N/A

street & number 19716 487th Ave not for publication N/A
city or town Hendricks vicinity X
state Minnesota code MN county Brookings code 011 zip code 56136

Singsaas Lutheran Church, constructed in 1921, is located in rural Brookings County near the community of Hendricks MN. The property includes the church, associated cemetery and a shelterbelt.

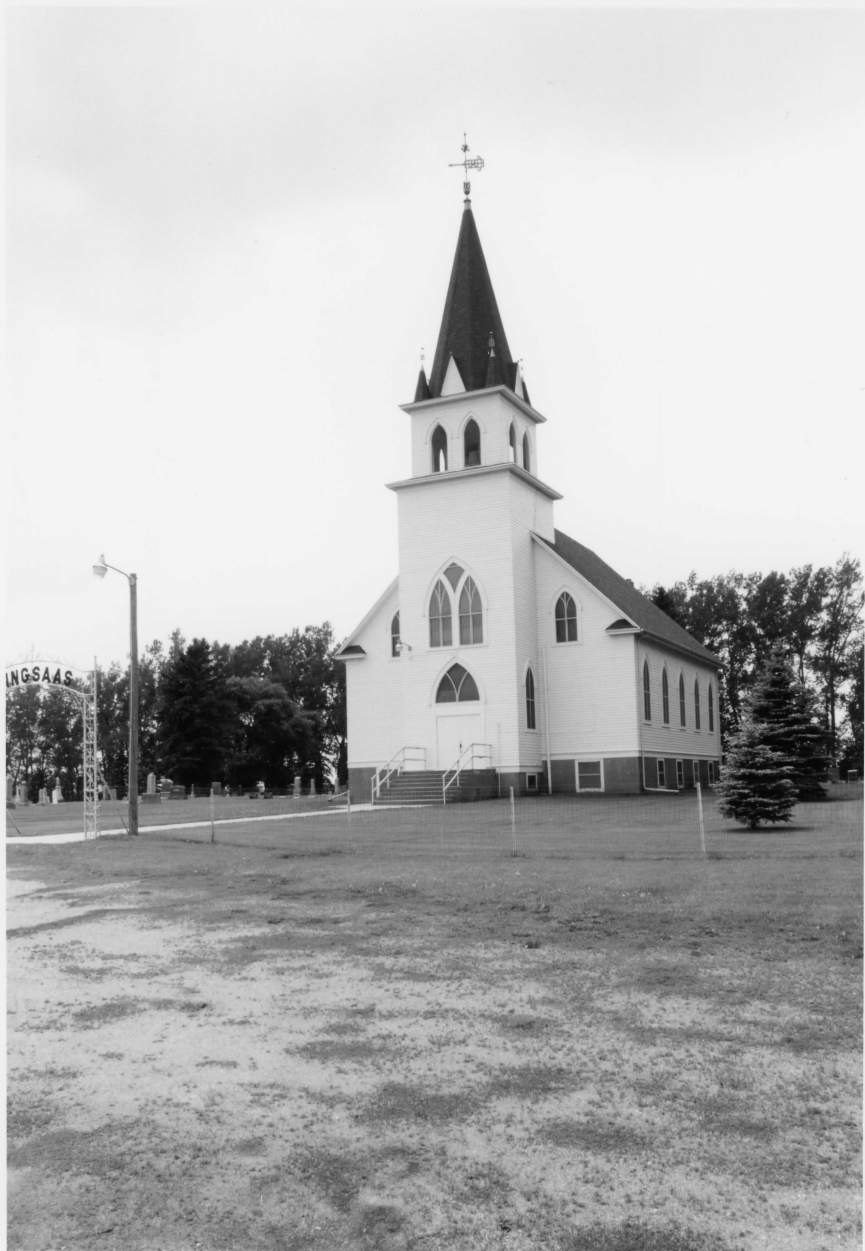
photograph 1

East elevation

The façade (east elevation) has a central double door entry, which is topped by a small gothic arched window with wood tracery. Concrete steps lead up to the entry. The second floor of the steeple has a pair of gothic arch windows set inside a larger gothic arch. Above the second floor window is a hipped roof capped by a square room. Each elevation of this portion of the steeple has two gothic arch openings. The steeple is capped by an eight sided conical roof with a cross at the peak. At the bottom of the conical roof is alternating decorative details of a triangle pediment and a smaller conical detail at the corners. The south and north elevation of the steeple has a gothic arch window with tracery on the first floor. To the south of the steeple is a one-over-one double hung window at the basement level and a doorway leading to the first floor. The second floor has a gothic arch window with tracery. To the north of the steeple is a one-over-one double hung window at the basement level. The second floor has a gothic arch window with tracery.

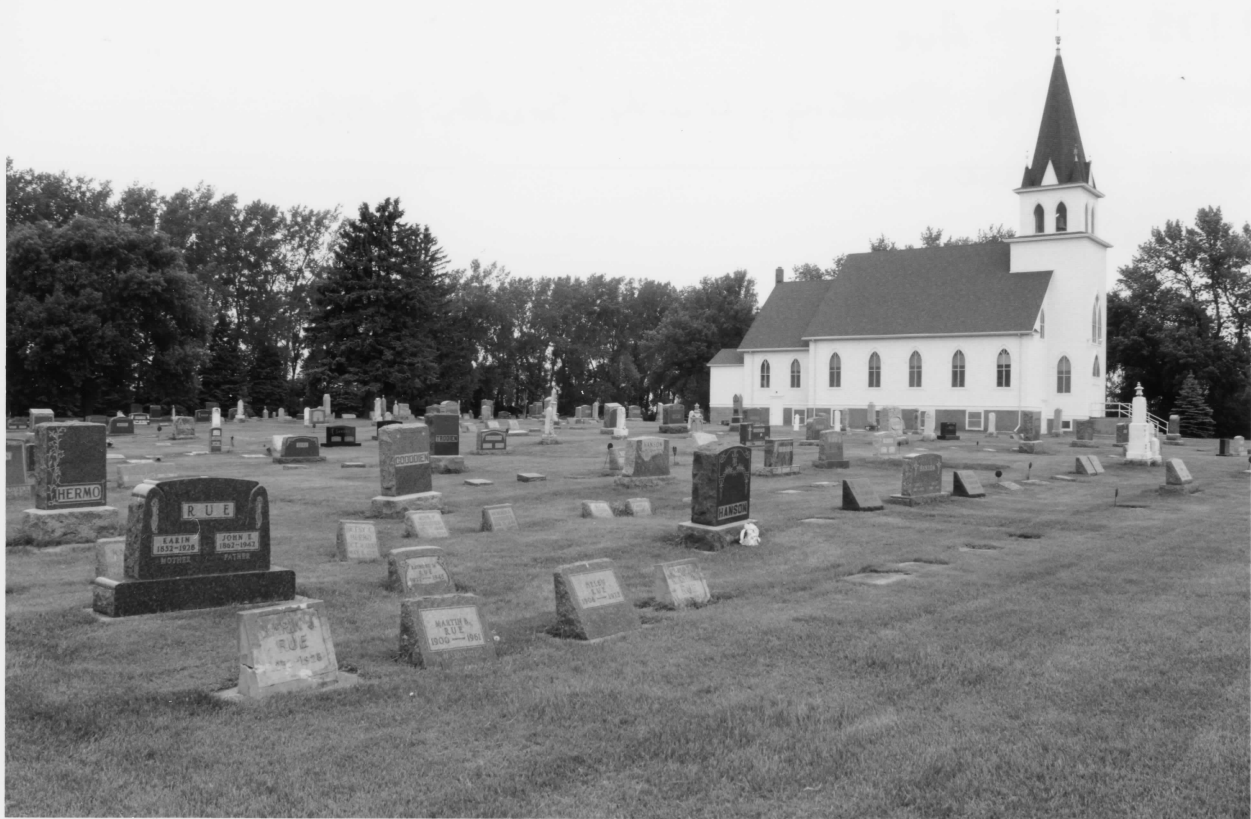
photograph 2

South elevation

The south elevation has five one-over-one double hung windows at the basement level. There is also a door at the southwest corner. The main floor has seven gothic arch windows with tracery.

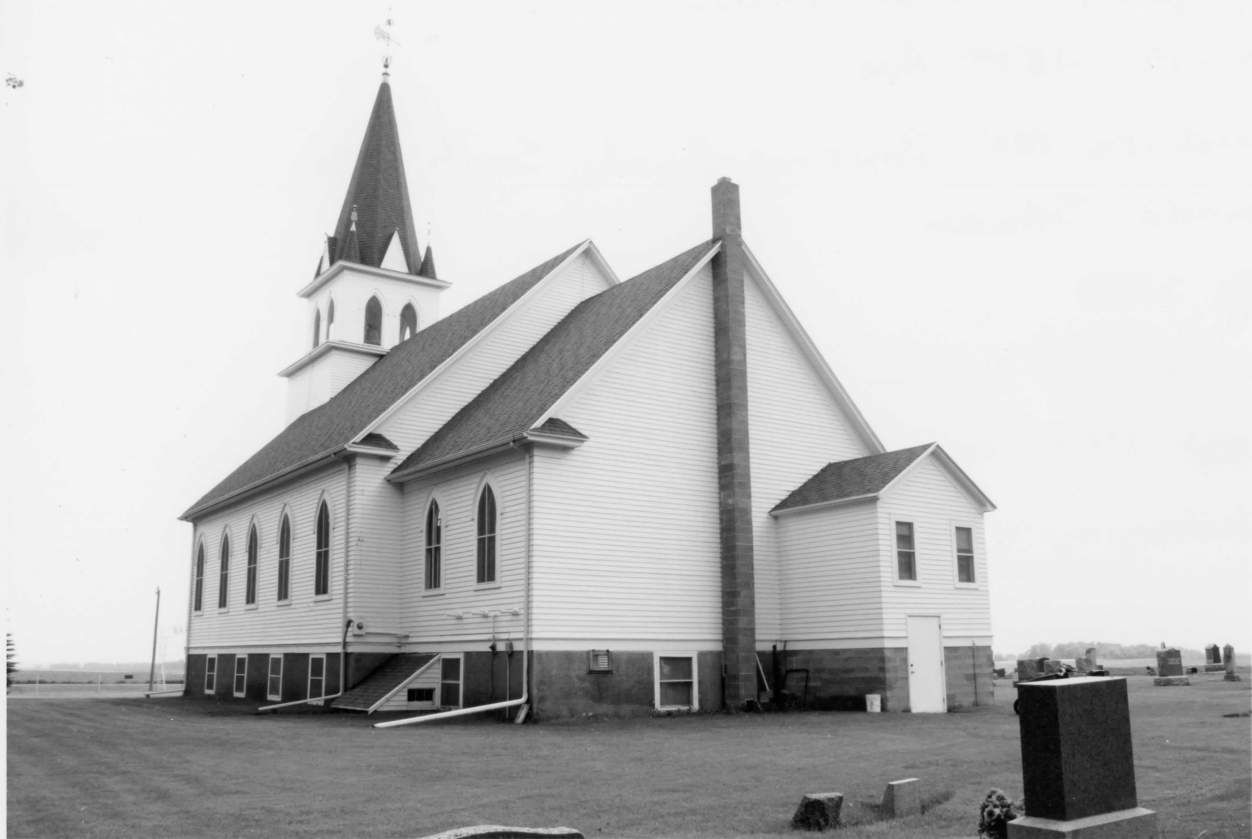
photograph 3

West elevation

The west (rear) elevation has a one-over-one double hung window at the basement level. In the center of the elevation is a concrete block chimney. At the southwest corner is a small gable roof addition. The west elevation of the addition has two one-over-one double hung windows on the first floor and an entry door at the basement level.

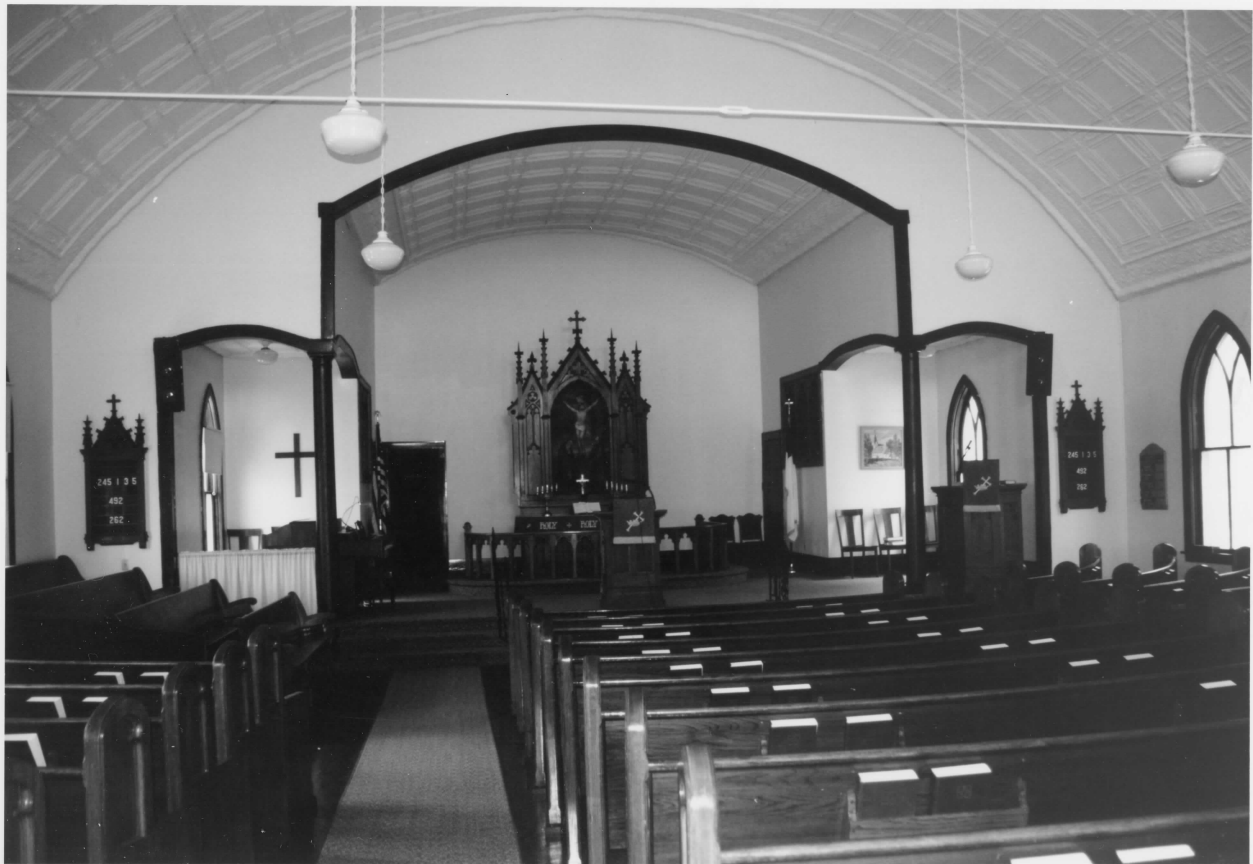
photograph 4

Interior

The sanctuary has many ornate details. The ceiling is covered with a pressed metal in an elaborate pattern. The altar has a U-shaped communion rail. The altar is constructed in three sections that are triangular at the top with decorative finials. The center panel has a gothic arch with a Christ crucifix in

the center. The side panels also have a gothic arch and are separated from the center panel with narrow columns. To the right of the altar is a matching pulpit. At the rear of the church is a second floor choir balcony.

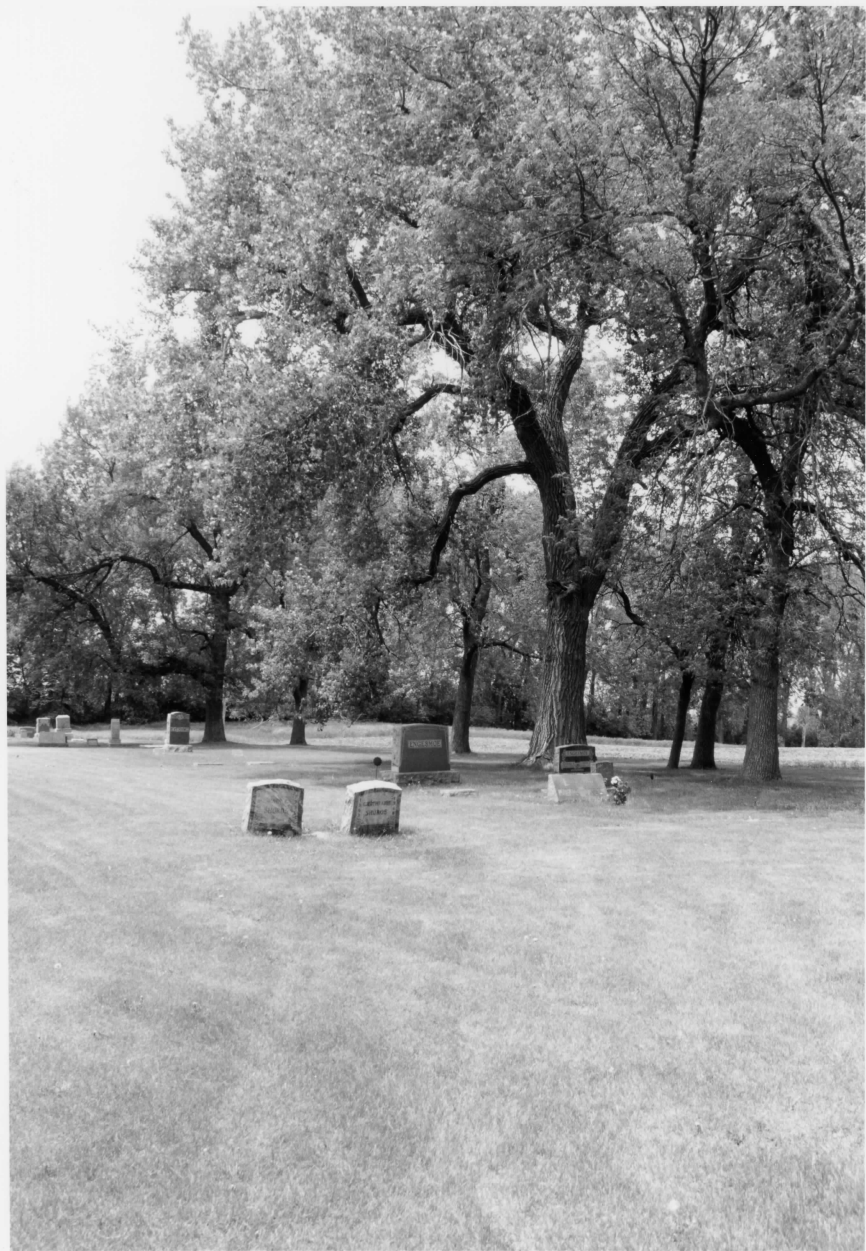
photograph 5.

Cemetery

The cemetery is located on the north, west and south sides of the church. It has been in continuous use since approximately 1880. There are no remarkable headstones but it does have multiple trees scattered throughout the area.
