National Register of Historic Places  
Continuation Sheet

Section number CZ 16 Page 2 Svatos Barn

Svatos, Frank, Rubblestone Barn (Czech Folk  
Architecture of Southeastern South Dakota  
MRA)  
Yankton County  
SOUTH DAKOTA

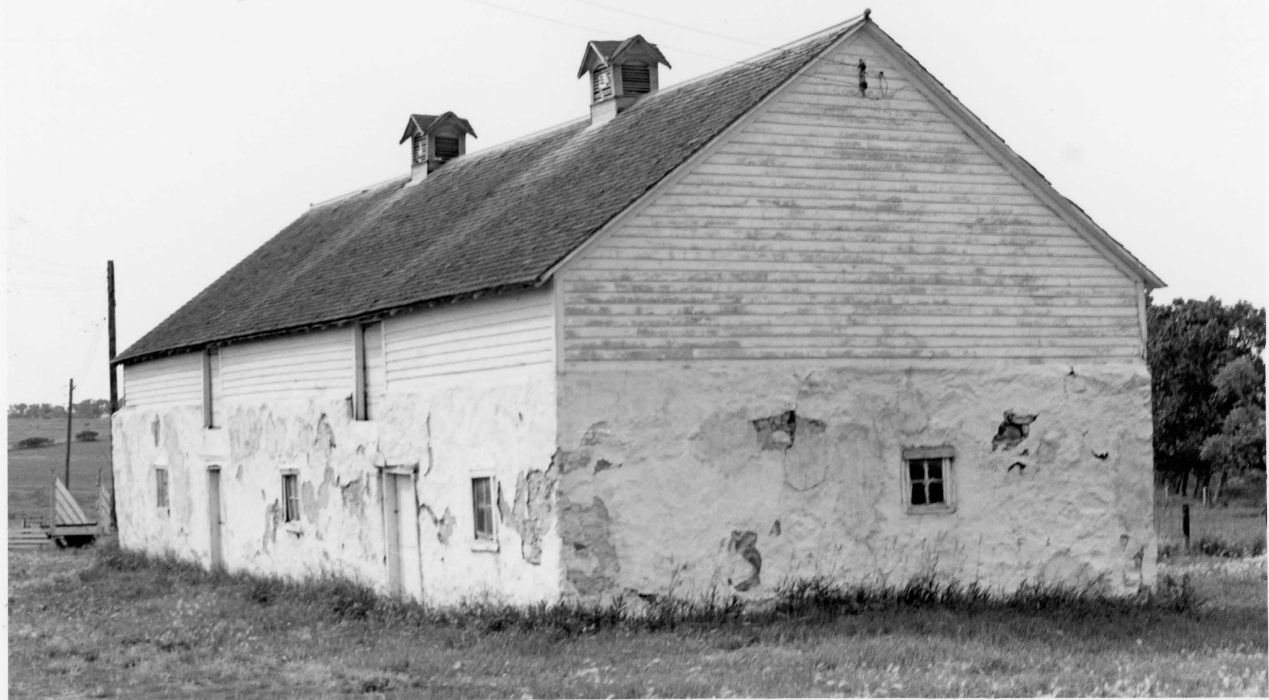
SD State Historical Preservation Center  
North and east facades, facing southwest  
Photo # 31. (CZ 16)

Frank Svatos Rubblestone Barn  
Ziskov Twp., Yankton Co., South Dakota  
Rolene Schliesman

Significant in architecture, the Svatos Rubblestone Barn is the purest example of medium-sized Czech masonry barns in the survey area. Its walls, roof, and fenestration are basically unchanged from when the structure was erected in the 19th Century. Thus, the barn offers an excellent model for the study of Czech folk building forms. In addition, the farm site is one of two within one mile of each other that contain similar masonry barns and log houses, both illustrating Czech settlement and folk architecture. The barn is used daily as a hog confinement facility.
