**NATIONAL REGISTER OF HISTORIC PLACES  
REGISTRATION FORM**

historic name Salem Church

street & number 208 Ohio Street not for publication N/A  
city or town Tulare vicinity X  
state South Dakota code SD county Spink code 115 zip code 57476

Narrative Description

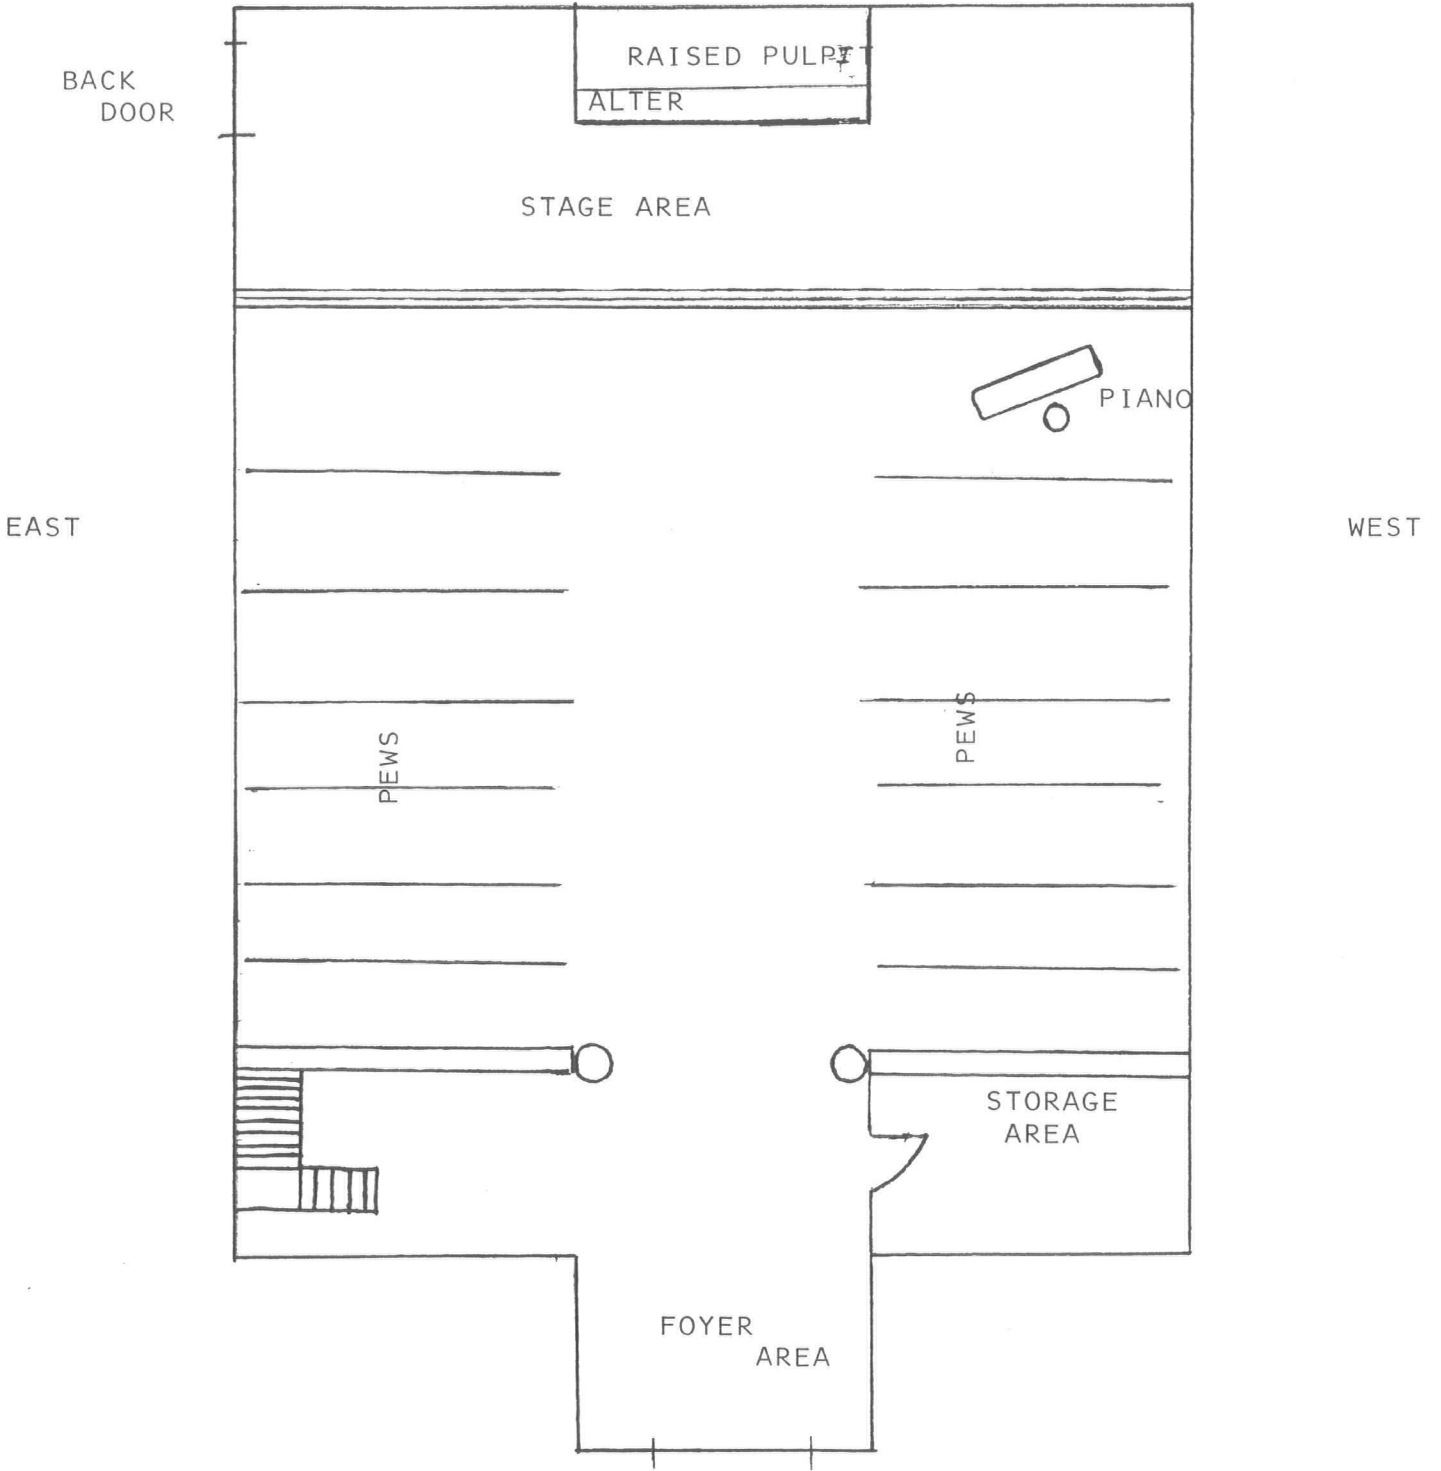
FLOOR PLAN TO THE SALEM CHURCH, TULARE, SPINK CO., SD

The building has a simple rectangular floor plan, the building is organized with a north-facing main entrance leading to the sanctuary. The apse at the south end still features the original baptismal font and altar. All of the interior woodwork remains, as well as a balcony at the back of the worship area.

Upon entering the building, the foyer provides a greeting area and staircase to the balcony on the east side. Directly in front of the entrance, there is the entrance to the sanctuary. The foyer wall material is pressed metal.

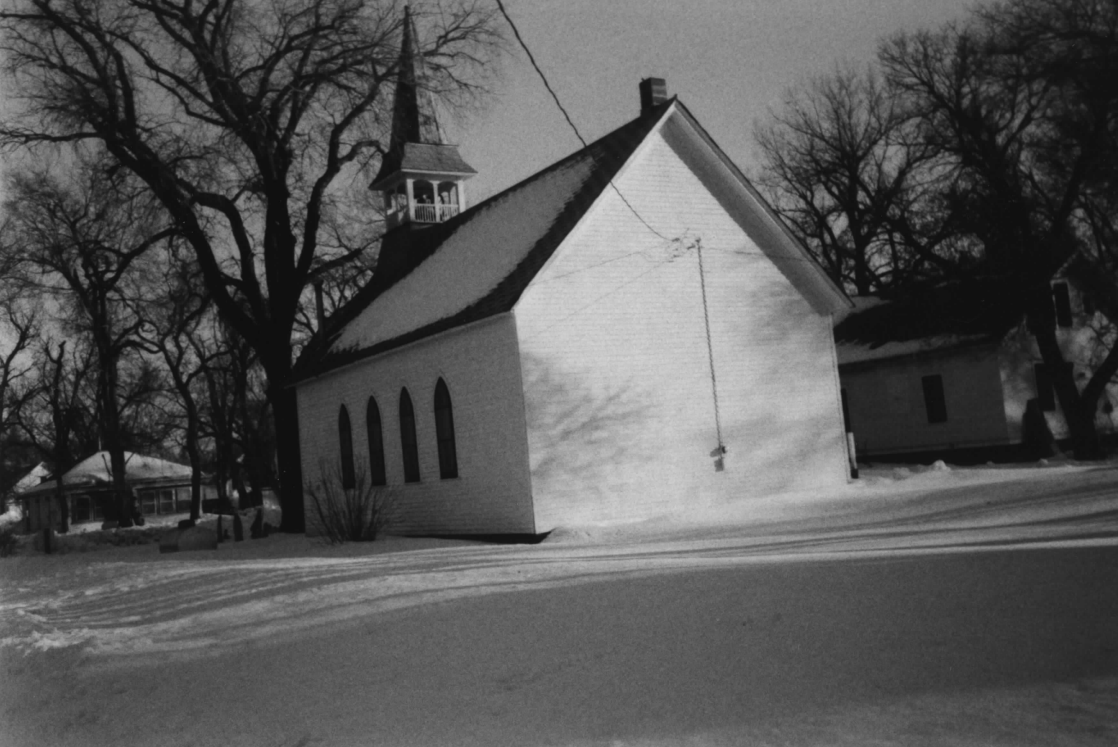
#1

Backoz Church and west side

The east elevation features four Gothic head stained glass windows and a side entrance to the church. The west elevation also features four Gothic head stained glass windows. The south facade is a blank gable wall. Some of the window frames were badly deteriorated and were replaced with similiar frames in 1995. The original glass was inserted in the new frames.

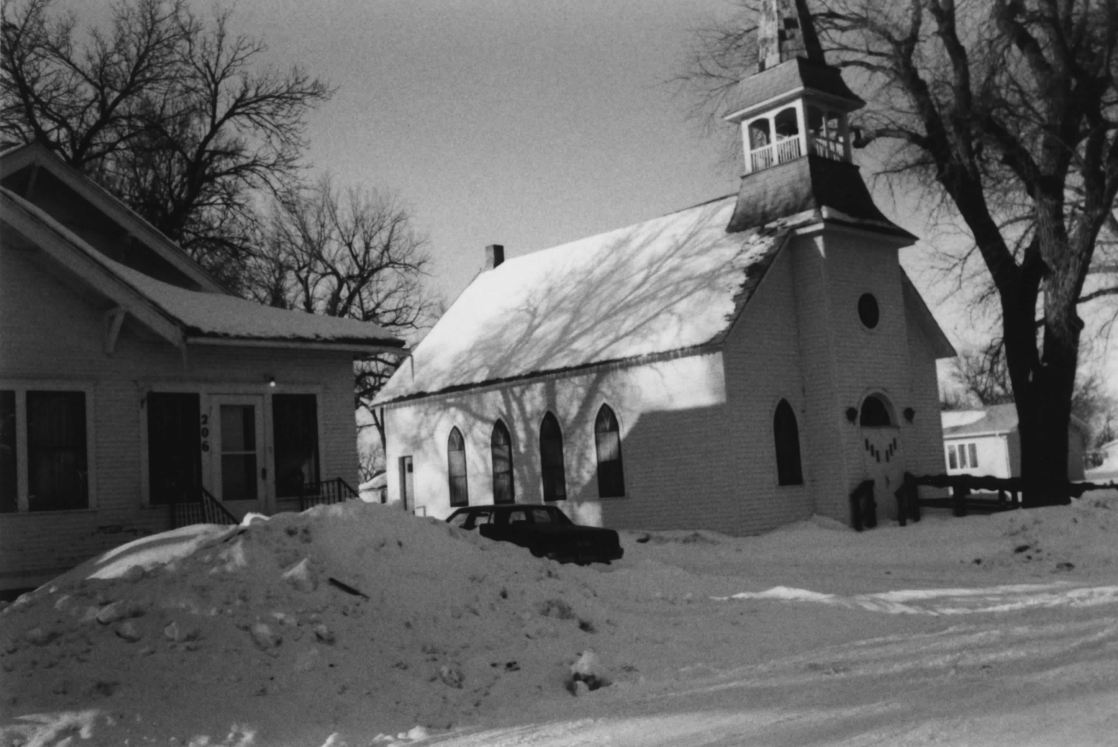
# 2

East side and north front of church

The north (facade) elevation features a tall centered bell tower with a steeple (a mansard roof) and a front-gable. The main entrance is centered on the bell tower. The entrance consists of double doors, and an arch fanlight. A bull's eye stained glass window is above the fanlight. A new wood entrance ramp was added to the front door in 1987, to provide better wheelchair access to the building. Located to the right and left of the bell tower are Gothic head stained glass windows.

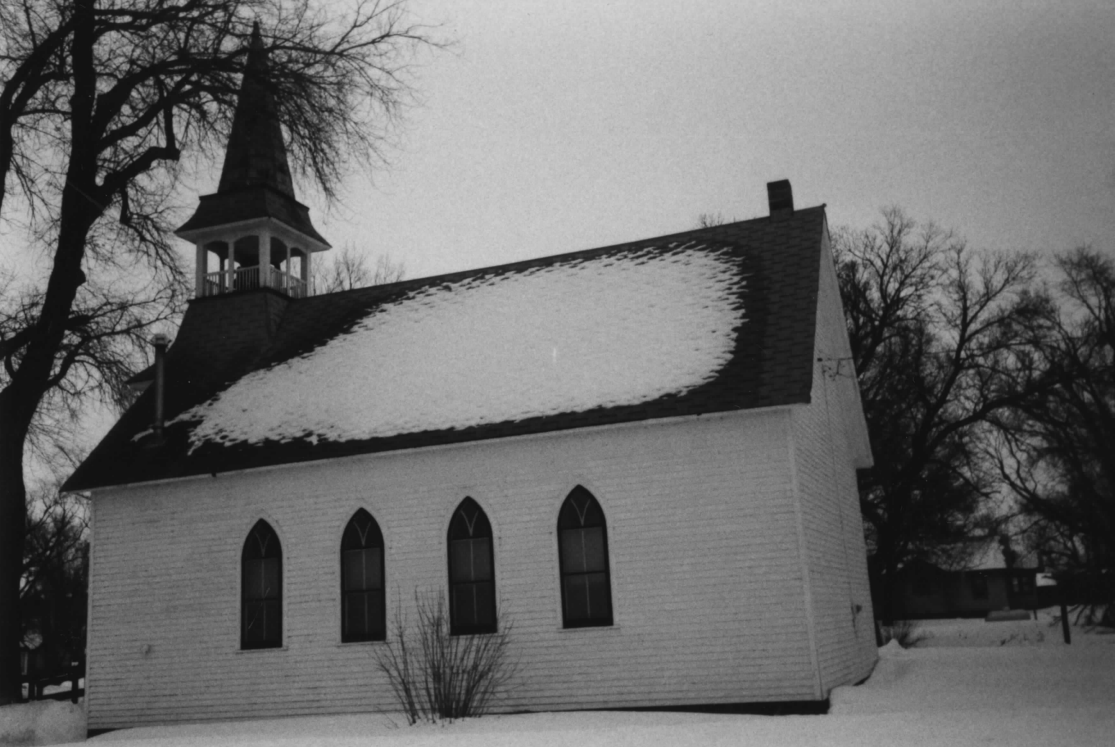
# 4

west side of church  
Salem church  
208 Ohio  
Tulare, Spink Co., SD  
Wm Otto

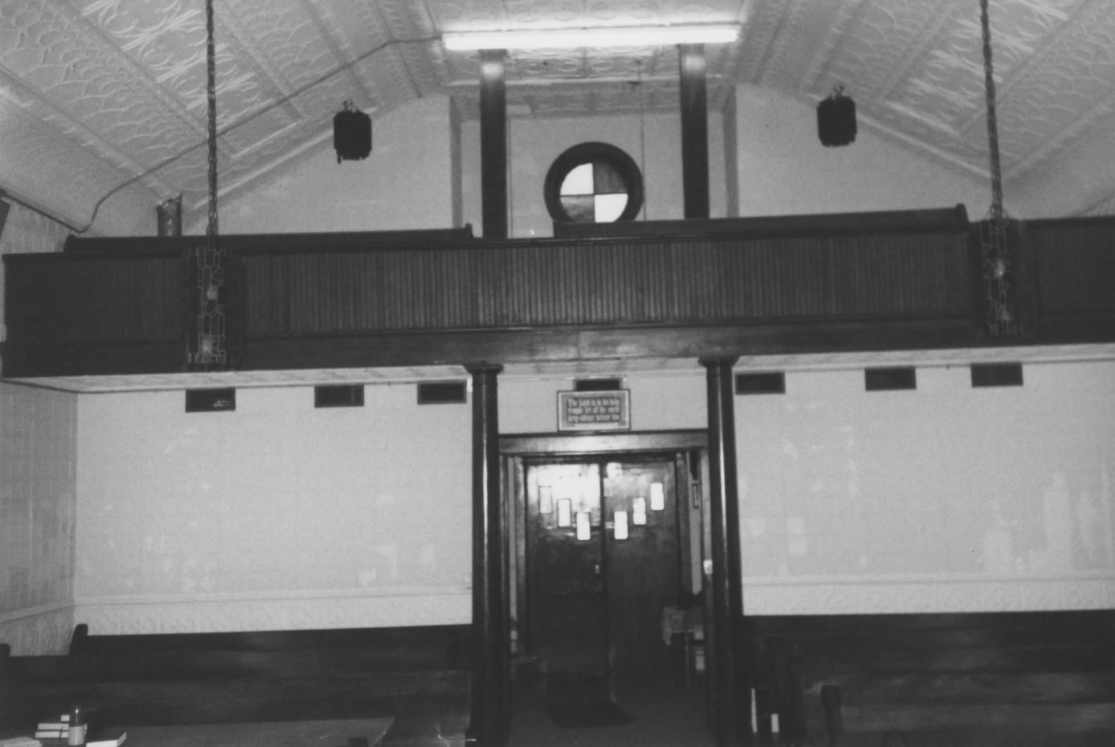
Balcony in back of Church #15

The balcony is supported by two posts, one on either side of the aisle. The front of the balcony is covered with wainscoting. Most of the walls and ceiling are covered with pressed metal.

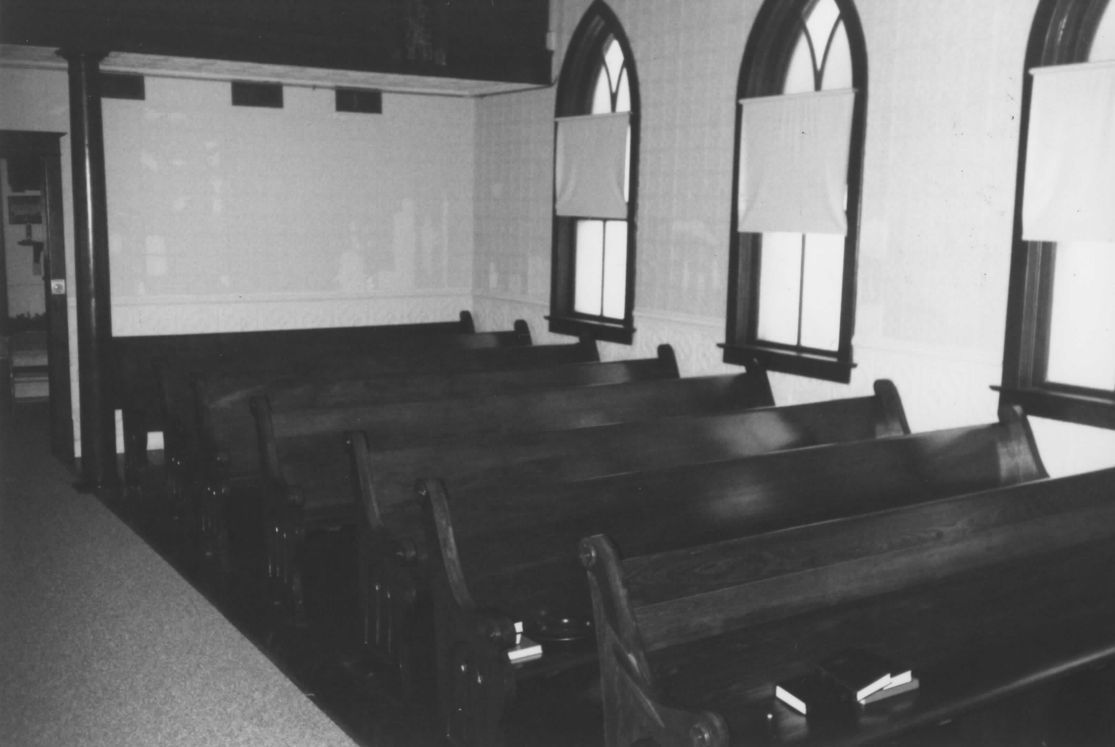
#6

Inside view of pews

The Salem church is a center-steeple church, one of the most common types built. The facade of this type of church relies on several center-oriented devices: the steps and porch, entry doors, window in the tower, belfry, and spire are all visually layered over each other.<sup>1</sup> The placement of the openings are symmetrical, and the rest of the building is modestly ornamented. Like other churches of this type, the Salem Church has the center-aisle plan with rows of pews flush against the walls.

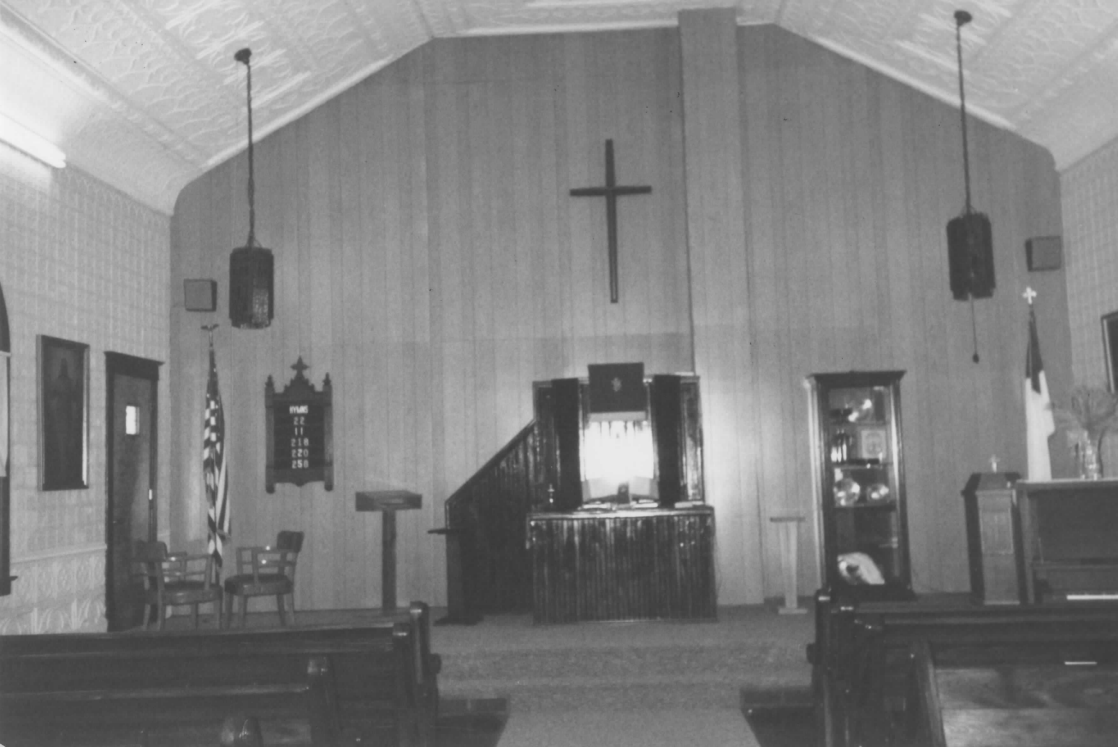
#7

front of church  
raised pulpit, altar, etc

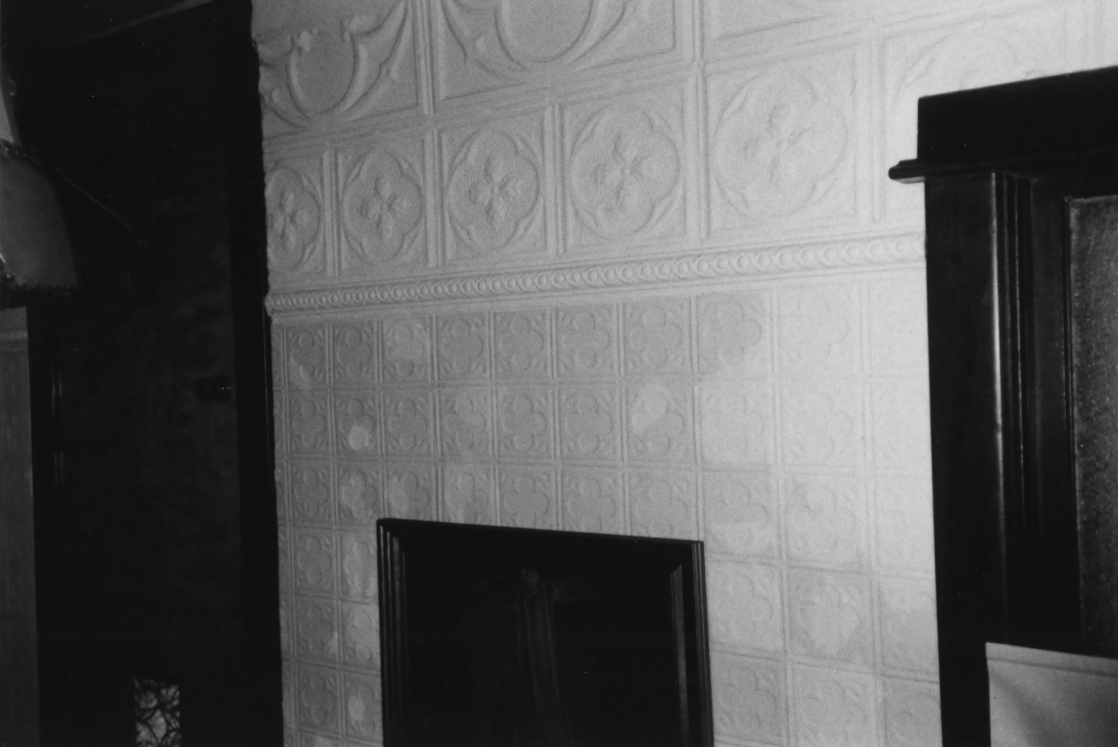
pressed tin on walls

The sanctuary walls and ceiling are covered with pressed metal. The pressed metal is in the quatrefoil design with a bead-and-reel-molding. The south wall metal was covered with wood paneling in 1965. This minor alteration was done because the metal was deteriorated but, the metal is still present under the paneling. The altar is centered on the south wall, it is a raised stage area with a two step rise. The pulpit is covered with dark stained wainscoting. The pulpit is accessed from a staircase on the left side of the pulpit. A chimney is located to the right of the pulpit. The pews are in a center-aisle plan with rows of pews flush against the walls. The floors and pews were refinished in 1990. This room also features the eight Gothic head stain glass windows and the second entrance to the building.
