**National Register of Historic Places
Registration Form**

historic name Primera Iglesia Bautista de Caguas

other names/site number Centro Musical Criollo José Ignacio Quintón

Primera Iglesia Bautista de Caguas
Caguas, Puerto Rico

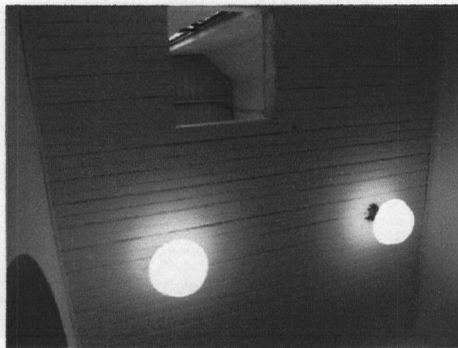
Fig. 4 Tongue and groove wood plank bell tower ceiling

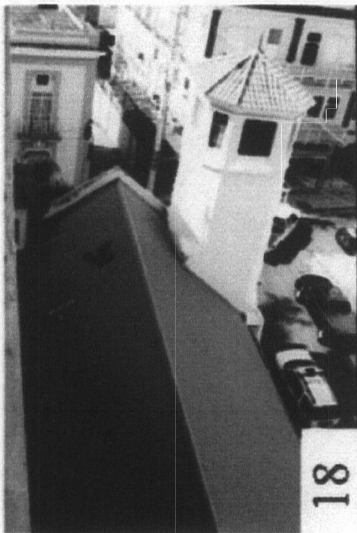
Caguas' First Baptist Church has a gabled, wood roof made of a plank and beam structure. It was covered with galvanized zinc. The rehabilitation project proposed galvanized steel instead of zinc supported by two arched wood trusses (Figs. 6 and 7). These wood trusses add character and proportion to the principal nave space. During the rehabilitation, the wood deteriorated components of the roof were substituted and painted as needed. To comply with seismic and hurricane codes additional steel members were installed, not altering the original geometry of the roof structure. The building's floor was made of polished concrete with joints imitating tiles. Due to severe deterioration, it was substituted by hydraulic cement tiles (similar in color and size).

Fig. 7 Roof detail

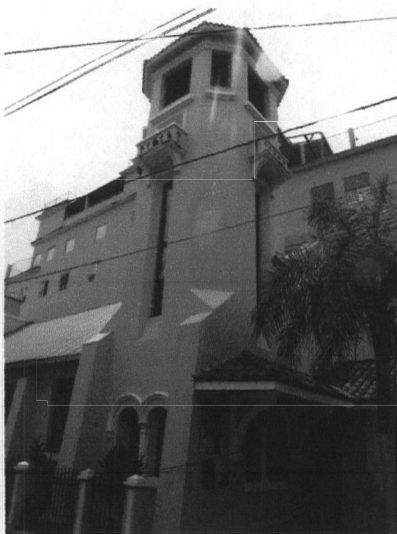
The gable that defines the building's main façade is embellished by a large rose window made out of stained glass. The stained glass pattern is geometric and polychromatic; restored by artist Claudio Solano. A similar rose window was present over the main arch that marked the bema. This element had been filled with concrete blocks. The rehabilitation proposed the reconstruction of this element. Two towers of different heights are the main façade's attractiveness. A main tower or bell tower shape is located at the Southwest corner of this façade (Fig. 9). Its plan shape is octagonal. It has a long rectangular recess fenestration with a stained glass window in it, which has been restored by artist Claudio Solano. The bells are no longer in the tower - the former owner of the building is still in possession of them - and the access to the interior of the tower has been closed. The tower has recessed door openings with balconies at the two elevations that face the street. It has an eight skirts roof covered with Spanish tiles stressed by a belt course.

A smaller tower rises at the Southeast corner of the main façade. It is a watchtower with a square shape and a Spanish tile covered roof. The main façade has a compound arch window to the Southwest, and a single arch window to the Southeast. Both windows are topped by a fanlight and a water table. The compound arch window is protected by a prominent eave that extends to the portico supported by hammer braces. Spanish tiles also cover the eave.

Fig. 9 Main tower

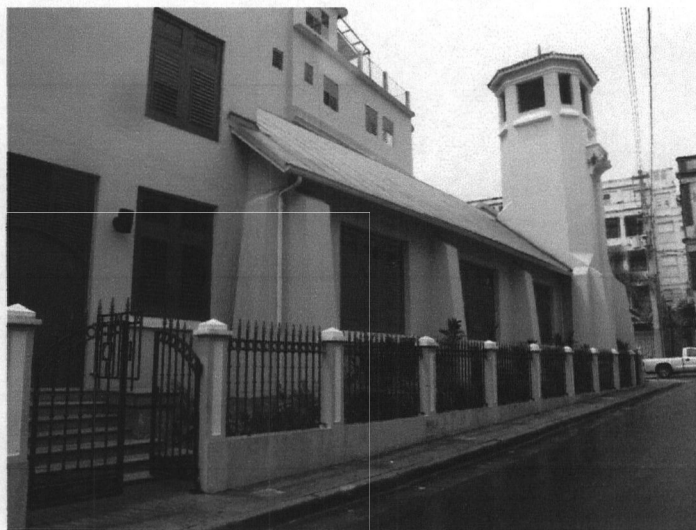
Fig. 10 Buttress on the West façade

Buttresses on the East wall, have been blocked with the construction of the neighbor's property. The main roof extends over the buttresses completely blocking them. Buttresses characterized the lateral West façade (Fig. 10). The original concrete walls and buttresses were consolidated, patched and repaired with epoxy wherever dowels were exposed.

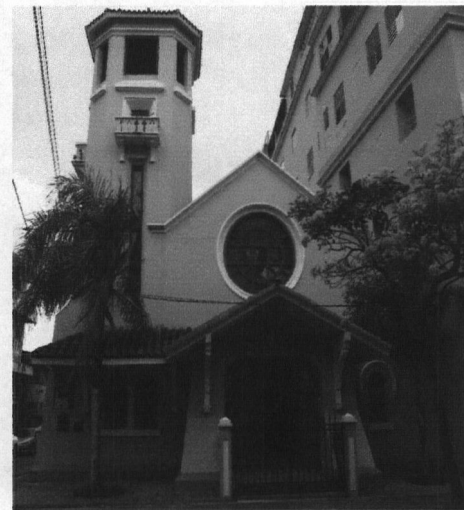
Fig. 12 The First Baptist Church through the years.

In 1993, the property was finally acquired by the City of Caguas.²⁵ After a successful rehabilitation process, the property was converted into a museum.²⁶ Through all the changes in functionality after 1957, the property has kept its integrity of materials, location, volume and feeling (Fig. 12).
