**NATIONAL REGISTER OF HISTORIC PLACES
INVENTORY - NOMINATION FORM**

COMMON:
Central Vermont Railroad Headquarters

CITY OR TOWN:
St. Albans

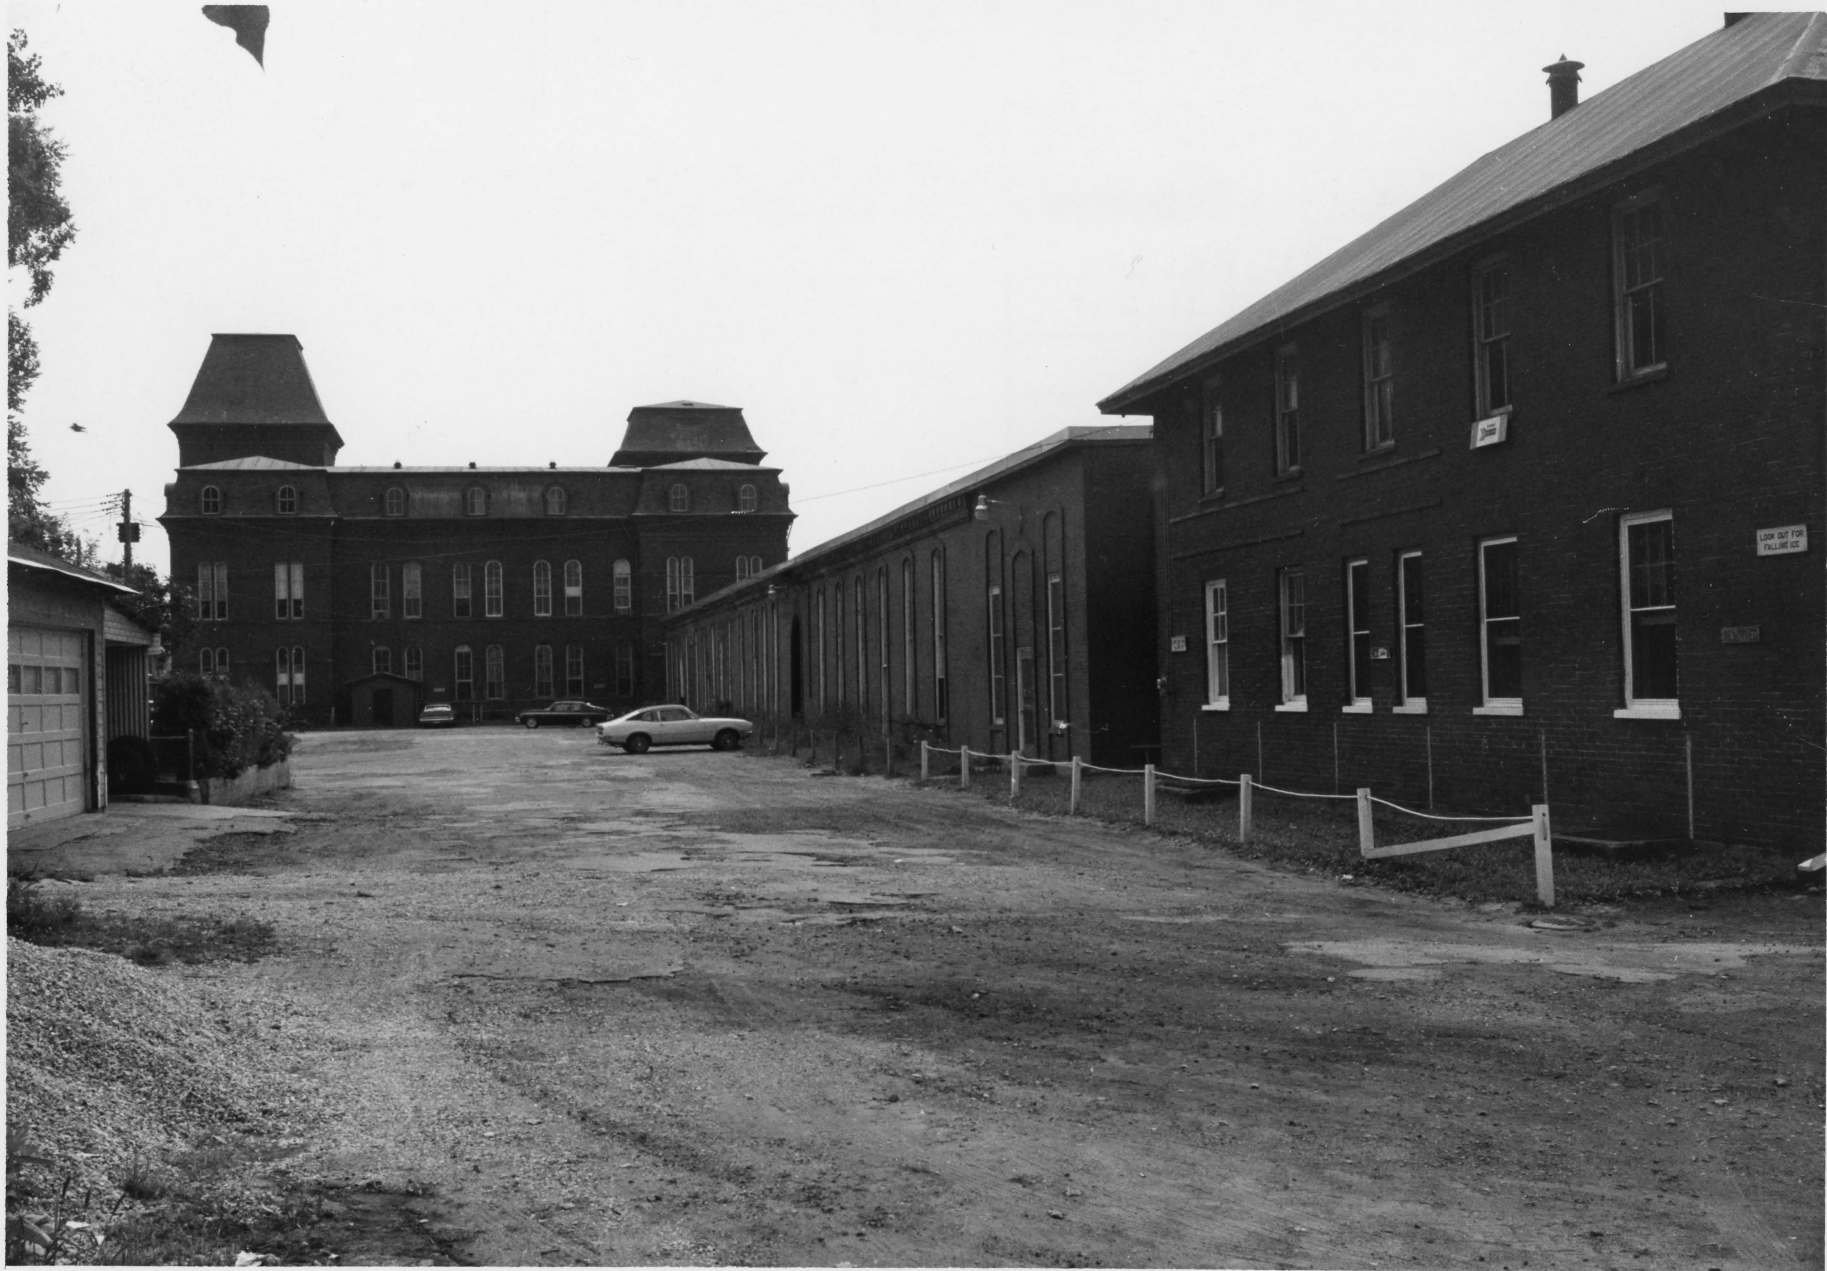
#1 of 5

Rear (north) elevation of general office building showing maintenance shop (2) and Amtrak station (3) in foreground; view south.

The general office building (1) is a rectangular-plan, 2½ story structure, with basement, set upon a low cut-stone foundation. The main (south) facade includes two flanking, three-story, 2½ bay, corner towers projected at each end of the facade. The building is constructed of brick, load-bearing masonry, and includes a tin-sheathed mansard roof, with slate-covered bellcast

The maintenance shop (2) appears to have been constructed about 1870. It is a single story, elongated, rectangular-plan building having a low cut-stone foundation. The structure is of brick construction, load-bearing masonry, with denticulated cornice on the south and west facades (not continuous). The west wall projects above the roof level and the roof is flat. Fenestration occurs on the east and west facades only. The east facade includes regularly-spaced, full-story, double-hung, segmented-arch, sash windows, framed by decorative brick detailing projected to the water table. The facade is interspersed by two rounded-arch doorways in utility widths. The east facade is pierced by an irregularly spaced series of rounded-arch and segmental-arched doorways of random placement. A two-story mansard-roofed tower, appended to the north end of this building, was removed about 1900. This tower occupied the northern three bays of the structure and was replaced by a single-story continuation of the present building.

The passenger depot (3) was constructed as a yard office about 1900. It is a two-story, rectangular-plan structure set upon a low-cut stone foundation. The main (east) and west facades are of six bay width. Wall construction is brick, load-bearing masonry, and is unembellished. The building includes a medium pitch gable roof. Fenestration is double-hung sash type, six over six light throughout.

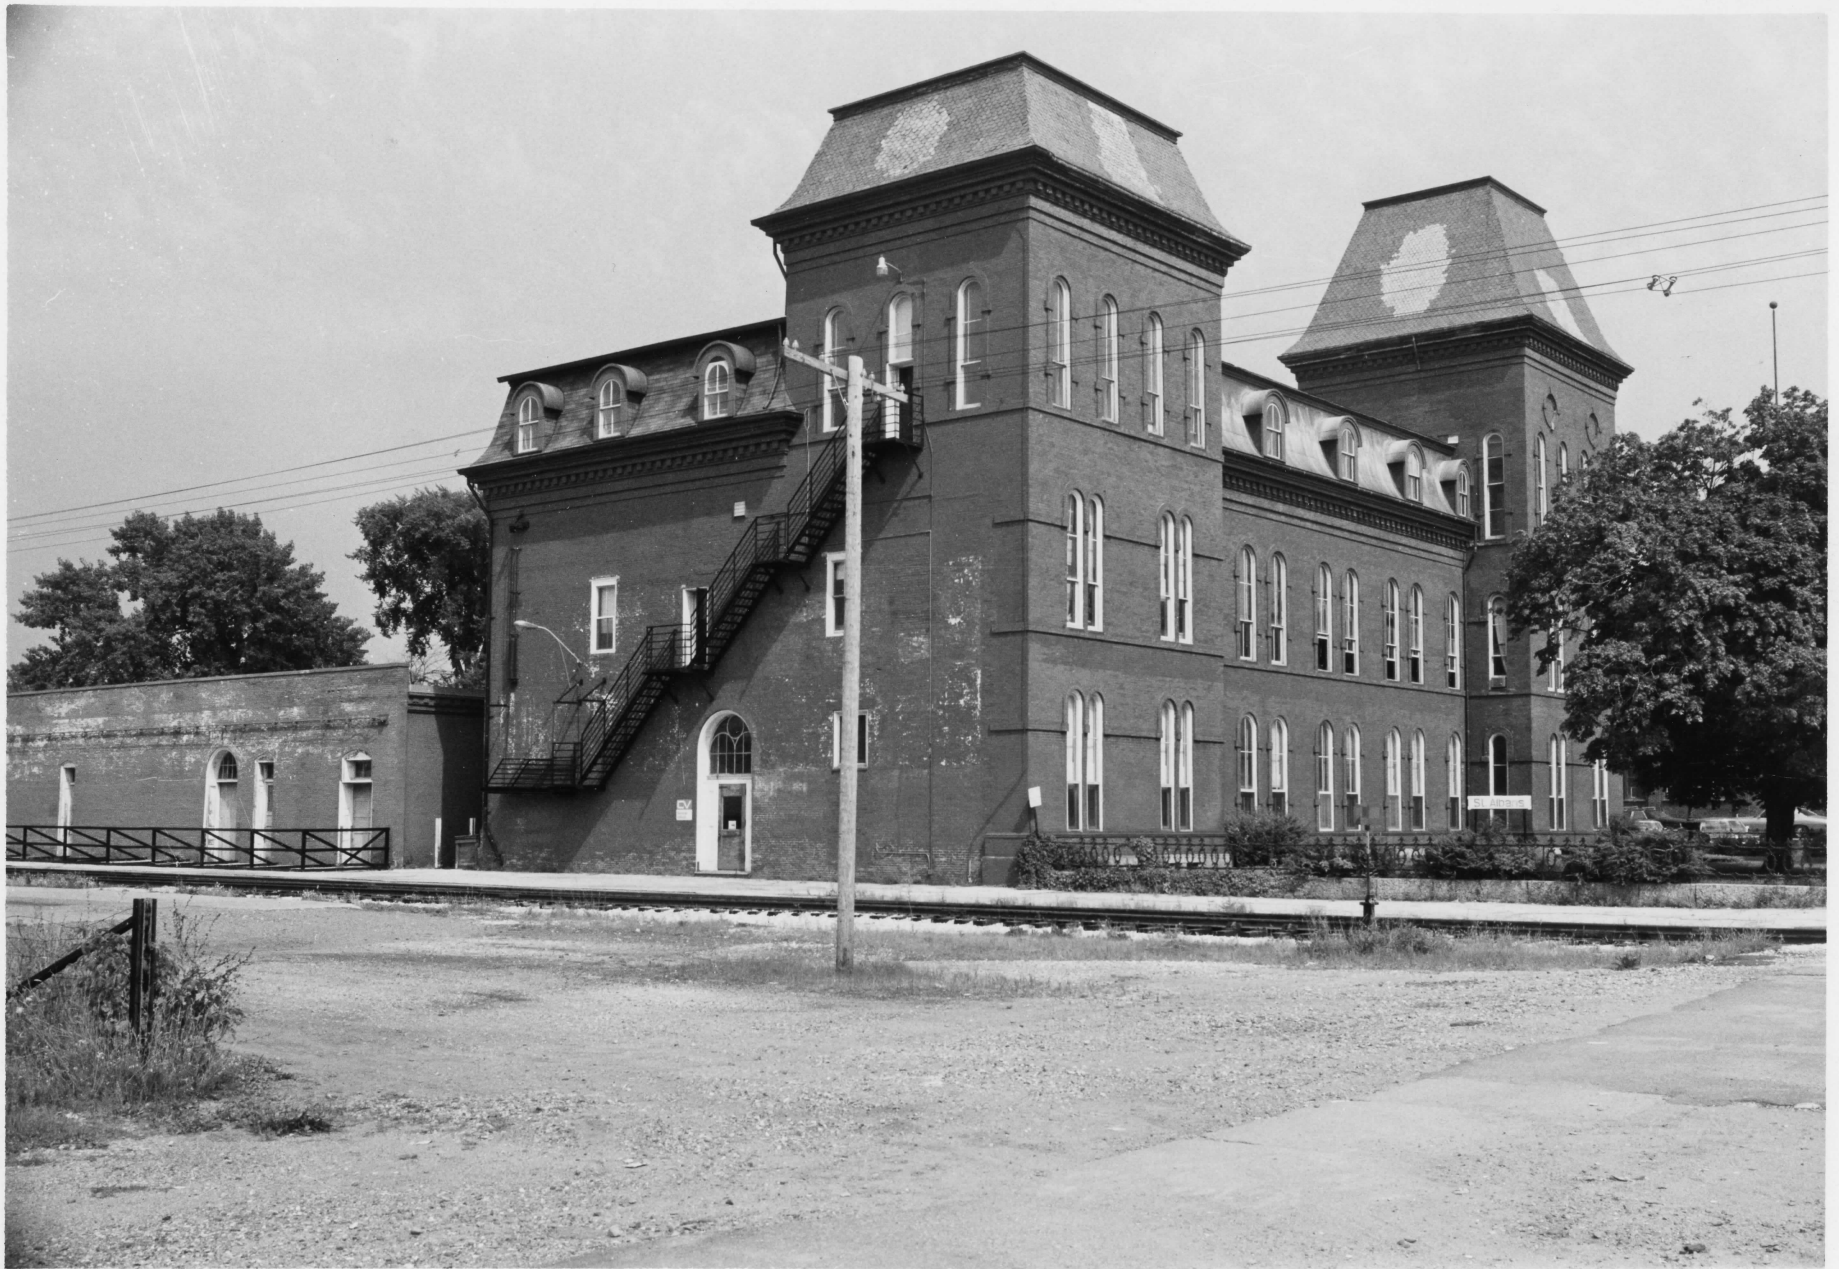
2 of 5

Central office building (1) showing main (south) and west elevations;
view northeast.

mansard roofs on both towers. Rosettes, or ornamentation, on the tower roofs have been removed. The tower facades are decorated with four regularly spaced brick belt courses which also bracket the window arches. A single belt course occurs below second story fenestration in the central portion of the south facade. A denticulated cornice appears on all facades. Windows on the south, north, and east facades are rounded-arch, double-hung sash type, and occur in pairs. Fenestration is two-over-two light in the towers on north and south facades, and four-over-two light in central portions of each facade. Windows are rectangular on the west facade. Hooded dormers are located on all sides of the roofs. Old views indicate that three chimneys were at one time placed on the roof slope between the dormers above the south facade. These have been removed.

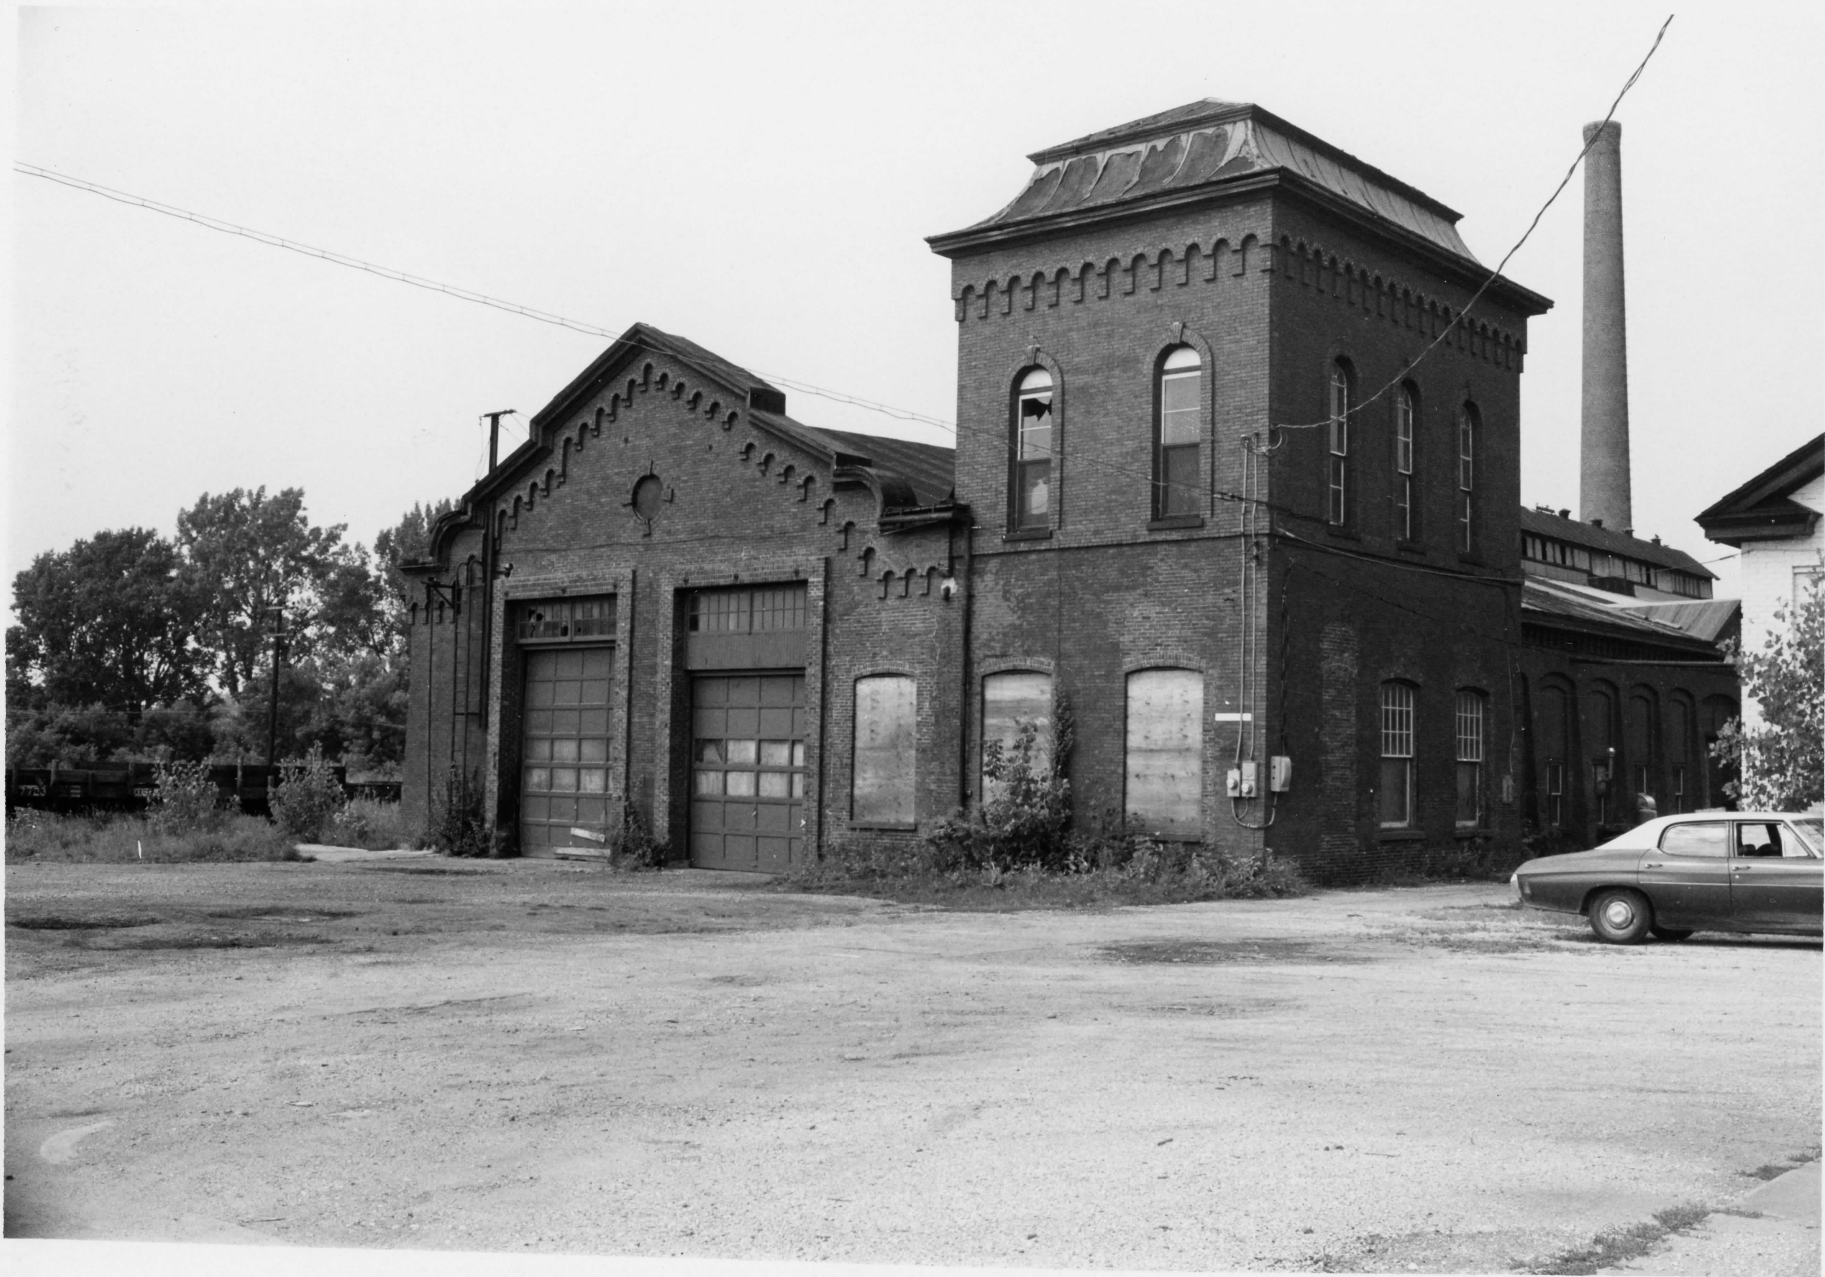
3 of 5

Locomotive shop (4) showing main (south) facade; view northwest.

The locomotive fabrication and repair shop (4) was constructed between 1863 and 1865. It is a single-story building having a two-story tower appended to the southeast corner. The plan of the structure is irregular, but basically rectangular, with an added frame appendage at the center of the west facade to accommodate a foundry and smokestack. The wall construction is of brick, load-bearing masonry set upon a low cut-stone foundation. Exterior walls are richly corbelled and detailed on all facades. Decorated

end gables (front and rear) project above the roof line in stair-step fashion. The occurrence of a decorated end gable at mid-point in the structure indicates that northern appendages are later additions. Brick buttresses, placed to correspond to the location of the roof trusses, form the major components of the structural system. Fenestration in the east and west facades is placed between the buttresses and provides an infill. These windows are segmented-arch, double-hung sash type throughout and are recessed in the side (east and west) facades. The large windows, flanked by brick buttresses, form pronounced bay divisions. Overhead doors in the main (south) facade are replacements, probably for rounded-arch engine passages. The roof is a truss-supported, low-pitch gable with an elongated cupola.

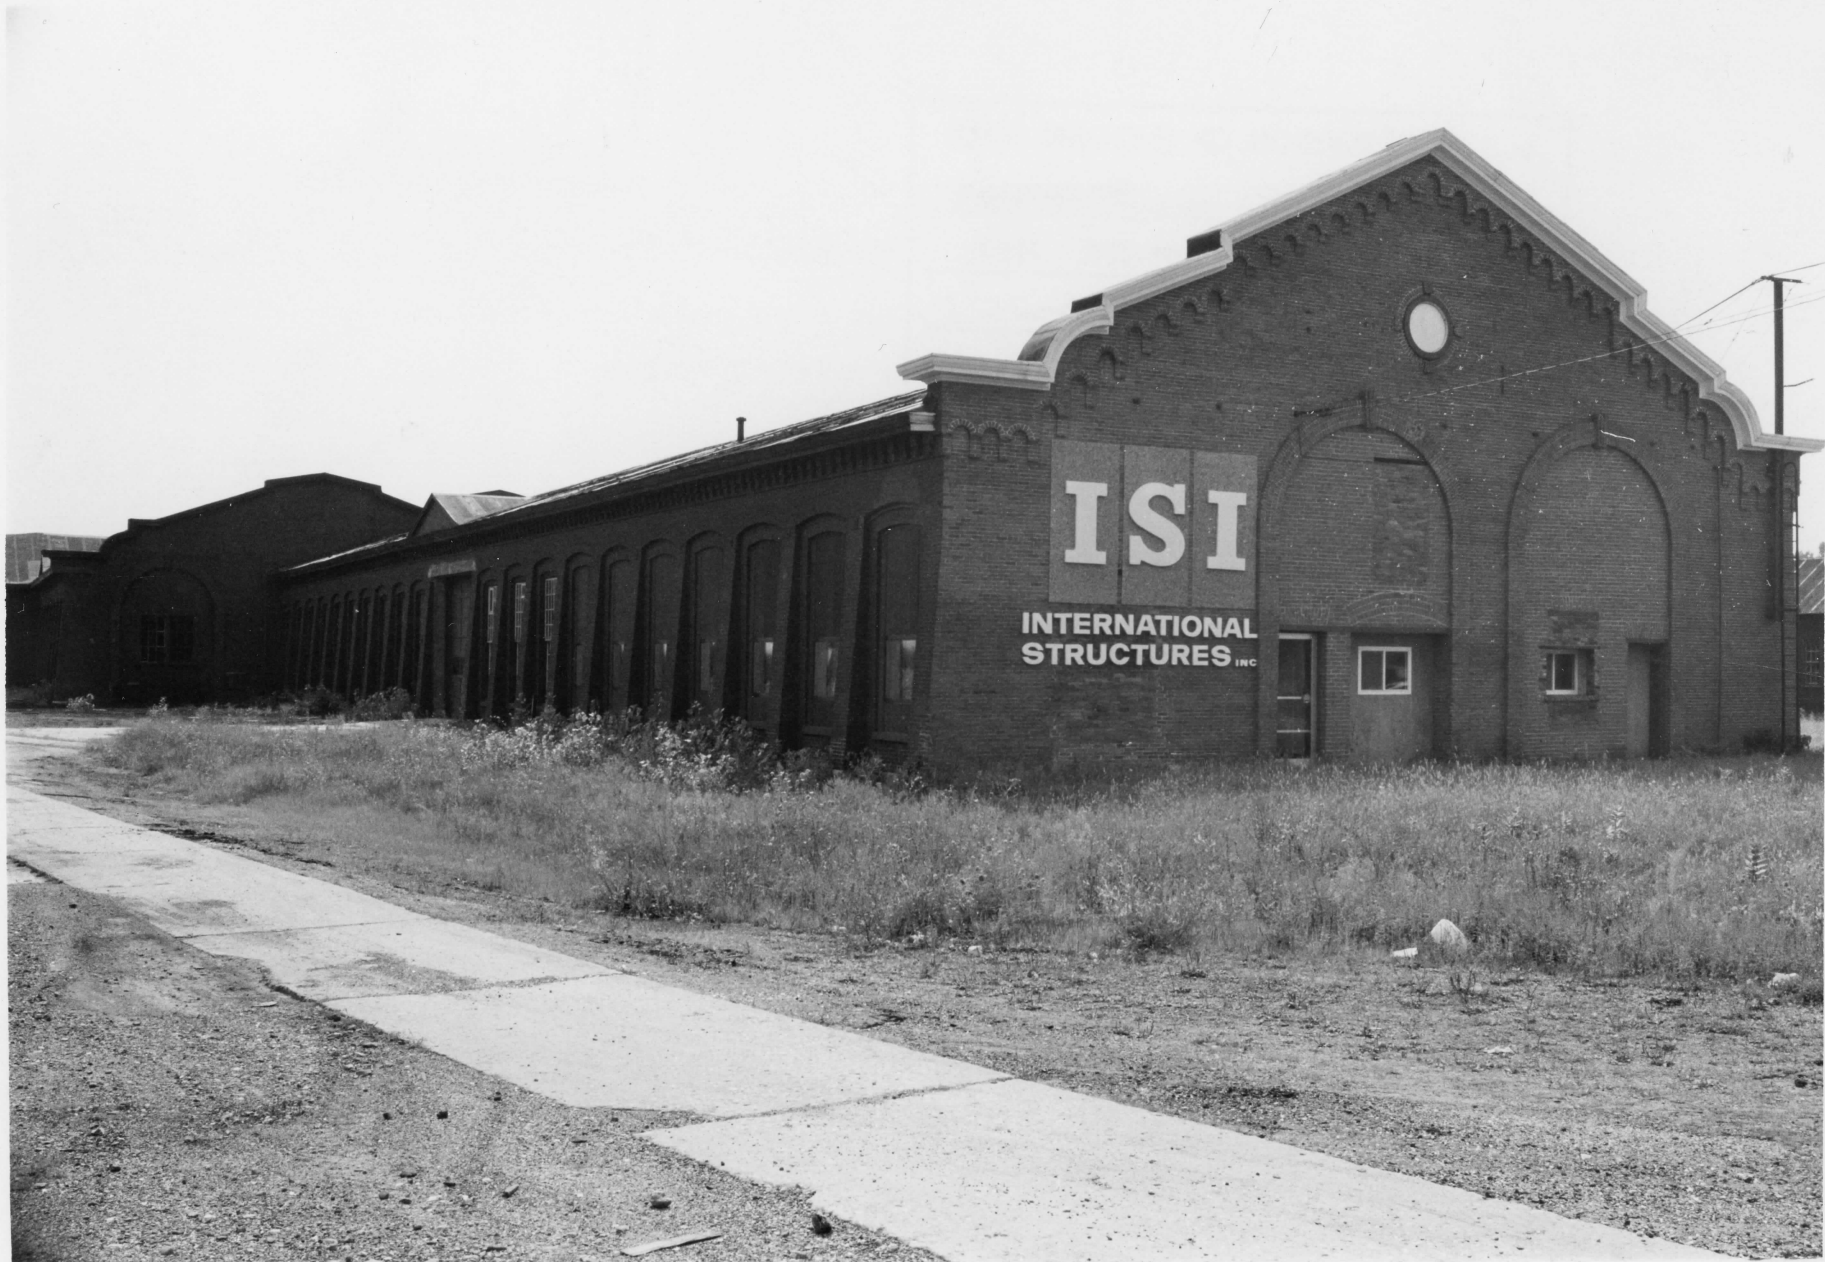
#4 of 5

Passenger car shop (8) showing north (main) and east elevations;
view southwest.

The passenger car shop (8) is a companion structure to the locomotive shop. The two shops are situated opposite one another on Lake Street and were probably constructed coincidentally. The front (streetside) portions of both shops are of similar architectural styles although the tower does not appear on the car shop. The passenger car shop housed woodworking facilities and did not include a forge. The car shop was constructed in four segments arranged linearly in a north-south alignment. The northern most segment appears to be the original structure, and other sections were appended in sequential order as the railroad required additional space. The truss and buttressing arrangement of the oldest section is identical to that of the locomotive shop as are the fenestration and decorative features. However, in an attempt to maintain architectural consistency most gable ends of the appended portions simulate those of the original structure although the various sections are not perfectly aligned. Although the structure is currently used by a private company as a warehousing facility, much of the integrity remains from its use as a rail shop. The major violation, however, was the removal of the brick smokestack and steam power plant about 1968. Two rounded, brick, keystone arches, forming the car entrances, remain intact in the main (north) facade although they have been bricked in.

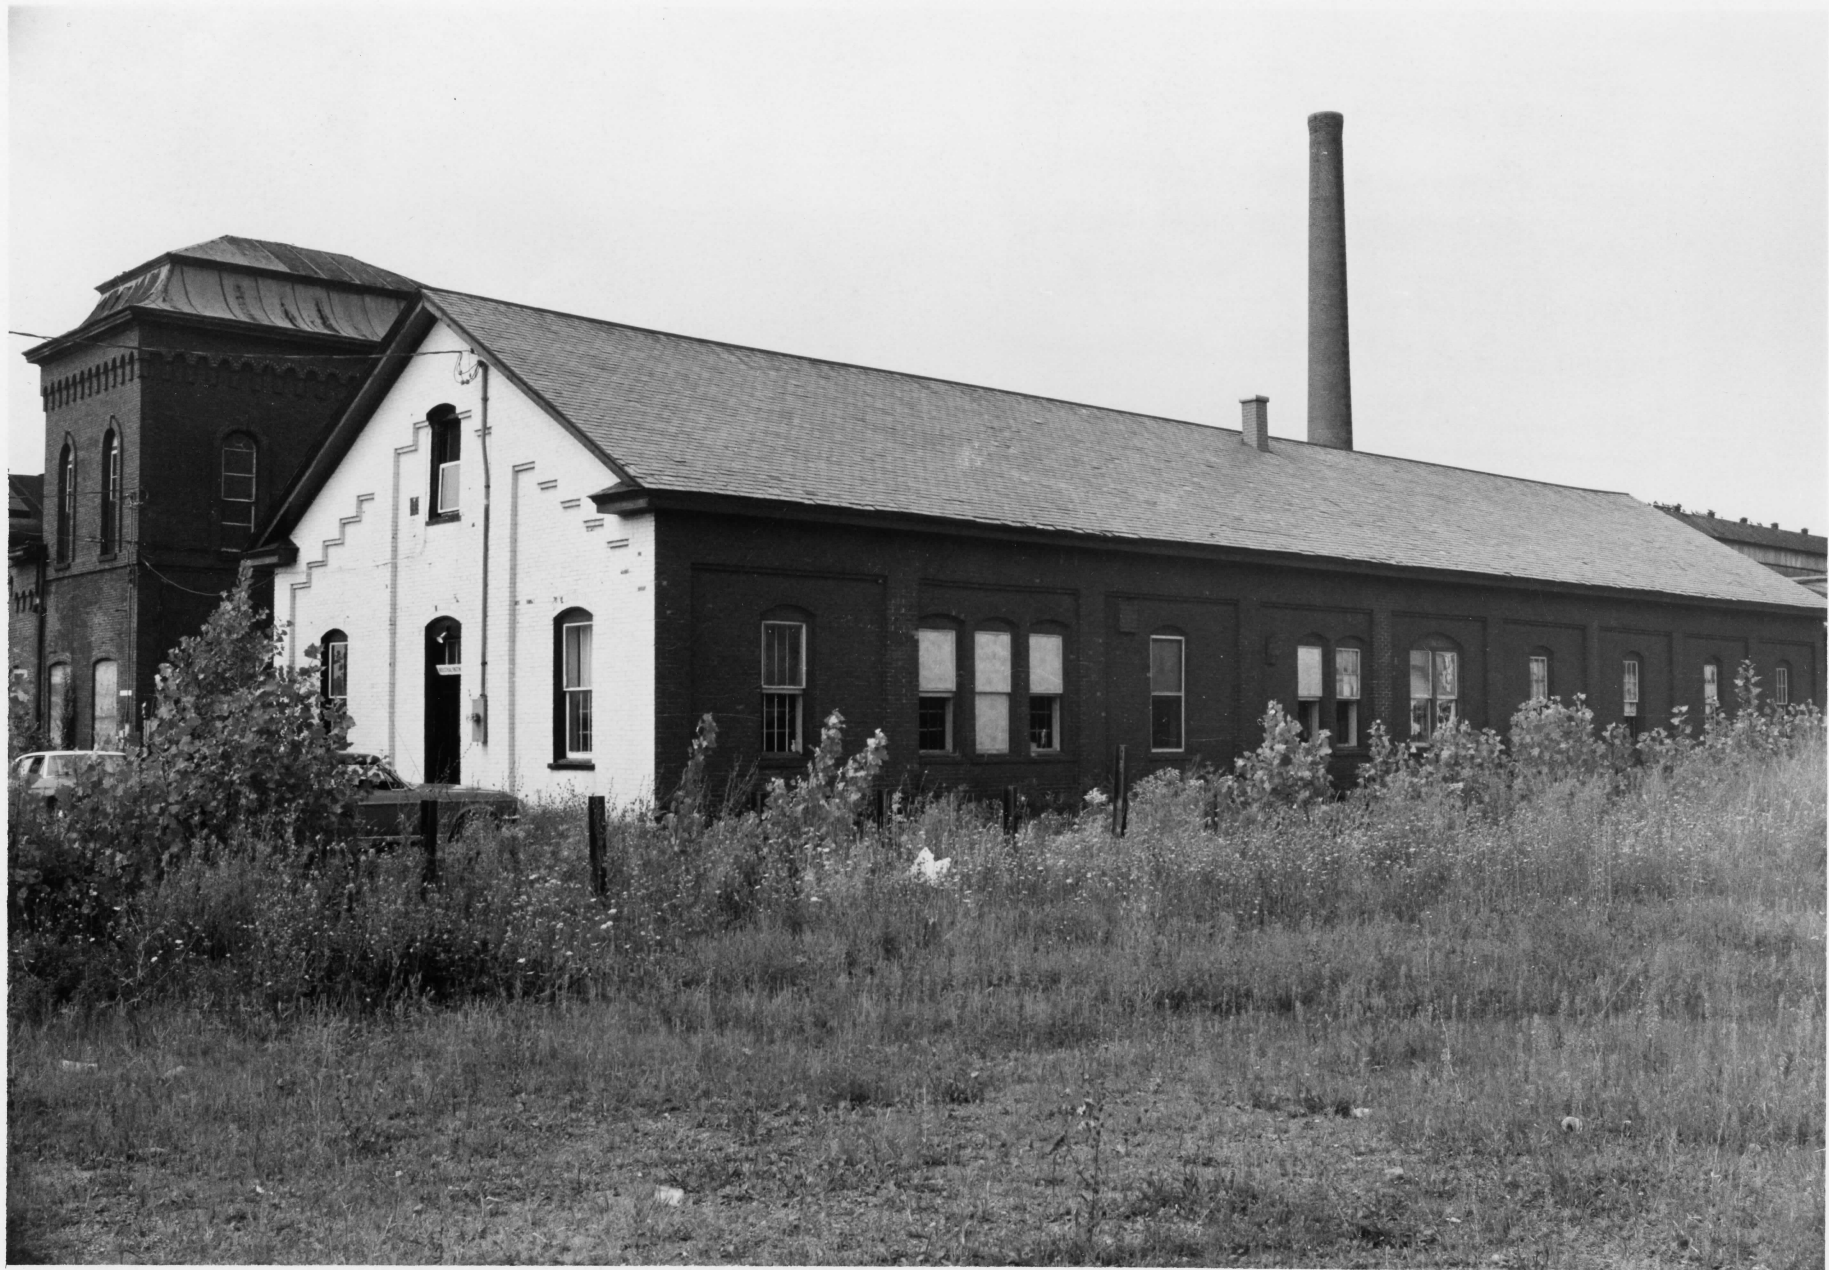
5 of 5

Maintenance shops (5) adjacent to locomotive shop on west; view northwest.

The maintenance shop (5) adjacent to the locomotive shop was also constructed between 1863 and 1865. It is a single-story, rectangular-plan structure set upon a low cut-stone foundation. The main (south) facade is three bays in width. Walls are constructed of brick, load-bearing masonry with stairstep corbelling and recessed decorative panels on the south, east and west facades. The roof is a medium-pitch gable type, shingled in asbestos. Fenestration is segmented-arch, double-hung sash type throughout. Windows are centrally located in each bay, excepting more recent additional windows on east and west facades.
