# Climate Control Unit

## Removal

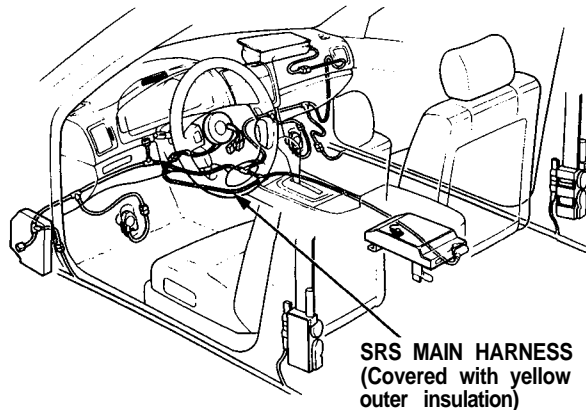
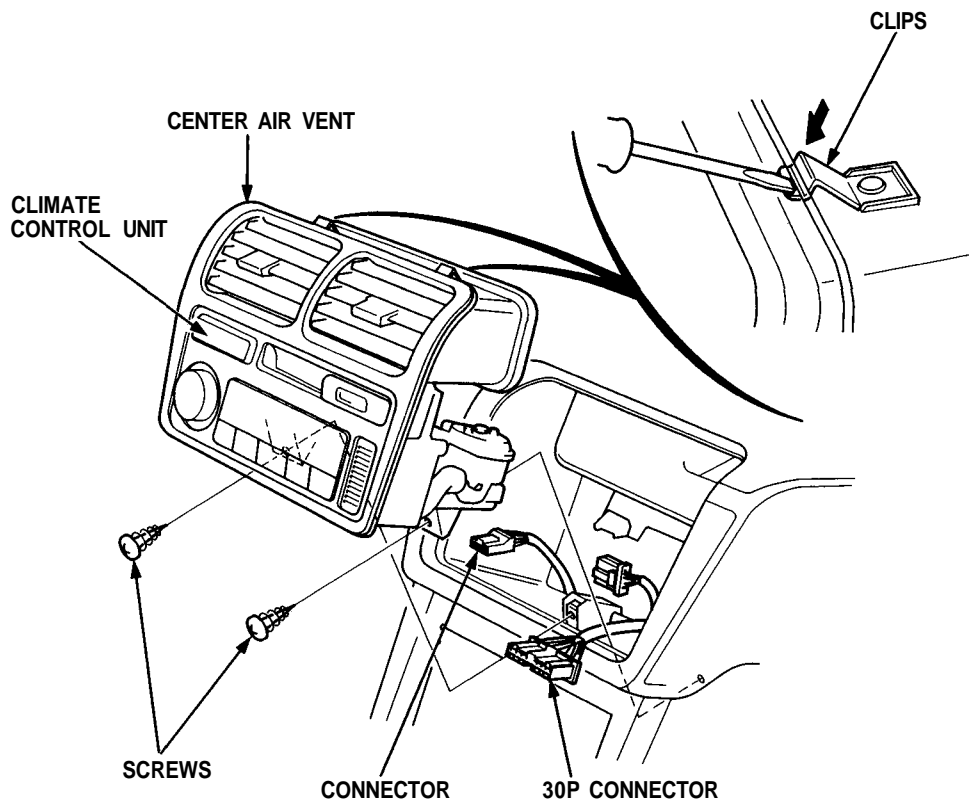
2. Remove the screws then disconnect the climate control unit connectors.
3. Remove the climate control unit assembly by pushing the clips down as shown.

**CAUTION:** Be careful not to damage the center air vent and dashboard.
