Stereo Sound System

Component Location Index

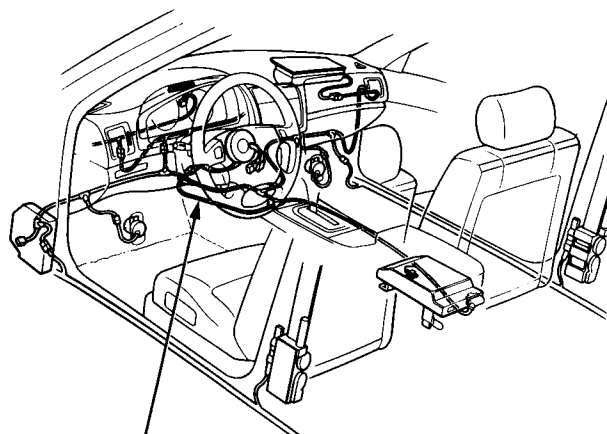
SRS MAIN HARNESS
(Covered with yellow outer insulation)

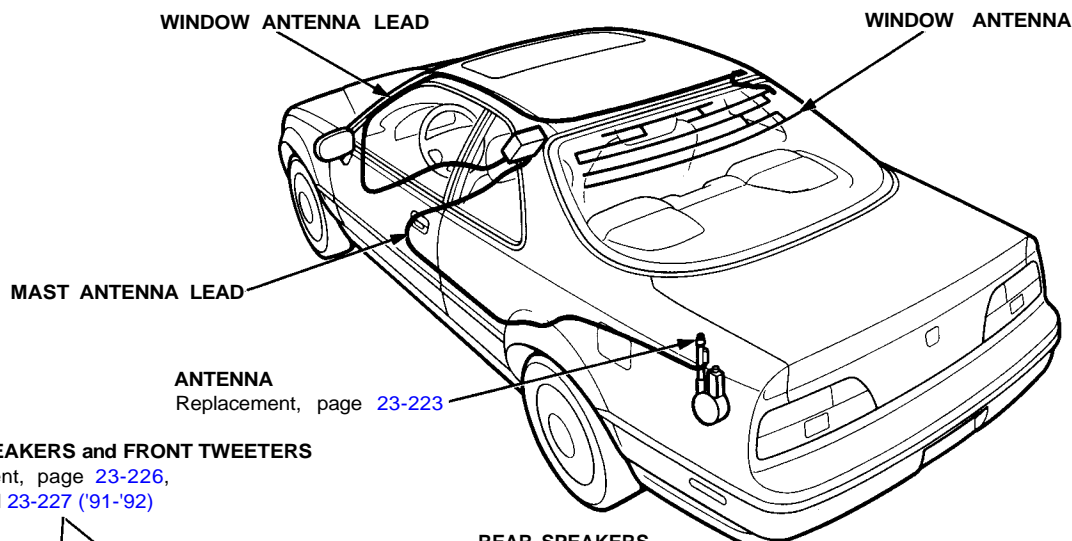
WINDOW ANTENNA LEAD

WINDOW ANTENNA

MAST ANTENNA LEAD

ANTENNA
Replacement, page 23-223

DOOR SPEAKERS and FRONT TWEETERS

Replacement, page 23-226,
23-226 and 23-227 ('91-'92)

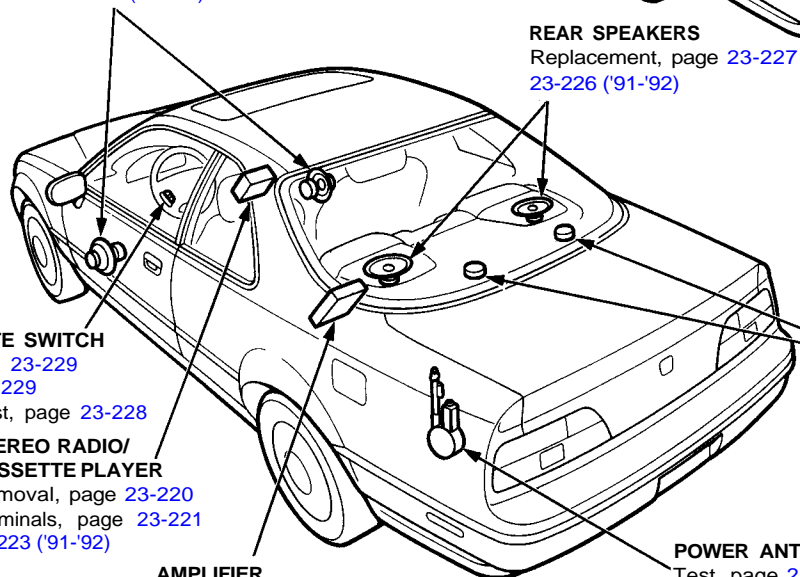
REAR SPEAKERS
Replacement, page 23-227
23-226 ('91-'92)

REAR TWEETERS
Replacement, page 23-227
('91-'92) ('93-'95)

RADIO REMOTE SWITCH
Removal, page 23-229
Test, page 23-229
Cable Reel Test, page 23-228

**STEREO RADIO/
CASSETTE PLAYER**
Removal, page 23-220
Terminals, page 23-221
23-223 ('91-'92)

AMPLIFIER
Terminals, page 23-225
Removal, page 23-224

POWER ANTENNA MOTOR
Test, page 23-222
Replacement, page 23-224
