Climate Control Unit

Removal

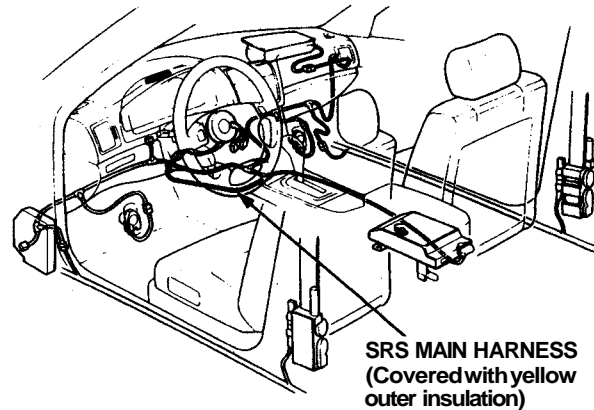
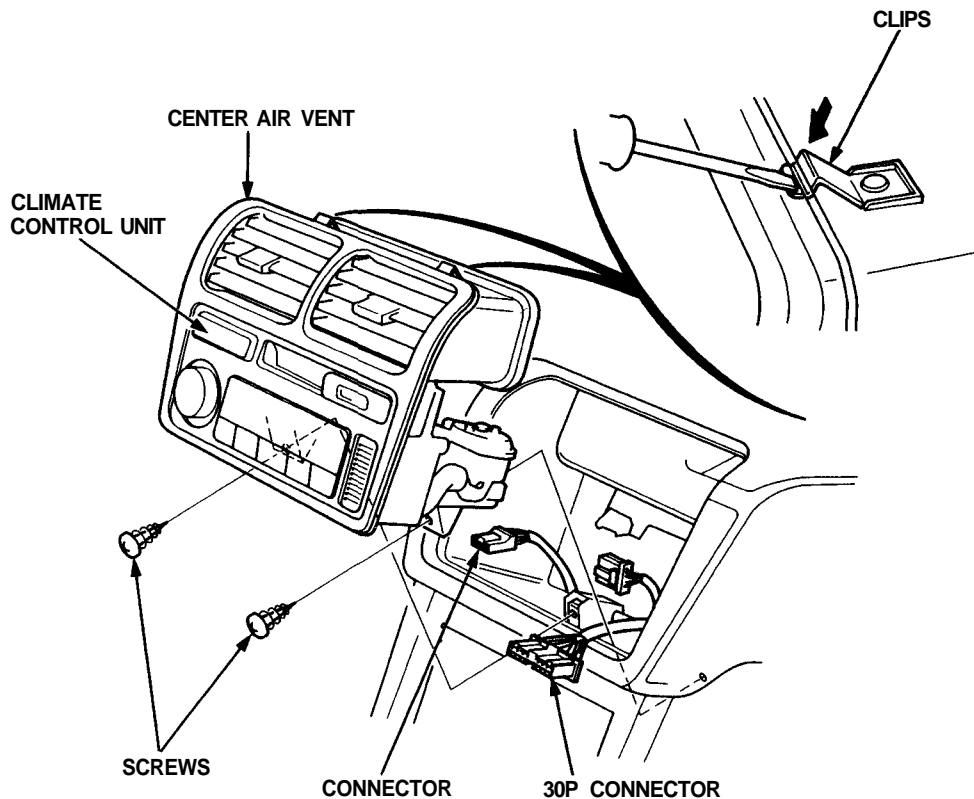
2. Remove the screws then disconnect the climate control unit connectors.
3. Remove the climate control unit assembly by pushing the clips down as shown.

CAUTION: Be careful not to damage the center air vent and dashboard.
