# Stereo Sound System

## Component Location Index

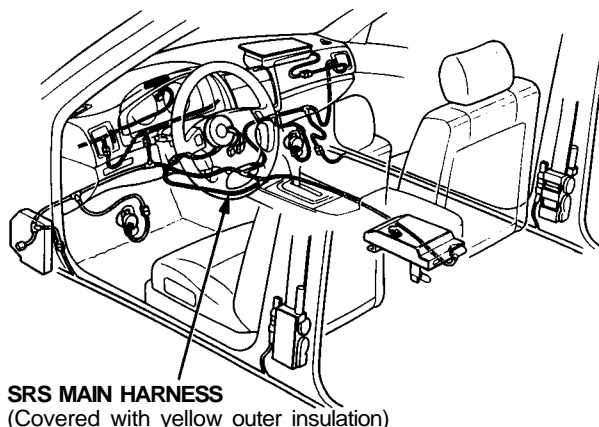
**SRS MAIN HARNESS**  
(Covered with yellow outer insulation)

**DOOR SPEAKERS/FRONT TWEETERS**  
Replacement, page 23-236

**REAR SPEAKERS**  
Replacement, page 23-237

**RADIO REMOTE SWITCH**  
Removal, page 23-235  
Test, page 23-235  
Cable Reel Test, page 23-234

**STEREO RADIO/  
CASSETTE PLAYER**  
Removal, page 23-228  
Terminals, page 23-223 ('91-'92) or  
23-229 ('93-'95)

**REAR TWEETERS**  
Replacement, page 23-237

**POWER ANTENNA MOTOR**  
Test, page 23-230  
Replacement, page 23-232

**AMPLIFIER**  
Terminals, page 23-231 ('91) or  
23-233 ('92-'95)  
Removal, page 23-232
