Replacement

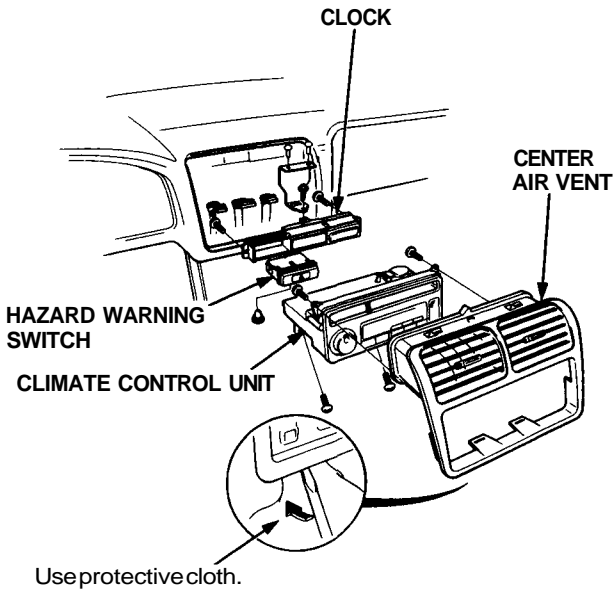
1. Remove the center air vent/climate control unit (see [section 20](#)), and separate the climate control unit from the center air vent (see [section 20](#)).
2. Remove the stereo radio/cassette player (see page [23-228](#)).
3. Remove the clock and hazard warning switch from the climate control unit.
4. Remove the hazard warning switch from the clock.
5. Install in the reverse order of removal.

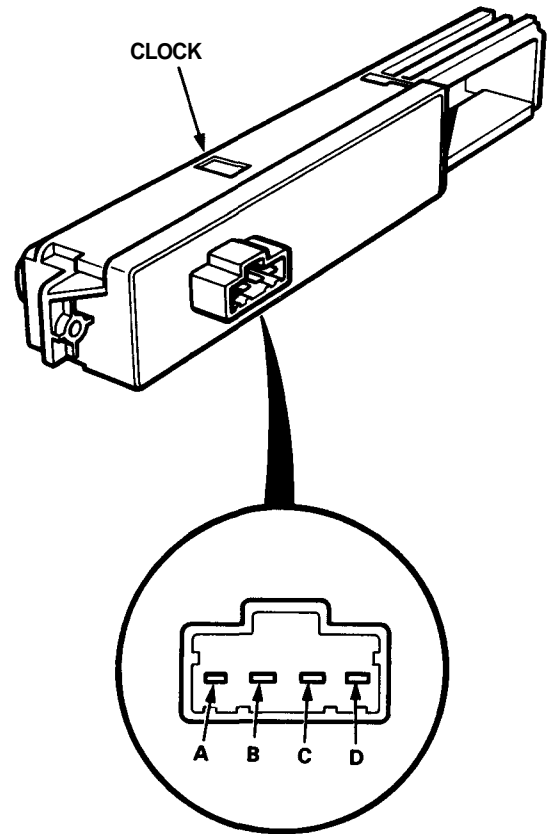
Terminals

Terminal	Wire	Connects to
A	BLK	Ground (G301, G302, G303)
B	RED/BLK	Lights-on signal
C	WHT/YEL	Constant power (Time memory)
D	YEL	IG1 (Main clock power supply)
