# EBEY'S LANDING NATIONAL HISTORICAL RESERVE

## PNRO INVENTORY

| NAME(S) OF STRUCTURE<br>Armstrong/ Scoby House | | DATE OF CONSTRUCTION<br><br>1895<br><br>ADDITION(S)<br><br>1974 | SITE ID. NO. | |

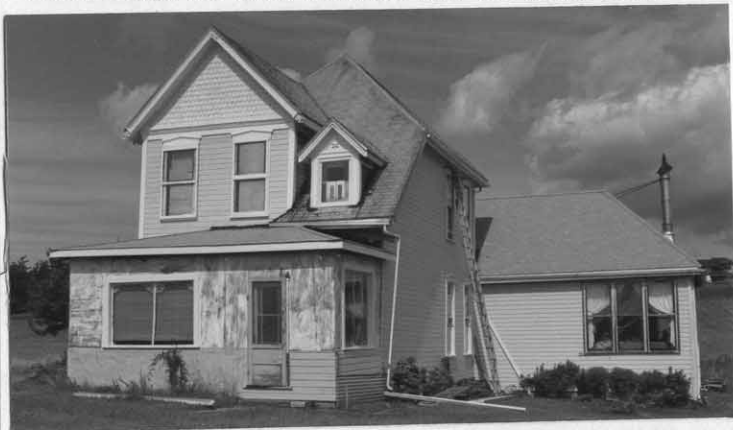
FROM SE

Vernacular Queen Anne Residence. Wood frame set on post and block foundation; rectangle (16'x38') with hip roof addition on east facade, gable roof addition on northwest facade; 2 bays wide; 2-stories; shiplap siding with octagonal shingles on south gable; asphalt-shingled gable and hip roof; off-center entrance on north facade. Exterior features include pedimented 1/1 double-hung sash; single pane fixed sash; gable-roofed dormer on south facade with moulded cornice and decorative star motif; enclosed hip-roofed porch on south facade with glass and wood-panelled door; partially enclosed gable-roofed entry on north facade; boxed cornice; decorative fascia board; plain frieze board; corner boards. Notable landscape features include 1 gable-roofed barn with shed-roofed extension.
