## EBEY'S LANDING PNR

NATIONAL INVENTORY

| HISTORICAL RESERVE | | | | | | | | | |
|--|--|---|---|---|---|---|---|---|--|
| Howard House/Lindsey House/Staal House | | | | SCALE QUAD NAME | | | | 1000 | |

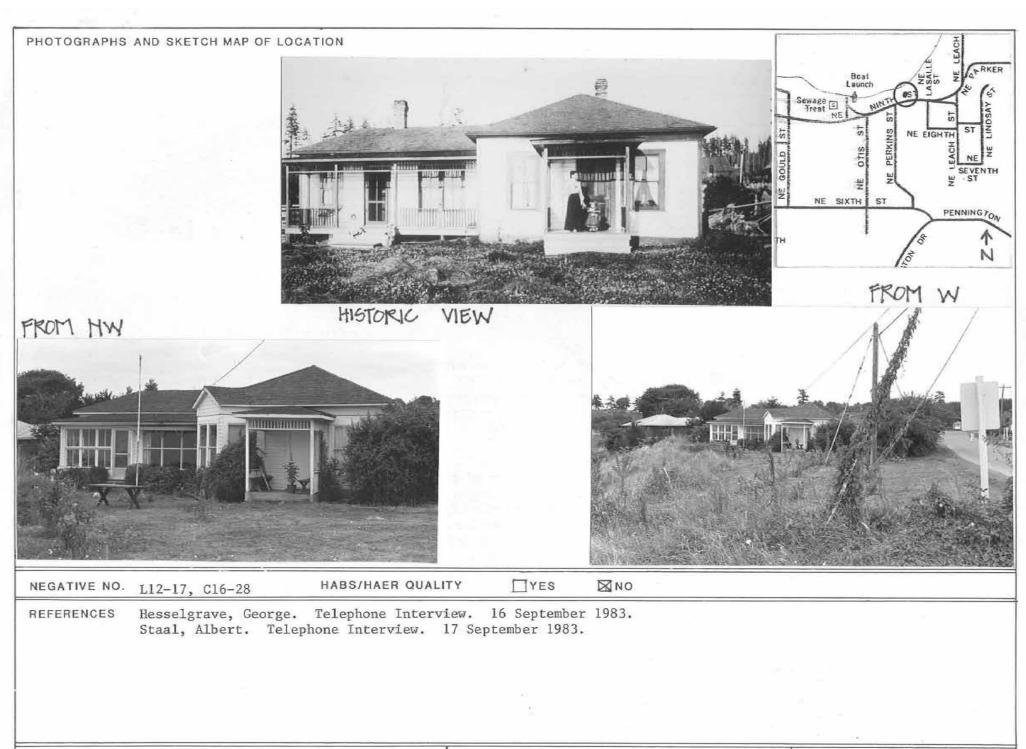
| HISTORICAL RESERVE | | | | | | | | | |
|--|--|---|---|---|---|---|---|---|--|
| foundation; square (24' x 24') with 1-story gable roof additions on north and east facades; 1-story; shiplap siding; wood-shingled hip roof; off-center entrance on west facade. Exterior features include 1/1 and 2/2 double-hung sash with | | | | | | | | | |
| plain surrounds; aluminum sliding sash; gable roof bay on northwest corner; boxed cornice; plain, wide frieze board; hip | | | | | | | | | |
| roof porch with plain stickwork undereaves; plain wood posts and railing; enclosed shed roof porch extends length of | | | | | | | | | |
| addition on west facade; enclosed porch extends length of addition on east facade. Notable landscape features include | | | | | | | le | | |
