NAME OF STRUCTURE  
· FIRST · ISLAND · COURTHOUSE ·  
COVELAND, - AT HEAD OF PENN COVE WHIDBY ISLAND, WASHINGTON.

SURVEY NO.  
39W-7  
HISTORIC AMERICAN  
BUILDINGS SURVEY  
SHEET 4 OF 7 SHEETS  
INDEX NO.

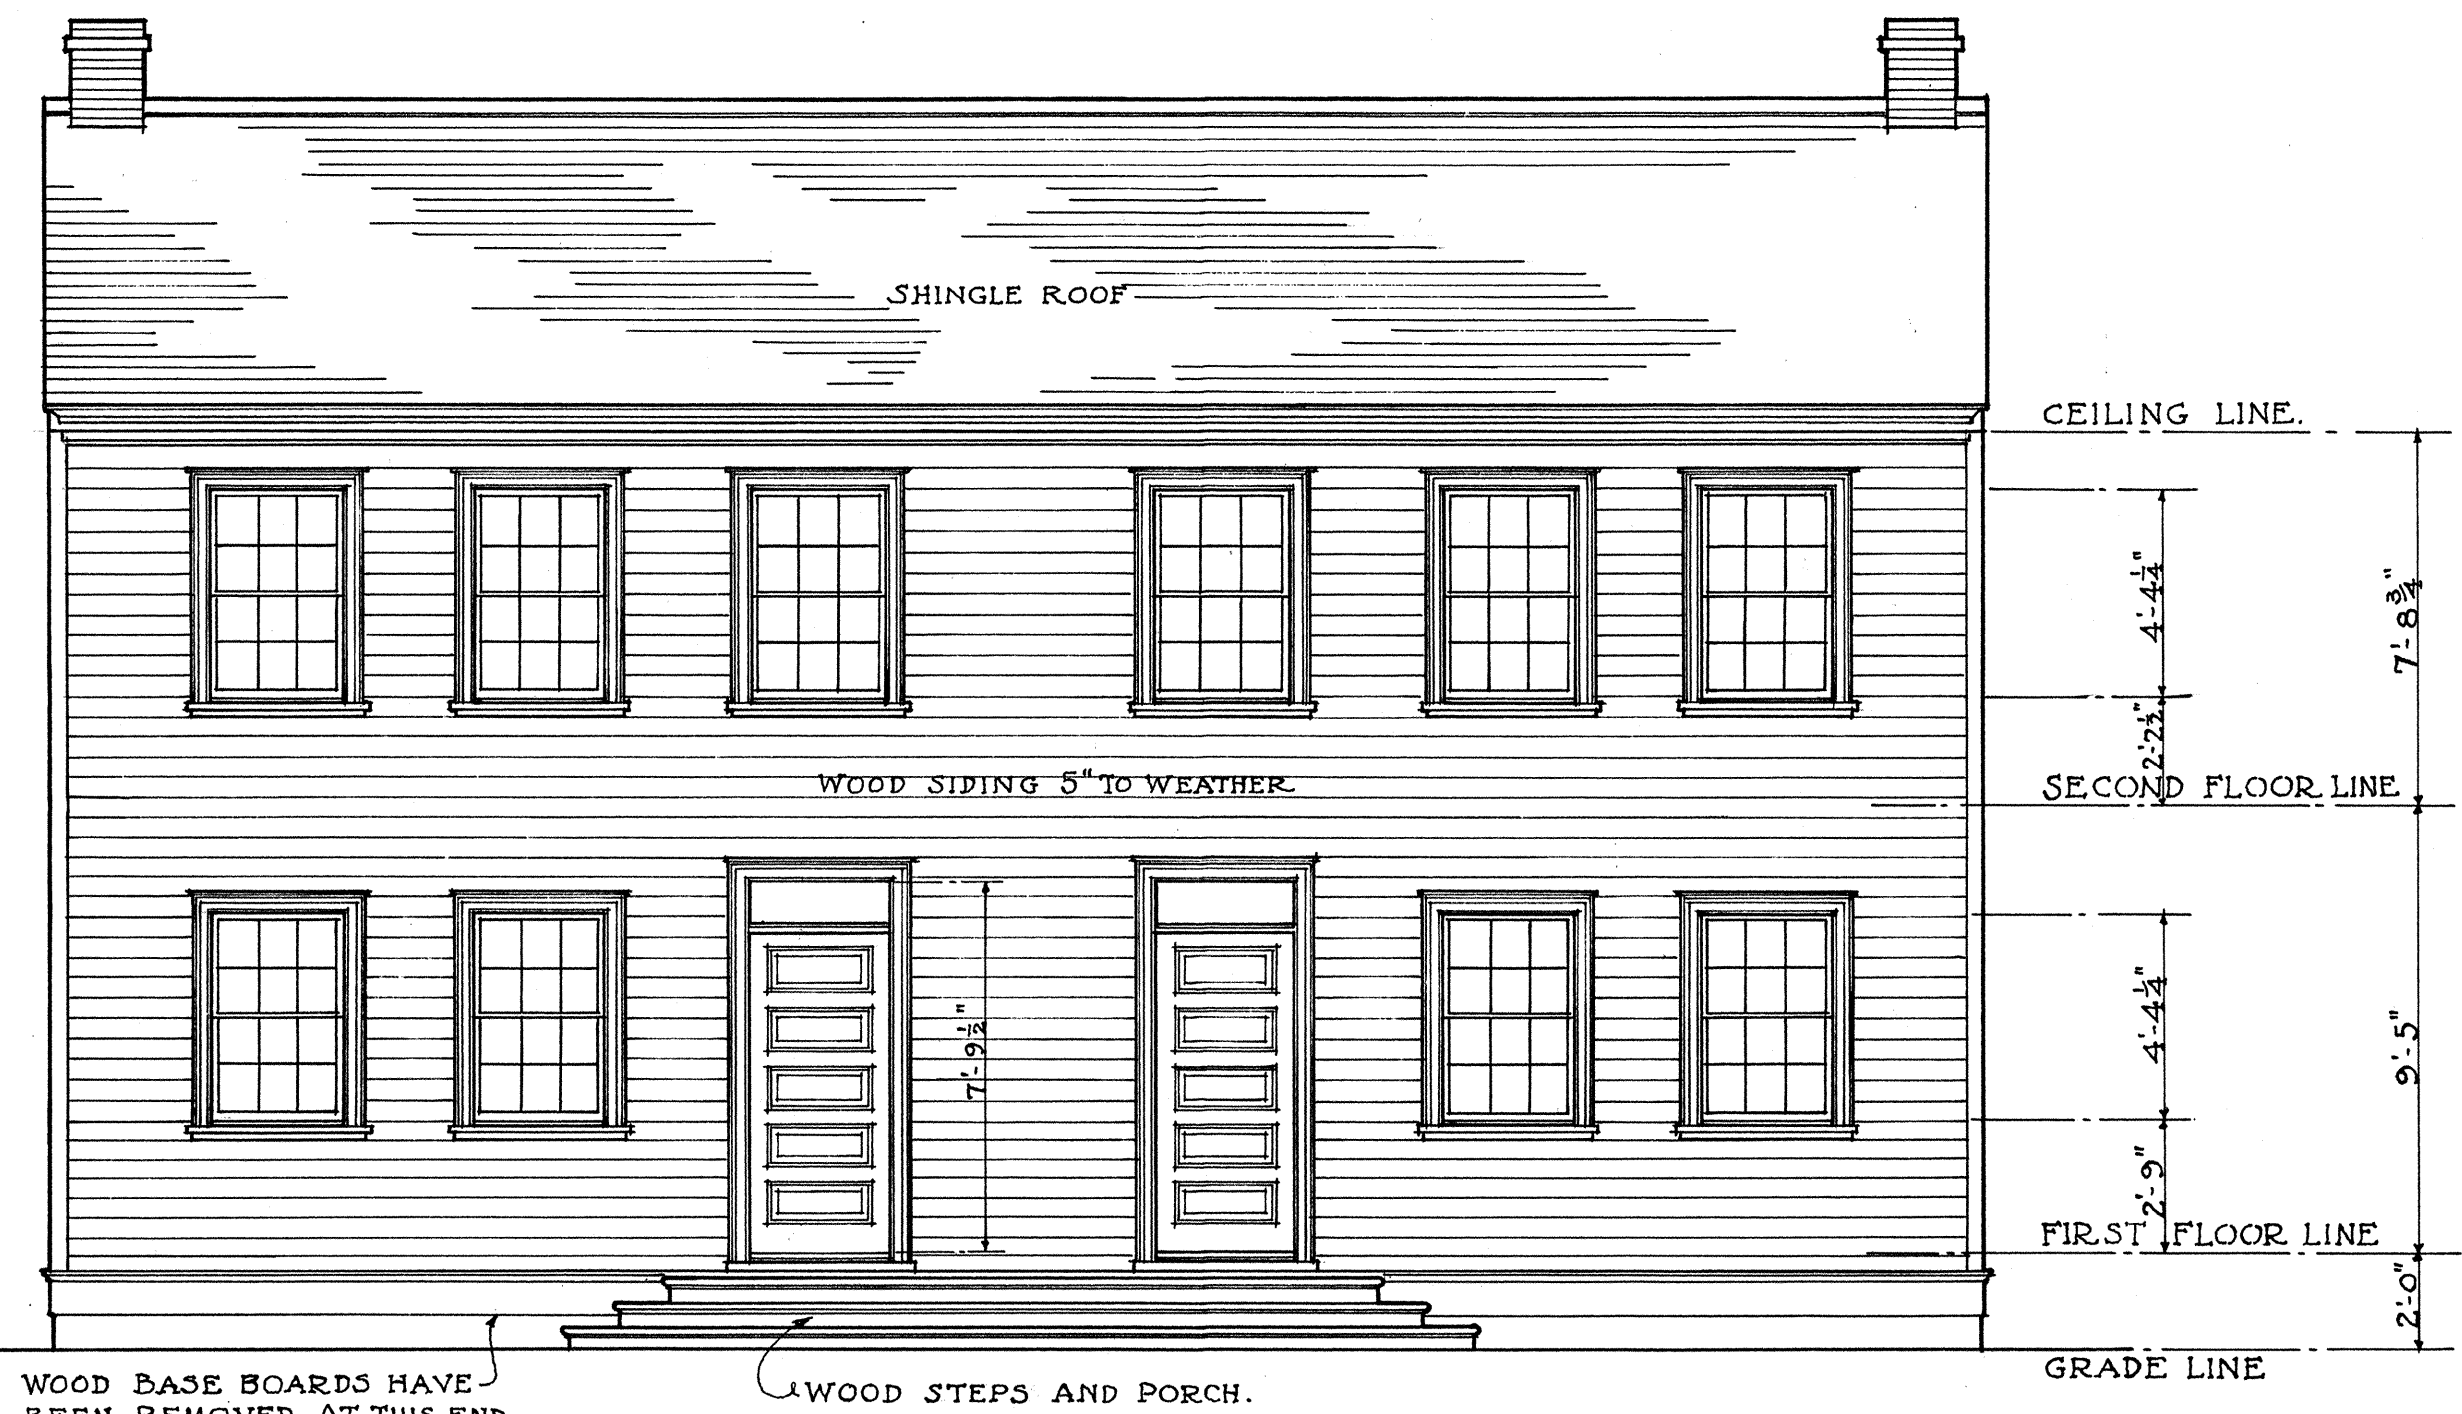
· EAST · ELEVATION ·

NOTES:  
PORCH AND STEPS SHOWN ON THIS ELEVATION ARE ALMOST TOTALLY CRUMBLD.  
ALL STRUCTURAL MEMBERS, SUCH AS STUDS, BEAMS AND RAFTERS ARE HAND HEWN. THEY ARE STILL PLUMB AND HAVE NO VISIBLE SIGNS OF DECAY.  
THE EXTERIOR SIDING IS BADLY WEATHERED AND A LARGE PART IS READY TO FALL OFF DUE TO RUSTED NAILS.
