# Crash Tests

### Toyota Kluger

11/2003 on 06/2007 - Dual Frontal

Variant: CVX 4 Dr Wagon

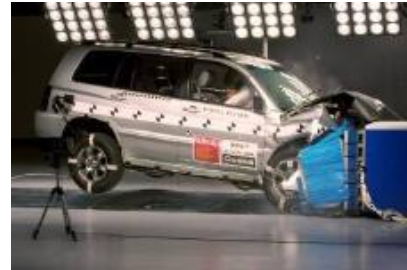
Offset crash test at 64km/hr

The passenger compartment held its shape well in the offset crash test. The brake pedal moved rearwards by 106 mm and downwards 23mm. The steering wheel hub moved rearwards 18 mm, upwards 52 mm and sideways 29 mm. The front ("A") pillar moved 15 mm rearwards. All doors remained closed during the crash. After the crash moderate manual effort was required to open the driver's door.

The airbag cushioned the head of the driver and contact was stable. Steering column components were a potential source of injury for the driver's knees. The passenger's head was cushioned by the airbag. The passenger's knees hit the glove box and dash.

The Toyota Kluger Grande scored 10.43 out of 16 in the offset crash test. The passenger compartment held its shape well. Protection from serious chest and leg injury was marginal for the driver.

Body region scores out of 4 points each: Head/neck 4pts, chest 2.14 pts, upper legs 2pts, lower legs 2.29 pts.
