KMH-CE1-RSB-01-202206

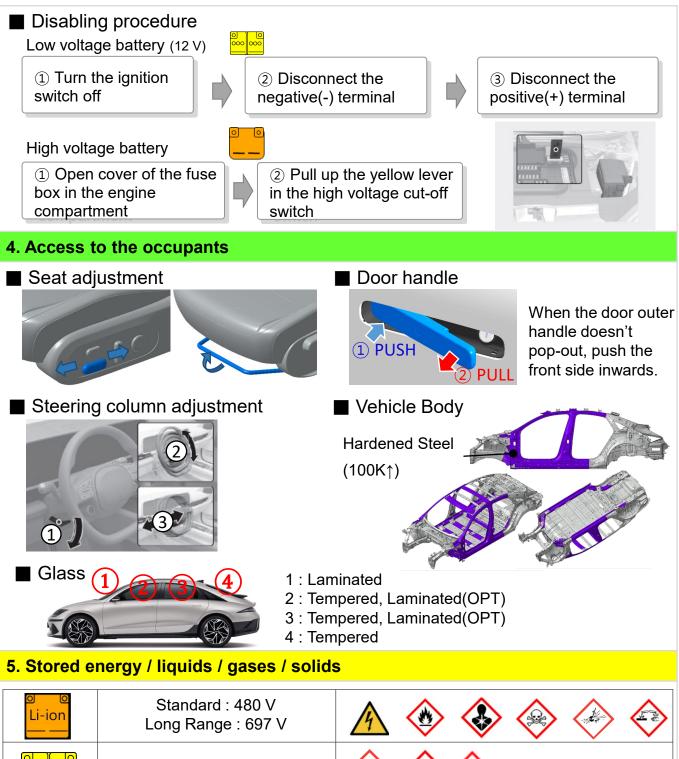
12 V								
***		w/o heat pump	with heat pump						
**	R-134a	750g	950g						
	R-1234yf	700g	900g						
When coolant leaks from the battery pack, it can become unstable with risk of thermal runaway. Check battery pack temperature with thermal imaging camera.

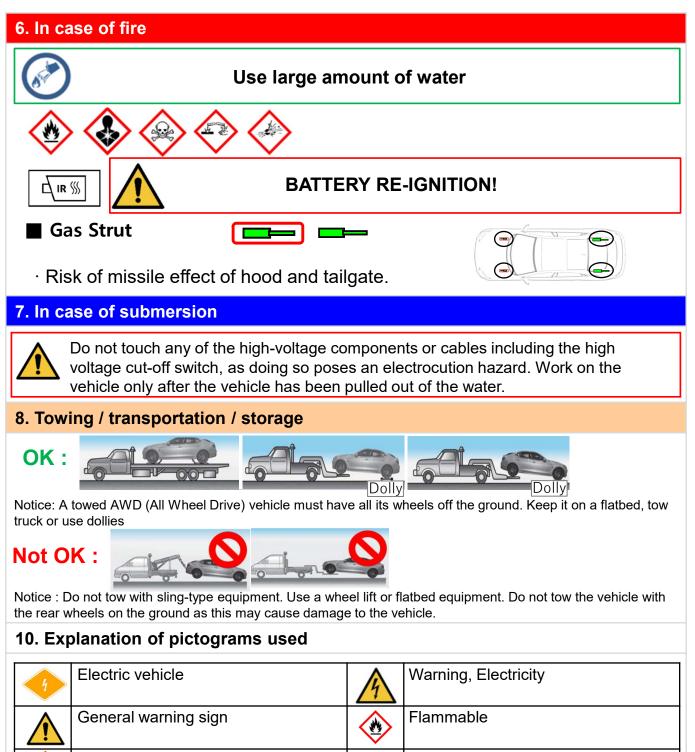
Corrosives		Hazardous to the human health
		Explosive		Acute toxicity
	₩	Air-conditioning component		Warning; low temperature
		Use thermal Infrared camera		Use water to extinguish the fire
		Bonnet		
L
