ŠKODA Rapid (from 2012)

ID No.	Version No.	Version date	Page
TMB-NH	01	02/2016	26

ŠKODA Rapid Spaceback (from 2013)

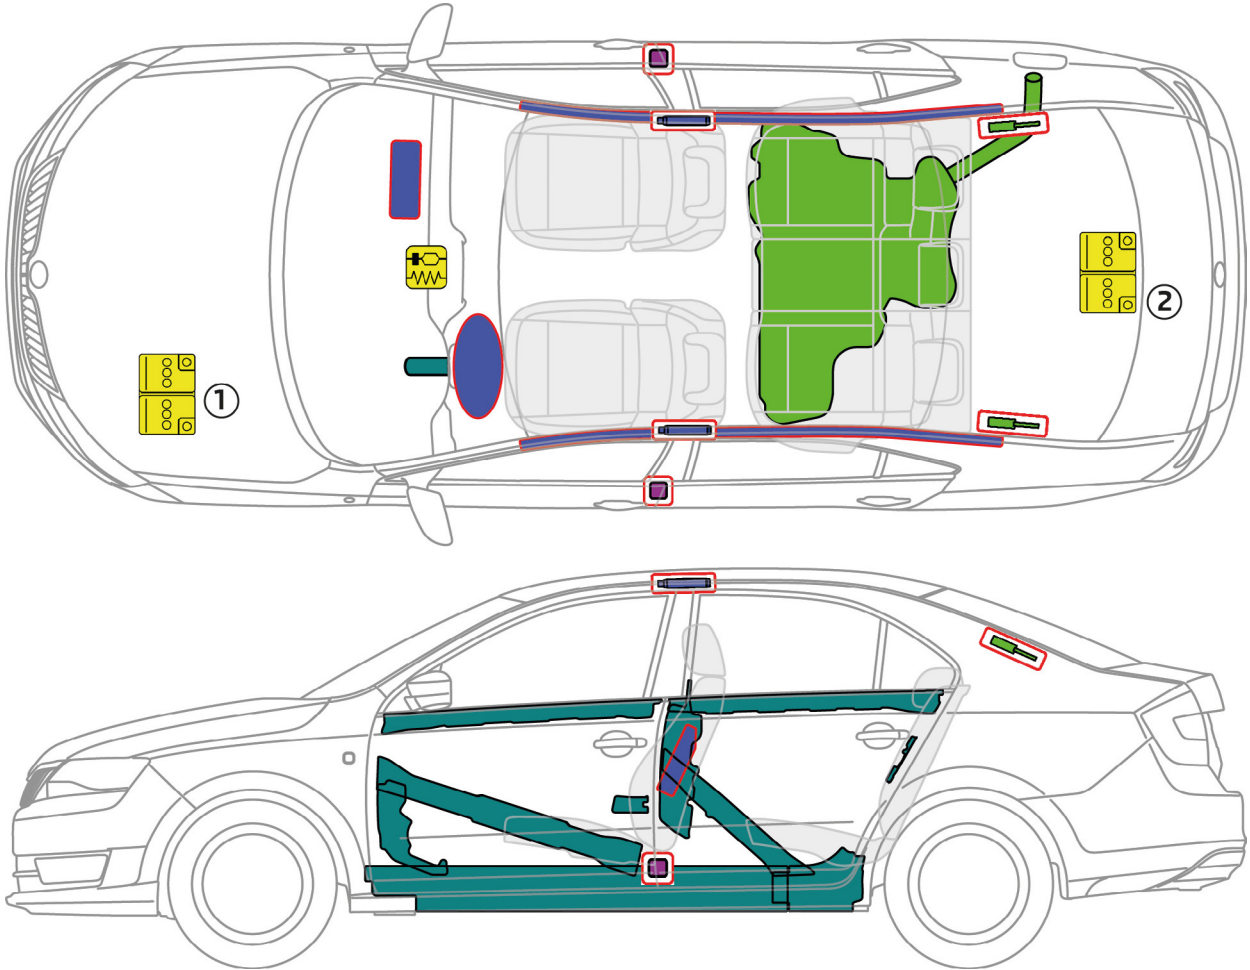
Note: The Rescue Sheet depicts a LHD vehicle (as allowed under the ISO 17840-1). All components (other than steering wheel and passenger airbag) are located in the same position in the Aust/NZ RHD model.

- ① All vehicles except engine 1.6 ltr./85 kW DI CR
- ② All vehicles with engine 1.6 ltr./85 kW DI CR
