# Crash Tests

## New Car Safety

### Toyota Avalon

10/2001 on 07/2005 - Dual Frontal

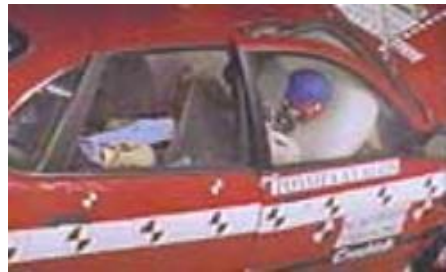
Offset crash test at 64km/hr

The passenger compartment held its shape well in the offset crash test. The front part of the driver's floor was pushed rearwards 170mm. The brake pedal moved rearwards by 150mm. The dash moved 70mm and the steering column moved 100mm towards the driver. The width of the driver's doorway shortened by 30mm. All doors remained closed during the crash. After the crash high manual effort was required to open the driver's door.

The airbag cushioned the head of the driver and contact was stable. The passenger airbag also performed well. During rebound the back of the driver's head hit the centre pillar. The driver's knees hit the dash and steering column cover. Injury measurements were good but the ignition switch could be a hazard to the knees in slightly different crash circumstances. The passenger's knees hit the glove box and dash and injury measurements were good.
