Crash Tests

Nissan Urvan (E25)

06/2001 on 01/0001 - Dual Frontal

Frontal Offset Crash Test

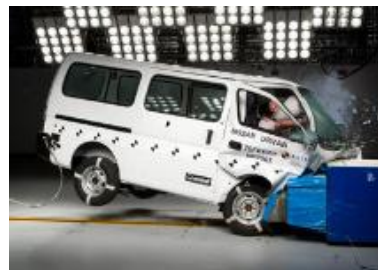
Offset crash test at 64km/hr

Body region scores out of 4 points each: Head/neck zero pts, chest 0.37 pts, upper legs 0.95 pts, lower legs/feet zero pts.

The passenger compartment lost structural integrity in the offset crash test. The brake pedal moved rearwards by 367 mm and upwards 206 mm, to a position where it posed a hazard to the groin of the dummy. The steering wheel hub moved 11 mm rearward, 191 mm upward and 3 mm sideways. The front ("A") pillar moved 143 mm rearwards. All doors remained closed during the crash. After the crash tools were required to open the driver's door. The dummy's left foot was trapped by the deformed footwell and the dummy leg was dismantled for extrication. There was a leak from the diesel fuel tank. The top of the tank had been speared by the front suspension torsion bar which displaced rearwards in the crash.

Due to steering column movement, the airbag tended to deploy upwards. The airbag partly deployed under the driver's chin, causing excessive bending of the neck. Airbag contact was unstable. Steering column and dash components were a potential source of injury for the driver's knees. The passenger's head was cushioned by the airbag. There was no sign of passenger knee contacts.
