ŠKODA Superb II (2008 - 2015)

ŠKODA Superb Combi II (2009 - 2015)

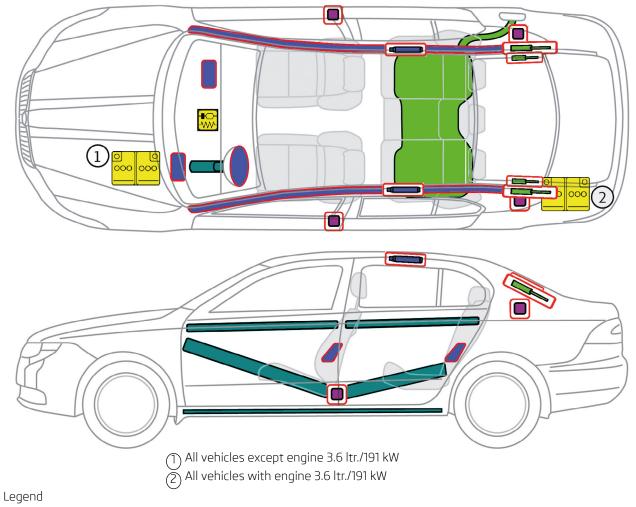
Note: The Rescue Sheet depicts a LHD vehicle (as allowed under the ISO 17840-1). All components (other than steering wheel and passenger airbag) are located in the same position in the Aust/NZ RHD model.

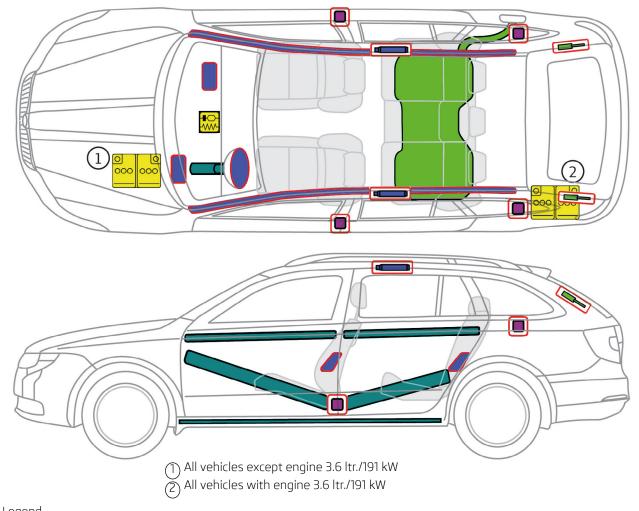
Note: The Rescue Sheet depicts a LHD vehicle (as allowed under the ISO 17840-1). All components (other than steering wheel and passenger airbag) are located in the same position in the Aust/NZ RHD model.
