## CUP SEALER STUCK IN DOWN POSITION

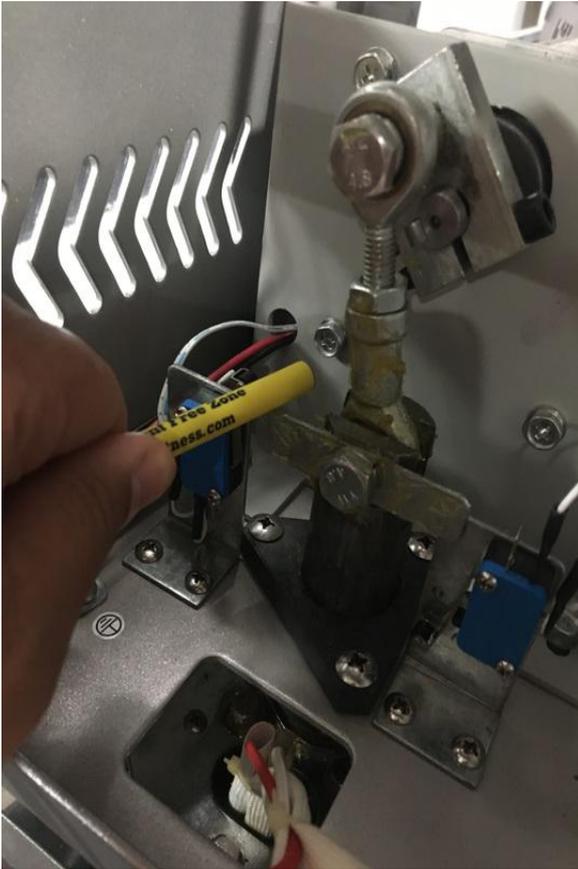
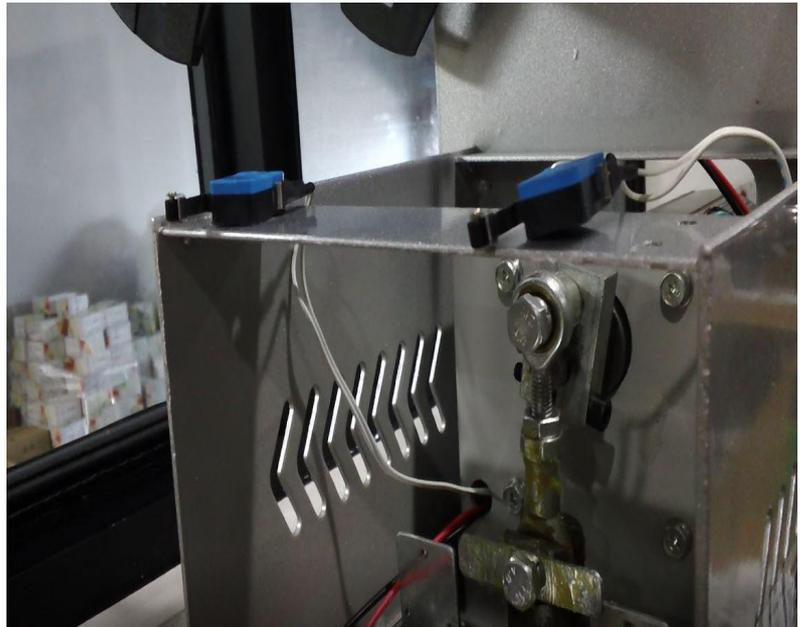
1.

Turn **ON** machine with the **LEFT** sensor depressed.

**(DO NOT USE YOUR HAND - USE A PEN, UNLESS YOU REMOVE THE SENSOR TWO SENSORS OUTSIDE OF THE MACHINE)**

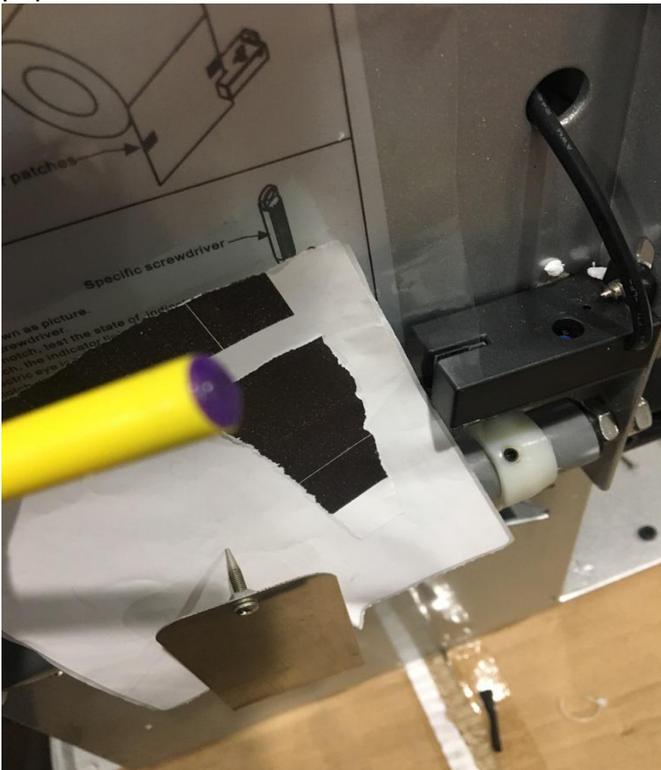
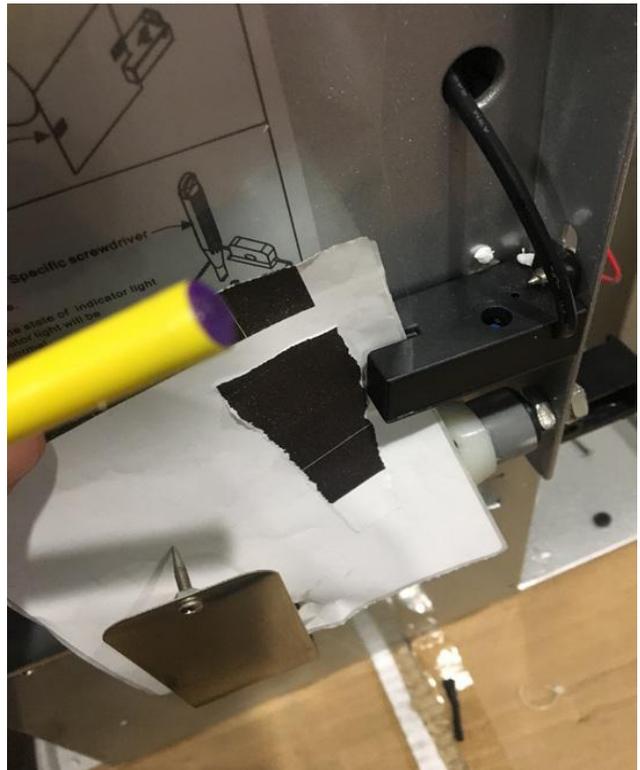
2.

Use a piece of **PAPER** to activate the **FILM SENSOR**. You may want to remove the paper and re-enter the paper to **ACTIVATE** the **RED LIGHT** on the film sensor.

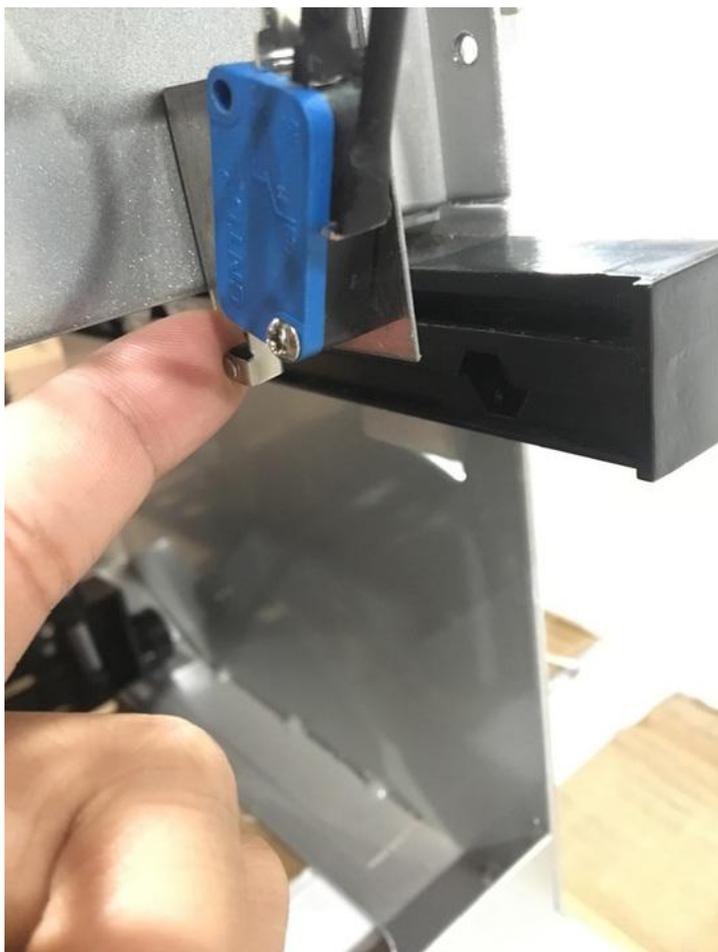
3.  
While holding the **LEFT** sensor, **PRESS** the **BACK** sensor where the cup tray enters to depress the back sensor.

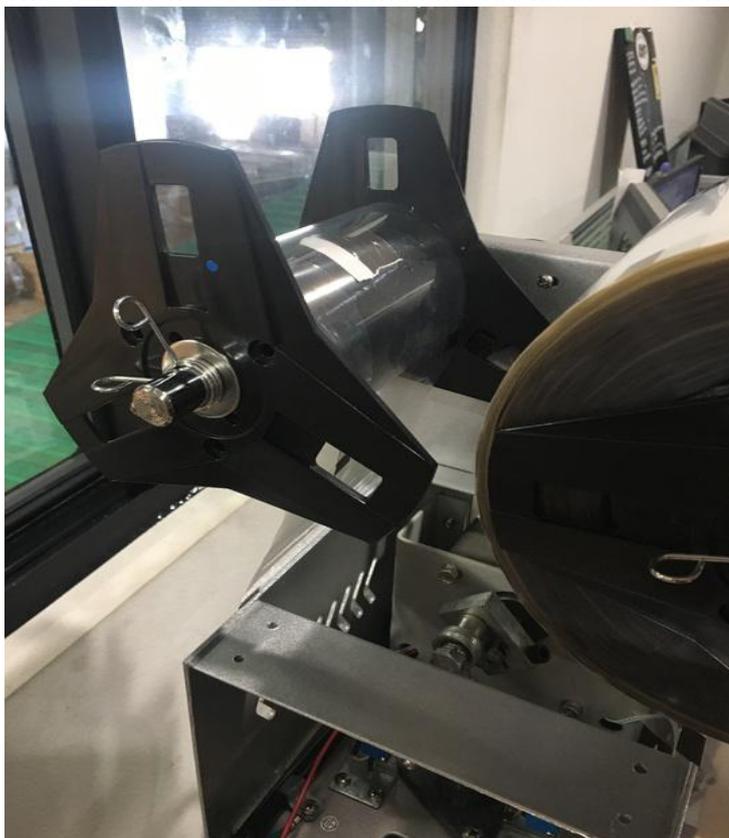
4.  
This will allow the **GEAR** on the left side film roll to **SPIN**.

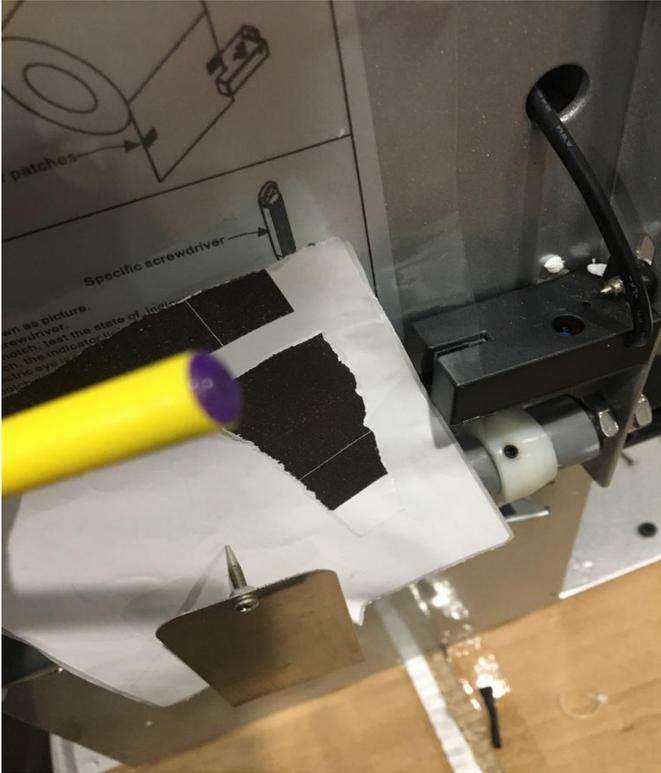
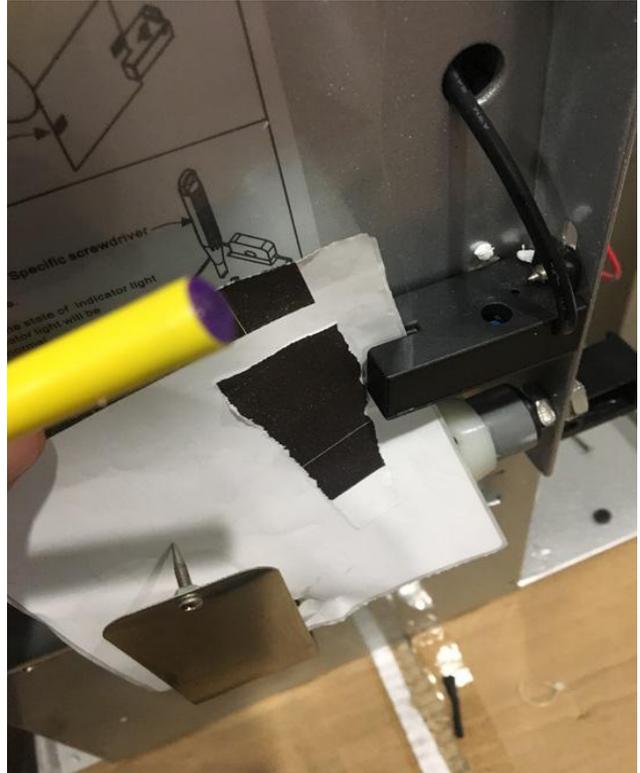
5.

**REMOVE** the paper to turn off the **RED LIGHT** and **RE-INSERT** the paper to **TURN ON** the **RED LIGHT**. This will simulate as if the film is being fed into the machine to make the next cup ready to be sealed. (STILL hold the left sensor on the front of the machine while removing/re-inserting the paper)

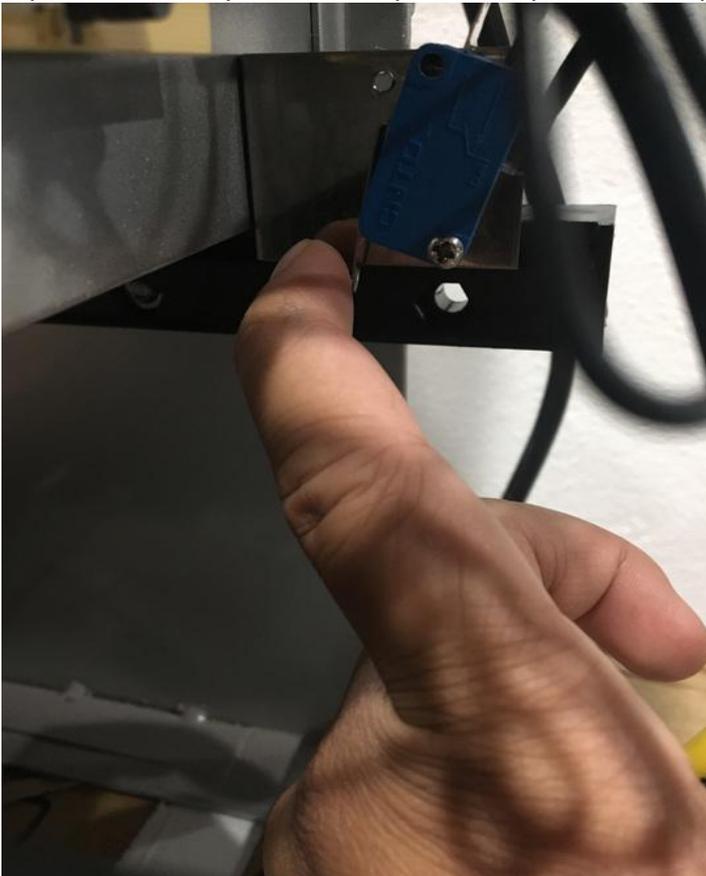
6.

When the **FILM SENSOR** is **RED** again, press the sensor on the **BACK**. At this point **RELEASE THE TOP SENSOR**. This will allow the heat plate to **COME DOWN** or **COME Back UP**. It will **PRESS** The top sensor if it is placed correctly and will stop at the top with the top sensor pressed again.

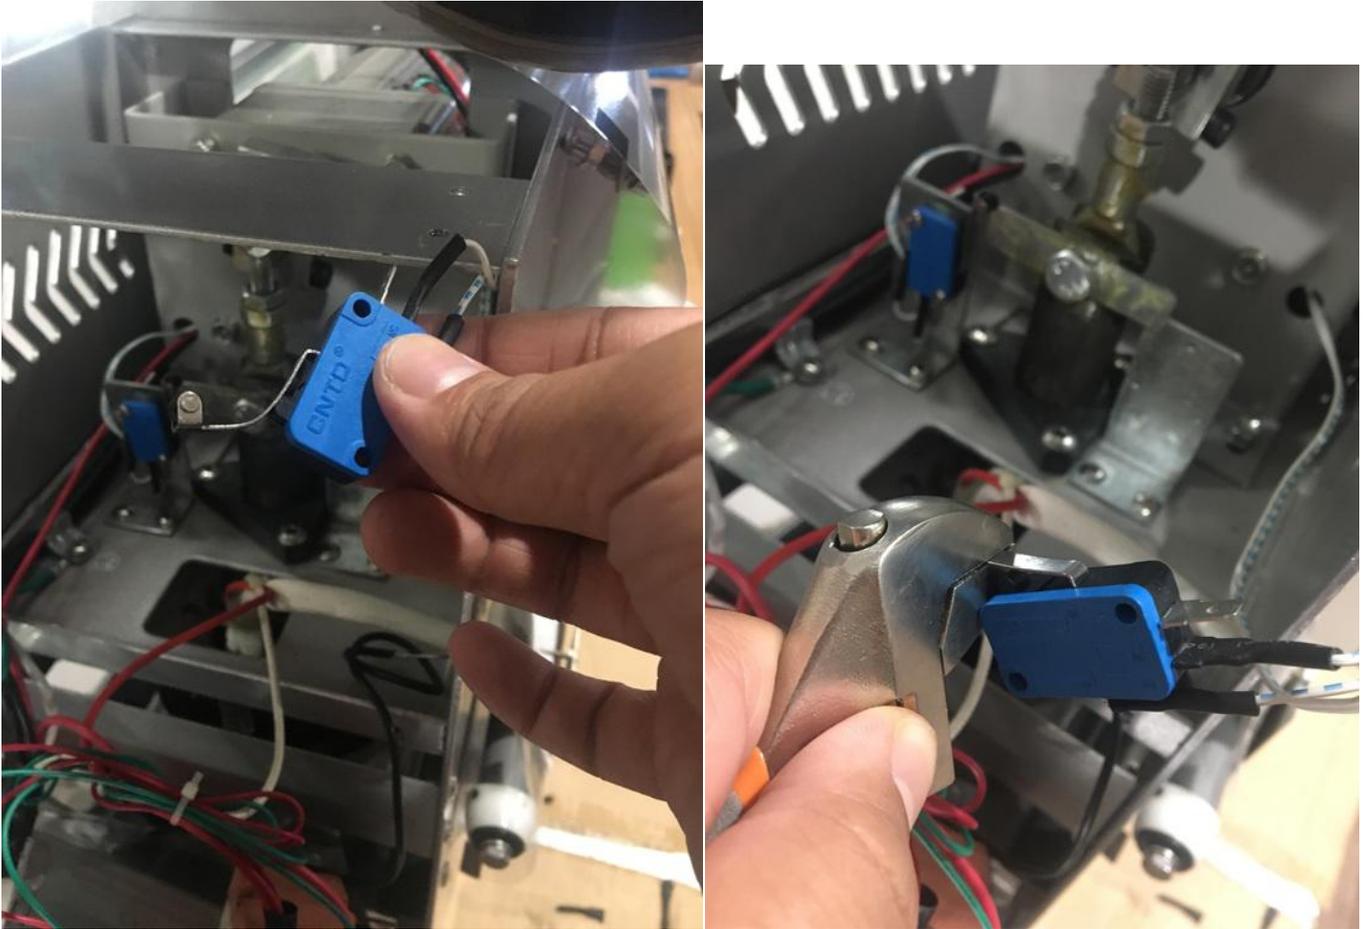
I also noticed, which CAUSED the heat plate to be stuck down to begin with , is that the replacement part we sent you has a STRAIGHT arm, while the one originally in the machine had a CURVED/BENT arm.

I took the replacement part with the STRAIGHT ARM and BENT IT with some pliers. This is so that when it presses DOWN , it can actually HIT the CURVED section , causing the straight side of the bar to CLICK the sensor. THIS solved the issue .
