How to fix a loss of supervision on a wireless sensor

Round Sensor (NOWDSF360)

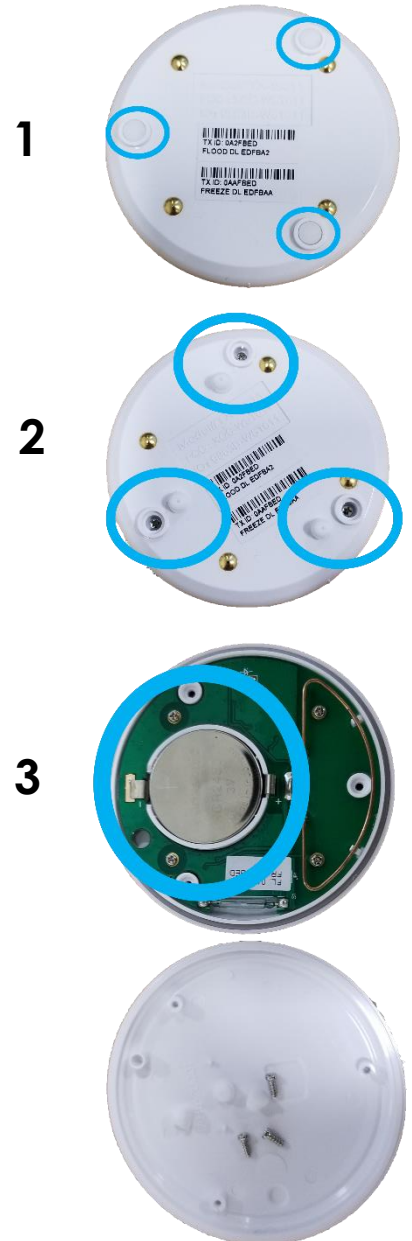
1. Remove the pads under the wireless sensor tabs
2. Unscrew the 3 small screws from the sensor tabs
3. Lift the top shell of the sensor
4. Remove the CR2450 battery by lifting it with the flat screwdriver
5. Heat up the battery for a few minutes
6. Put the battery in the space provided, making sure to see the positive side
7. Replace the top shell on the sensor making sure the gasket is in place
8. Screw the small star screws
9. Replace the pads in the sensor tabs
10. Use a magnet and tap it against the mark on the side of the sensor while being close to the Nowa 360 panel.
11. If the magnet is strong enough, it should send a tamper alarm and restore the low battery in the control panel state.
12. Use the "Reset" button to cancel the alarm.
