# UNDERSTANDING NYLON INSERT LOCKNUTS

## UNDERSTANDING NYLON INSERT LOCKNUT DESIGN

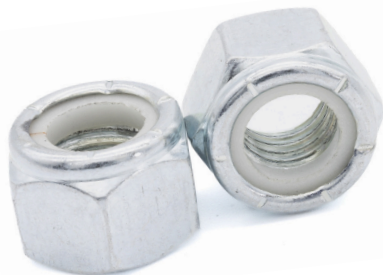
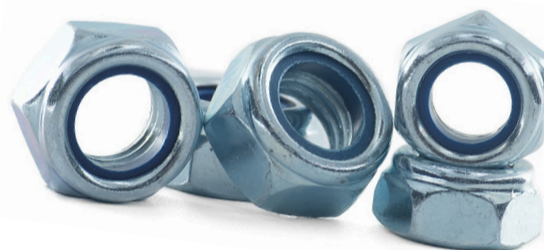
- These type of locknuts feature a hex nut with a nylon-filled collar at its back end.
- The collar forms a tight frictional fit around the mating screw or bolt to prevent movement when it is subjected to vibration.

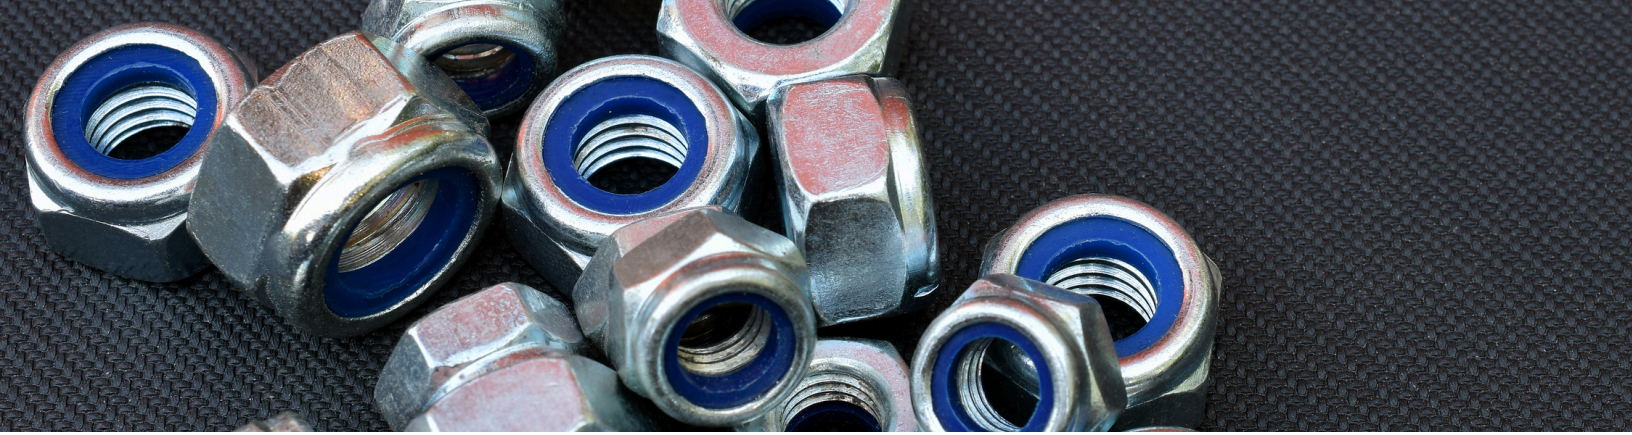
There are only six visual symptoms on why a nylon insert with appear to have failed:

- **Brittleness – cracking, soft, dust-like residue where the nylon breaks off**
  - Less than 1% of all issues
  - Exposure to cold working temperatures below -70°F

- Low humidity environment over extended period; prior to installation
- **Pig-Tailing – pieces of the nylon have curled and / or are breaking off**
  - About 1% of all issues fall under pig-tailing

- Usually as a result of a burr or nick on the mating part which is cutting into the nylon insert
- **Undersized Inner Diameter – nylon mushrooms or expands upward**

- Approximately 8% of issues
  - Mushrooms or expands to compensate for the width of the mating end
- **Off-Center – the nylon is not correctly centered inside the nut**

- Very rare to identify and typically not an issue
  - The mating end threads are pushed against the nylon while being torqued and are securely locked as the nylon material tries to return to its original form.

- **Melting During Installation – the nylon literally melts or pops out of the nut**
  - 90% of issues are the result of melting or popping out
  - Most cases are due to the End User's installation practices of installing too fast and too far down on the mating end. Impact Wrenches typically run at 5000 to 10000 RPM and are often used in assembly.

- When the nut is driven at high speeds, the nut body literally out runs the nylon ring resulting in the ring being ripped from the nut as the nut runs away from the ring.

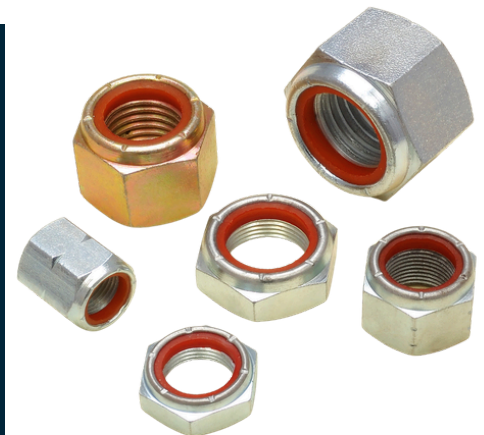
- Installing Nylon Insert Locknuts should not exceed the Prevailing Torque of the 1st On by the Industrial Fastener Institute (IFI) Prevailing Torque Requirements
  - For Example; a 5/8-11 nylon insert locknut has a 420 in-lb (35 ft-lb) maximum prevailing torque for 1st On install.
- Nylon Insert Locknuts are NOT designed to be effectively installed at ultra-high speeds.
  - The friction from the nylon insert produces heat, and can cause the insert to melt or pop out at high speeds
  - Instead of using Impact Wrenches, consider using a Nutrunner. Most Nutrunners run at a speed of 700 – 1200 RPM
