**Printware**

## 1175C Feeder Green Belt Bearing Squealing

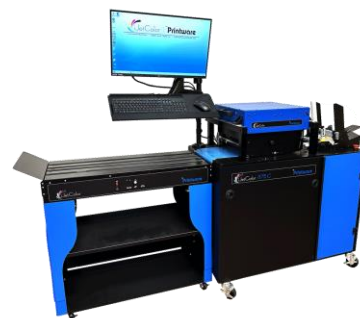
Printware has noticed that the bearings of the green alignment belts of the 1175C feeder may exhibit a squealing noise or seize up completely. While the issue has been limited to a small number of machines thus far, we are extending the recommended procedure to all our customers.

Printware recommends that all customers use light-weight grease for the bearings. We use Super Lube Multi-Use Synthetic Oil, but you can use any similar light-weight grease.

- Apply a small amount of grease to the shaft near the bearings.
- Using the operator-side knobs, move the belts so the bearings pass over the greased area.
- Hit the “Jog” button located on the back of the feeder to run the belts and bearings.
- Repeat the greasing process as necessary until the belts run smoothly and quietly.
- You can follow along with our video on [Greasing the 1175/1175C Feeder Bearings](#)

We recommend that you grease the bearings bi-monthly or more often as needed. If you have any questions, please reach out to us at (800) 456-1400 EXT 2 or [support@ijetcolor.com](mailto:support@ijetcolor.com)
