## **Volvo 850 a/c: Under the Hood Refurb 07.2017**

By JimBee

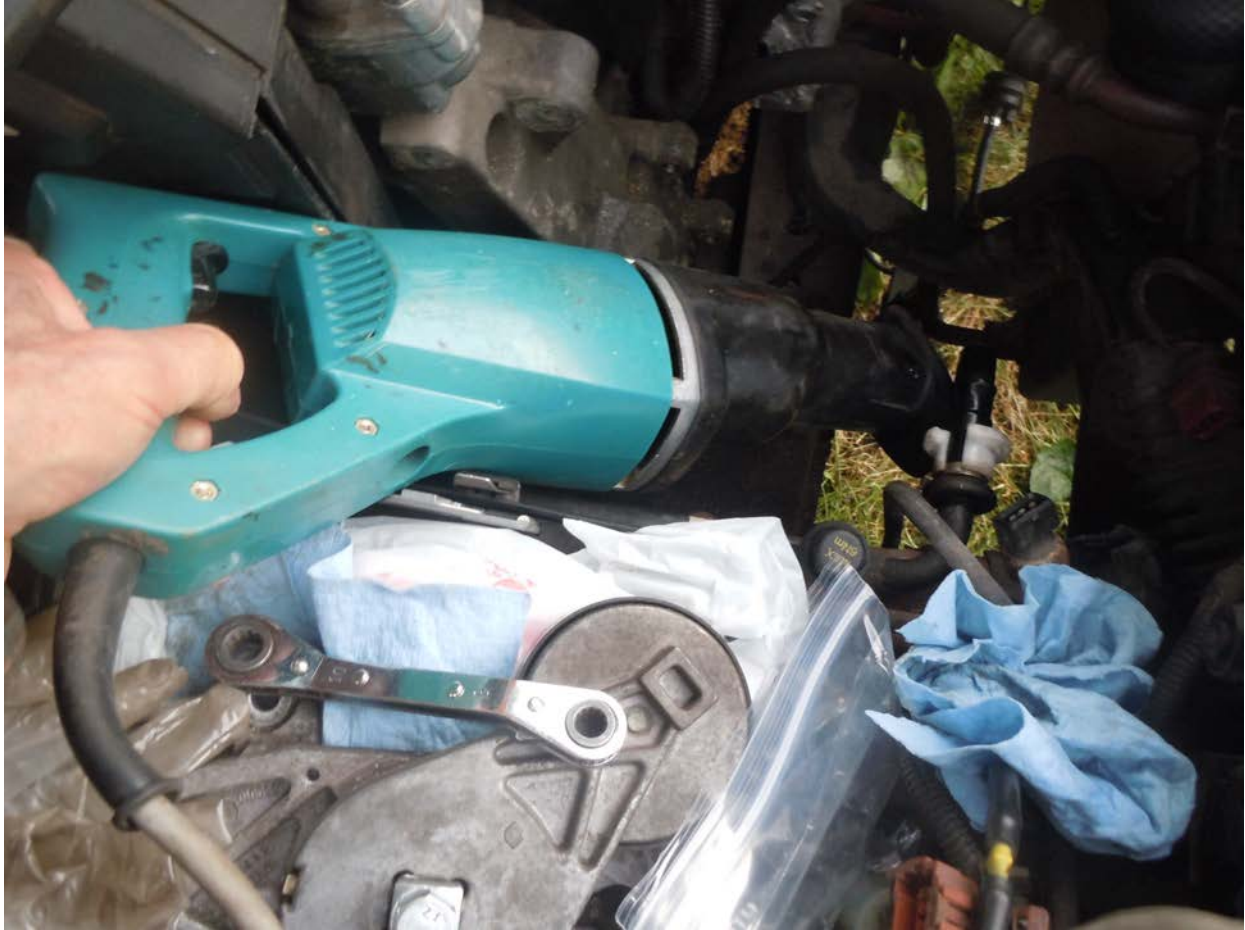
The most troublesome part of this project is removing the old dryer, which defeated me the first time around the previous year.

This time, after running into the same rusty springlock connector, I decided to do surgery. The problem is there's no room to swing the dryer side-to-side to work its gooseneck connector apart, even after dousing the springbuck with PB Blaster the day before and while using the release tool. Sure, give it a try, but if you can't get them loose, get more aggressive.

The solution is cut the gooseneck, ideally close to the top of the dryer canister to keep filings away from the springlock union.

*I strongly recommend against doing it as shown. If you do, proceed at your own risk and use a short hacksaw blade. Of course, this is a two-handed task; here, the saw is off as I was shooting a picture with the other hand.*

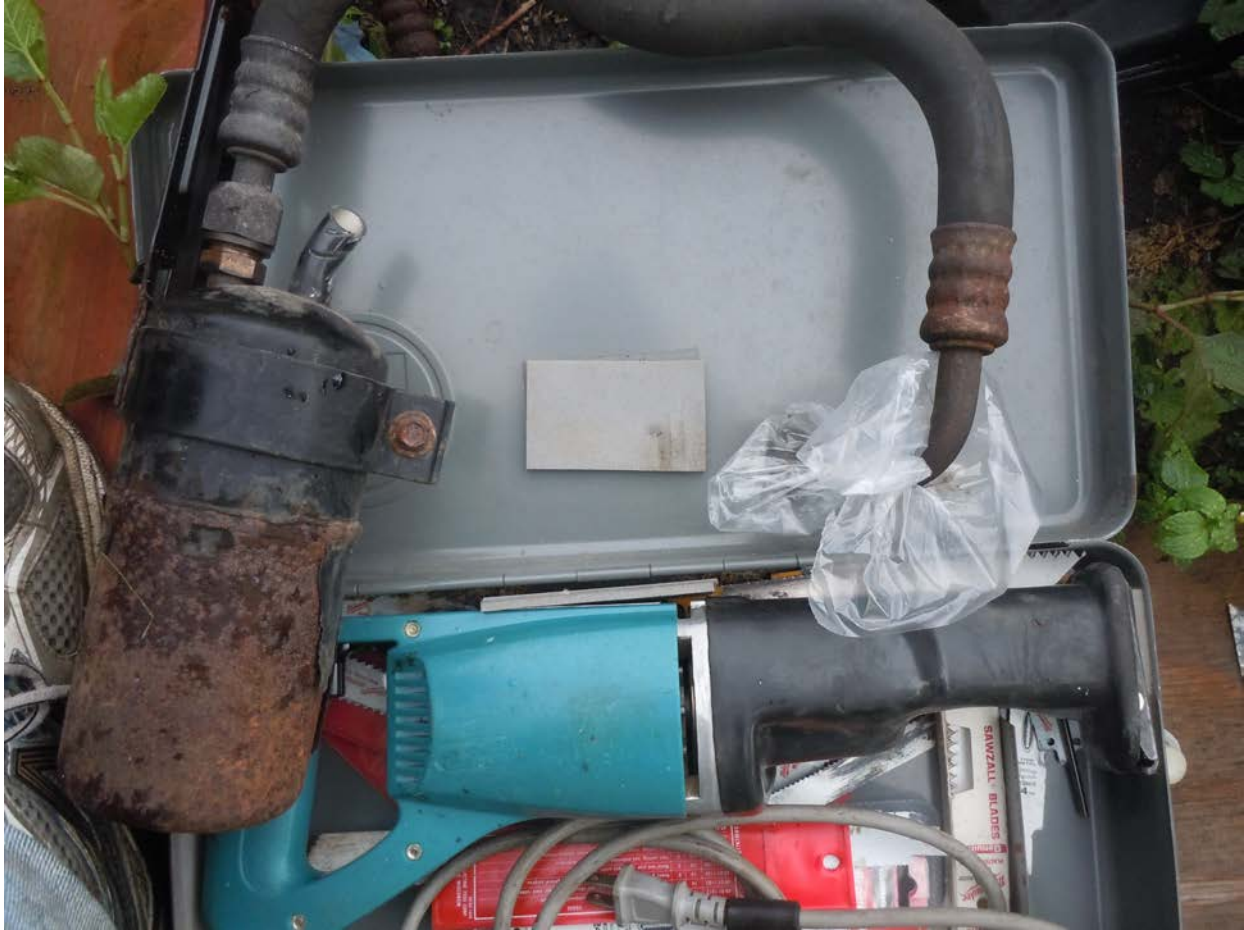
**Remove the dryer after cutting the gooseneck.**

On the back of the compressor, remove the hex bolt that connects the large hose from the dryer. I used a short 3/8 extension with the hex bit. If your car has an oil cooler, you need to get a path through the hoses. I unbolted the bracket that holds the oil cooler pipes to the engine block to get a little more flexibility in there.

There's a 10 mm bolt behind the p.s. headlight that secures the dryer bracket. Don't try to loosen the cinch bracket around the middle of the dryer canister while its still installed—just pull the whole thing, hose bracket and all. **(Note for reinstallation: if you have a splash guard under the radiator, make sure the new dryer is secured high enough to clear the splash guard. Make sure your new dryer has the same dimensions as the original.)**

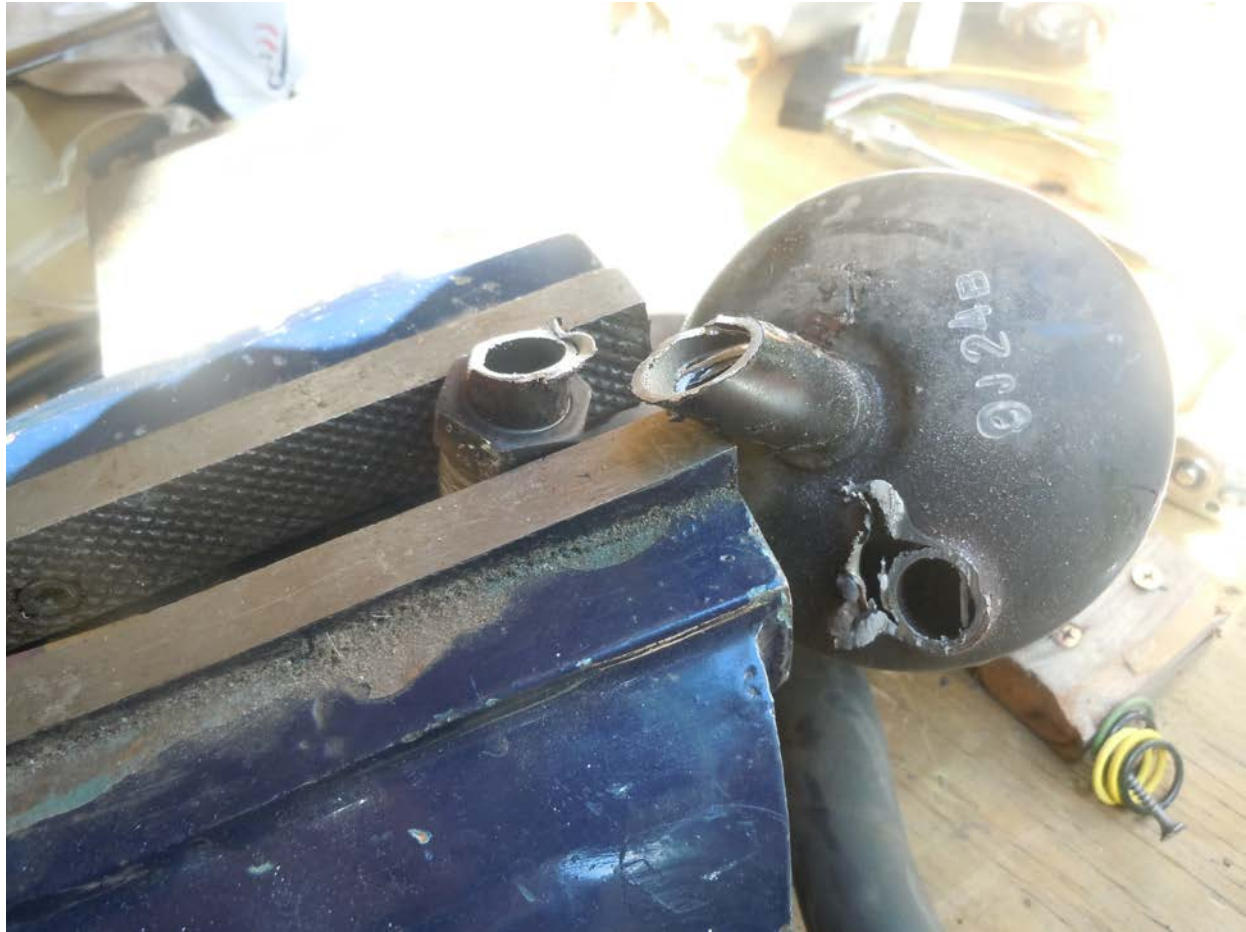
If you're just replacing the dryer canister, remove the large hose from the canisters fitting. The problem here, is the large (26 mm?) nut that connects the large hose to the OEM steel dryer is steel. The dryer's male nipple threads are coated so they don't rust, but the female coupling nut isn't coated and it does rust, making it very difficult to loosen.

Instead, grab the canister in a vice or strap it down somehow and cut off the nipple *below* the canister nut, next to the canister, as shown. Not shown is that you can now hold the hose nut in your vice and get a socket with breaker bar on the nut shown here in the vice.

Held the other way in your vice, with the nut (shown below) turned upward with the large hose still attached, you can use a pipe wrench (with a pipe extension if needed) on the large hose nut to break it loose.

Solution. I don't use my 5" vice often but I'm glad I have it when I need it. Likewise, the Sawzall.

You might try heat on the large nut, but be mindful there's a rubber o-ring in that union and you don't want to melt it to the inside seat of the hose flange since you'll reuse that.

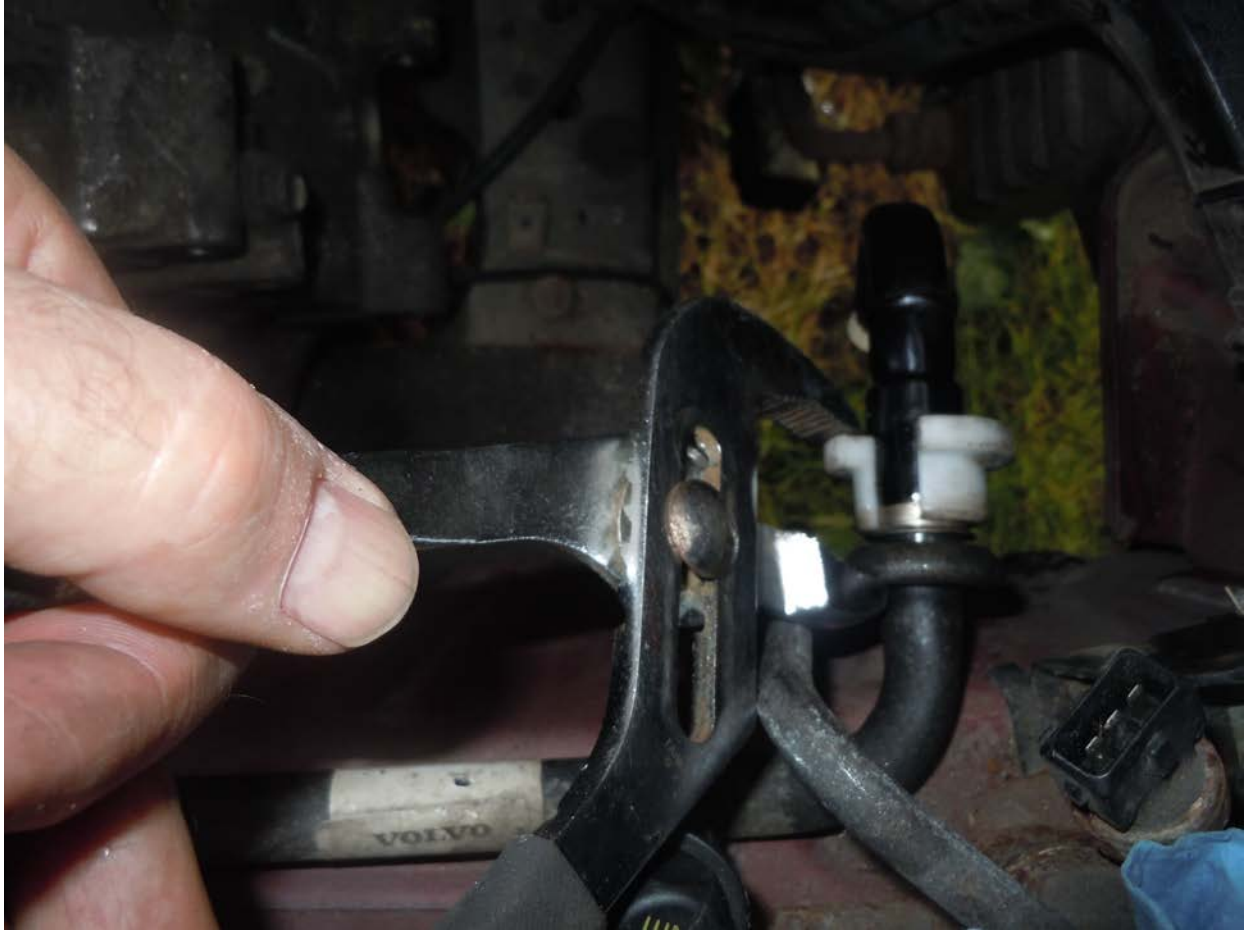
#### **Rework threads on the dryer nipple.**

Keep the scrap nut to rework the threads in the hose nut. Taking care not to get solvent inside the hose, use some solvent on the threads and work the nuts together until the threads turn freely. The hosenut threads on mine were very rusty. I did both 850's. One of them has a very slight leak at this point, meaning it wasn't tightened enough—though it felt very tight— so I'll probably redo it. If the nuts screw together very hard, you cant know when you've bottomed on the new o-ring, so it's worth taking some extra time on those threads.

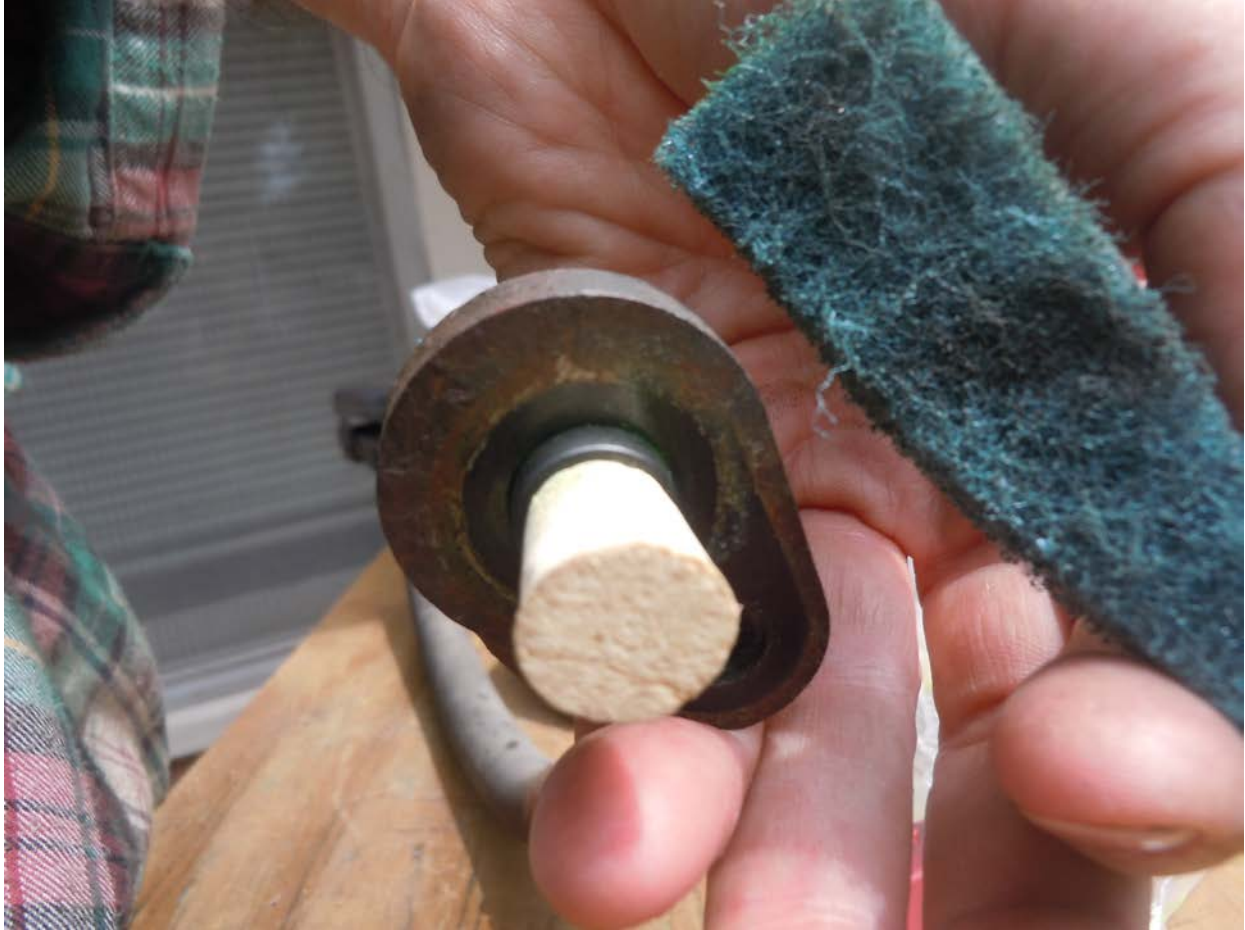
**Removing the gooseneck stub.** In the next picture, the springlock is already parted; you can see the flare end that had been captured inside the cage by the garter spring.

To separate the springlocked coupling, after adding more PB Blaster, I used Channellock pliers to force the plastic release tool into the cage to cause the garter spring to ride up on the flare, "unlocking" the flare end of the female tubing. But the flare doesn't just pop out of the cage.

While holding the tool in place, with the garter spring "opened" (stretched up and over the flare), the gooseneck stub can be easily rotated and pulled off the male pipe. My dryers came with new o-rings and a garter spring for this union. When you remove the female tube with the flare-end, you'll see there are two o-rings on the male part. The springlock connector just holds the two pipes together while the o-rings seal the pipes.

**Reinstallation note:** The gooseneck of your new dryer snaps back together in the springlock cage very easily, but make sure you have everything ready to go back together because it will be just as hard to get it apart if you forgot something (like oiling the new o-rings, or adding fresh oil into the new dryer—see other MVS posts that discuss oil amounts).

**On that note, before removing the original dryer, carefully note the angle of the large hose (dryer to back of compressor) because the coupling of that hose needs to be fully tightened to the new dryer before you install it; there is no room to get a wrench on that nut once its installed with gooseneck reconnected.**

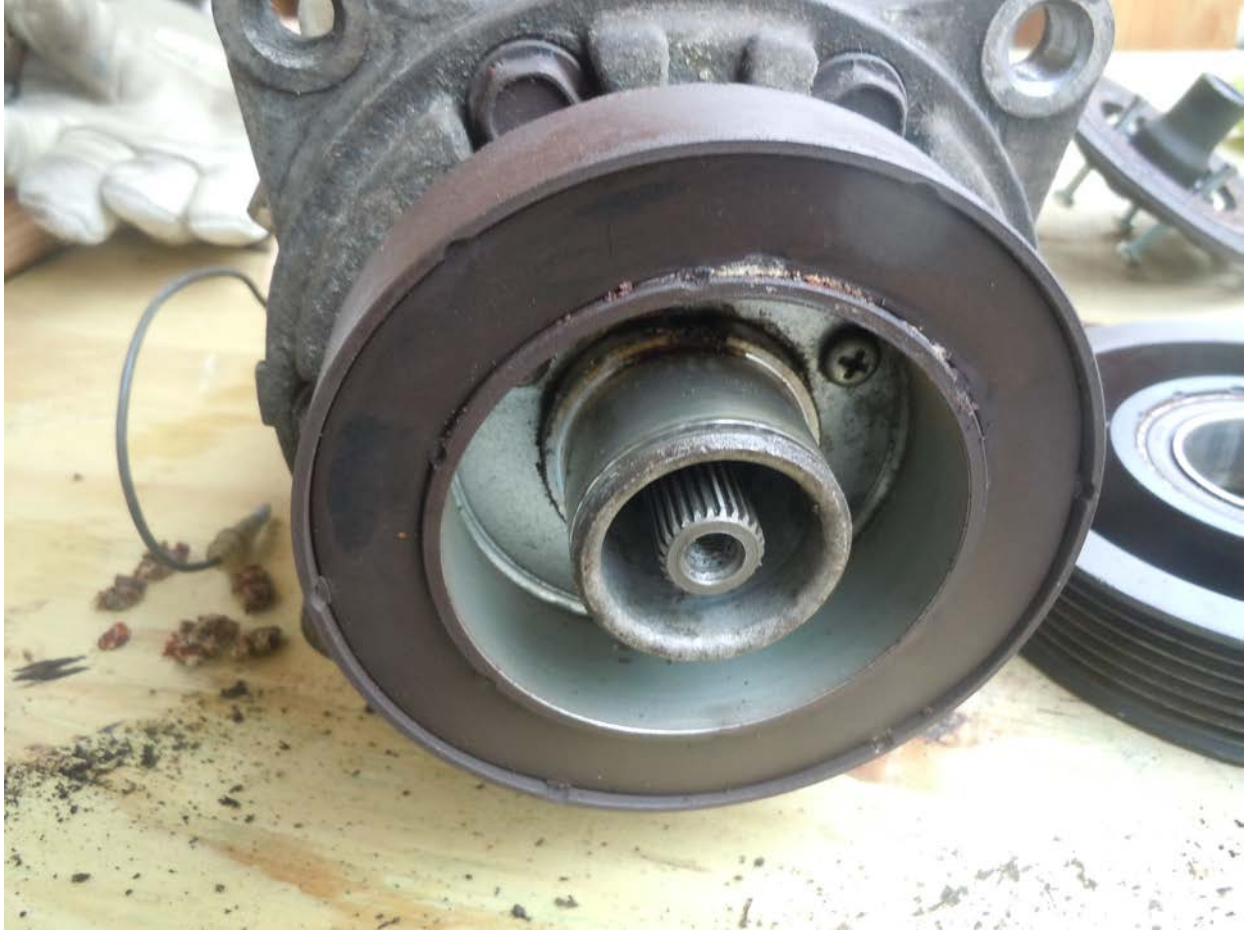
The large iron ring is the electromagnet that pulls the clutch plate to the pulley face.  
The pulley runs freely on the bearing which is mounted on the casting "nose" that surrounds the compressor power shaft. The shaft only turns when the electromagnet is energized, pulling the clutch plate against the pulley to turn the shaft that operates 6 pistons (which oscillate horizontally on a warble plate) that circulate refrigerant.  
The clutch plate is visible at upper right of picture. Oriented upward is the splined clutch hub that goes on the shaft.  
Lower right, the back of the pulley reveals its open area where the electromagnet resides.  
Note the dimples around the outer perimeter of the bearing. They position the bearing at the right depth of the pulley so it will be properly aligned for the belt. If the bearing is changed, the dimples should guide its correct position.

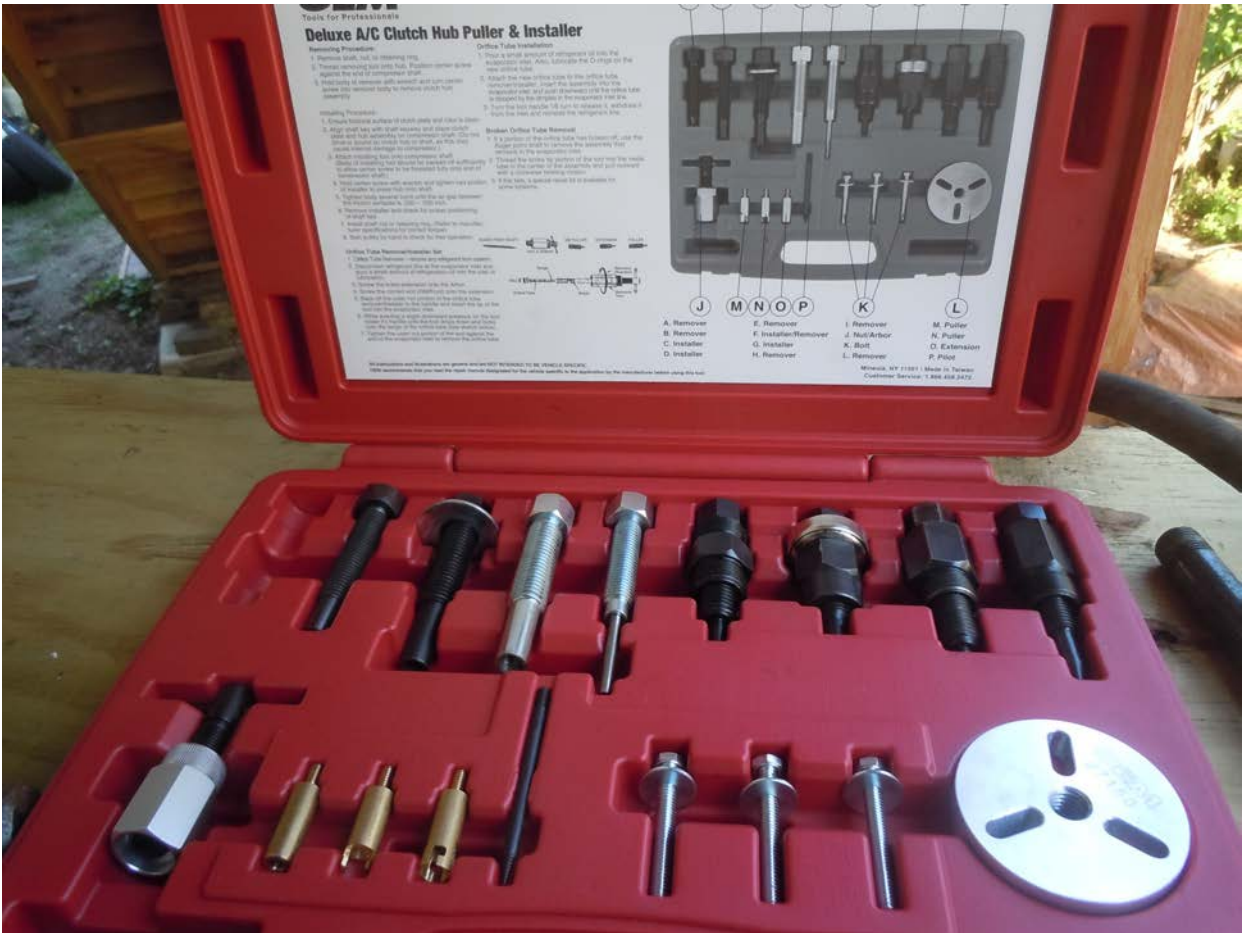
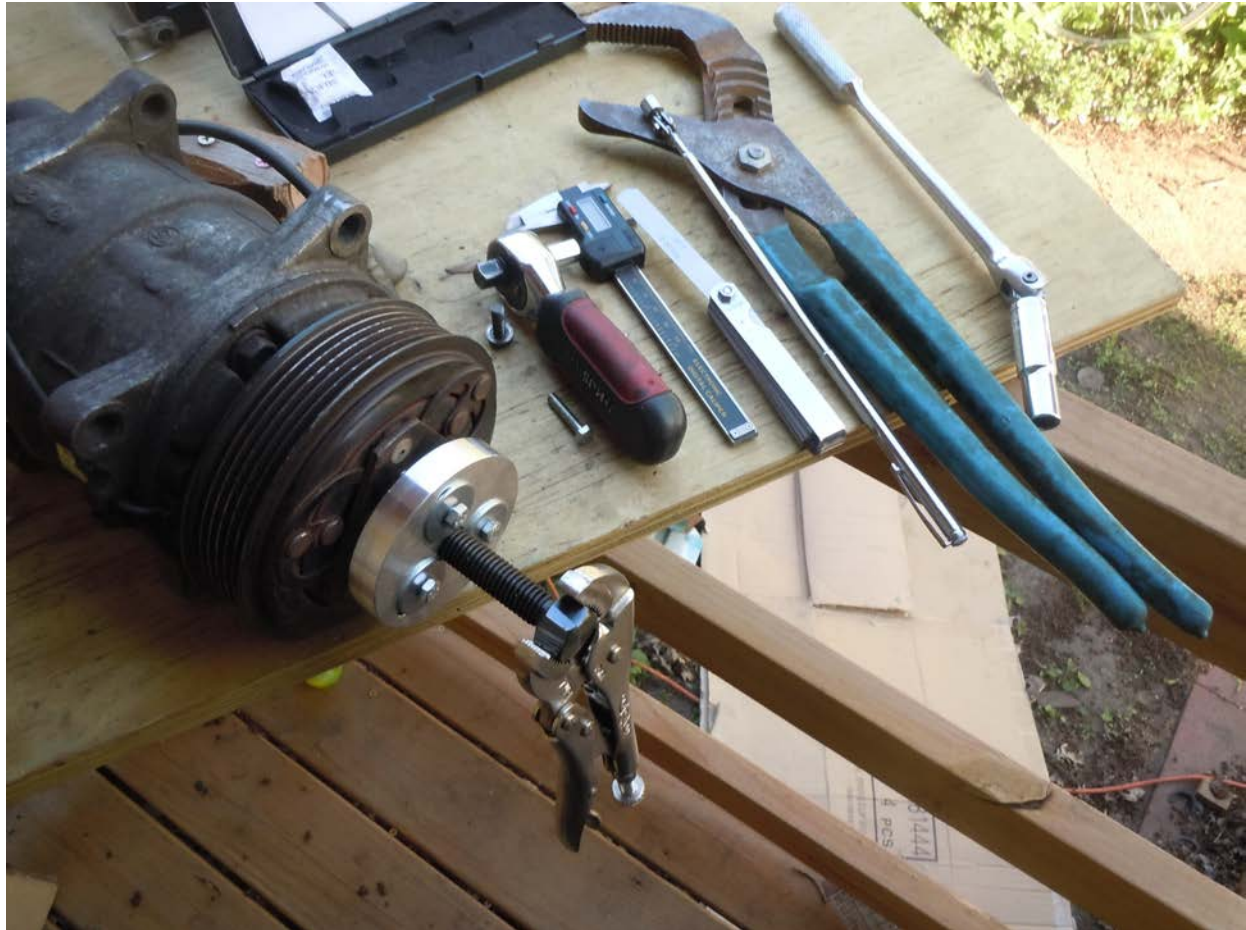
#### **Clutch removal tool (Autozone rental).**

Disk and 5 mm bolts, with center bolt (2nd from upper left in kit). You'll also need 3 flat washers.

The 5 mm bolts are screwed into the threaded holes on the clutch yoke. **Again, do not bottom the screws to force the clutch off.** Doing so can ruin the bearing's grease seal.

The removal tool's center bolt will center on the clutch's loosened 10 mm bolt head. This will pull the clutch hub off the compressor's splined shaft. There's an audible crack when the clutch hub breaks loose but you'll still need to use the puller to move it off the shaft. To finish removing the clutch, its center bolt needs to be backed out a little more to allow the clutch's hub to move further off the shaft. Then further tighten the tool's center bolt against the clutch's center bolt to continue walking the clutch hub off the shaft. Make sure

Center bolt of puller pressing on head of loosened compressor center bolt. Clutch is off in 5 minutes and if the adjustment is wrong when you tighten the clutch back on, another 5 minutes and it's off again, change the shim, then a couple of minutes to put it back on.

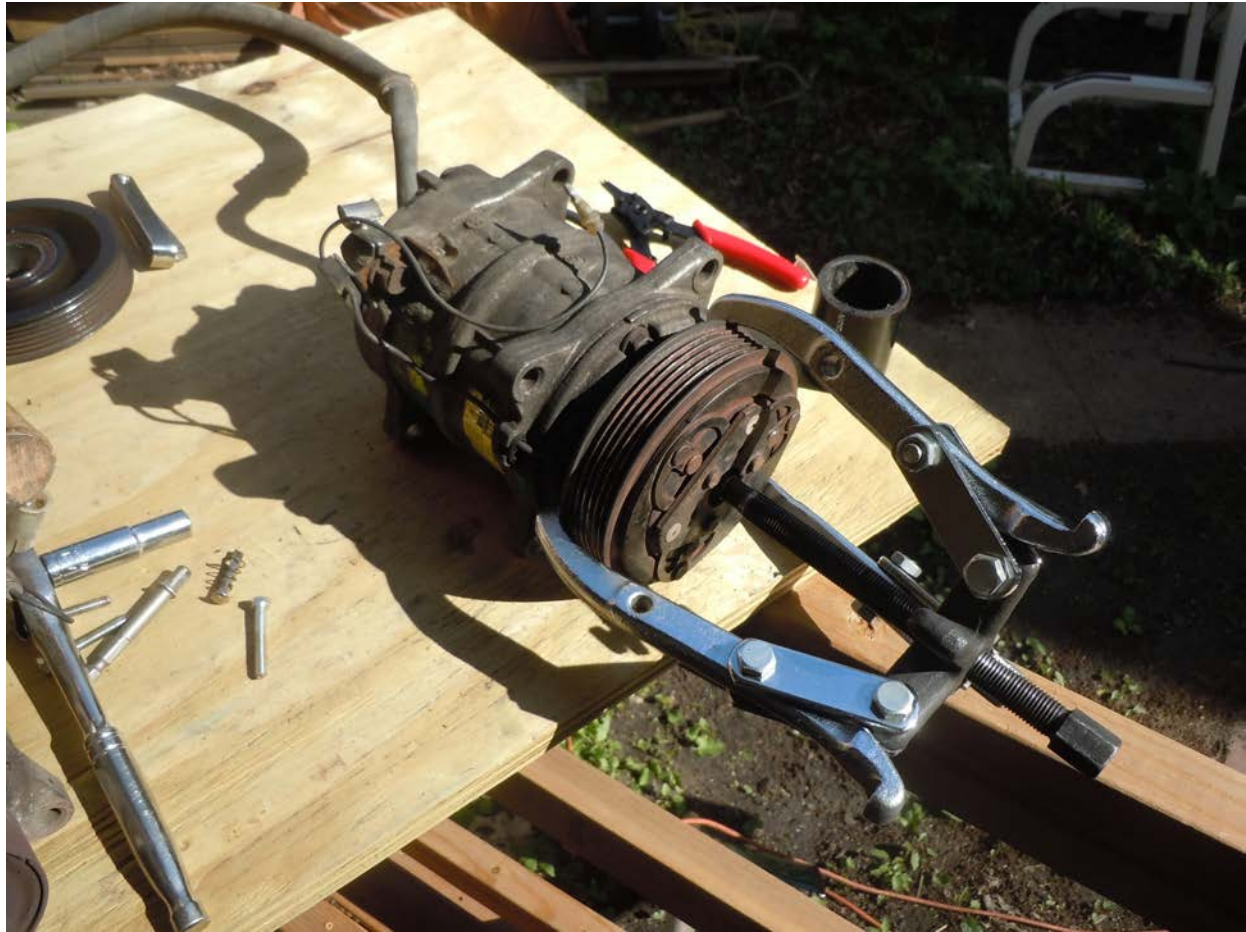
The picture below is a little misleading. It shows the puller used to remove the compressor pulley.

In this scene, first the pulley with its new bearing had already been pressed back onto the nose of the compressor casting, followed by the clutch with shim removed (regapped to .3 mm) tightened and torqued. Although the splined clutch hub goes on firmly all the way, you can feel when it bottoms.

So why is the puller in use now? Although I had premeasured the clutch gap and removed the appropriate shim to get the gap to .3 mm, the gap was wider than .3 mm when I got it back together. How could that be?

The reason was the pulley/bearing assembly was not properly positioned back on the casting—it was pressed on too far. How did I determine that?

Not shown here is the large circlip that goes in front of the pulley bearing to properly position the pulley for correct belt alignment. The circlip groove is visible in the above picture showing the pulley removed.

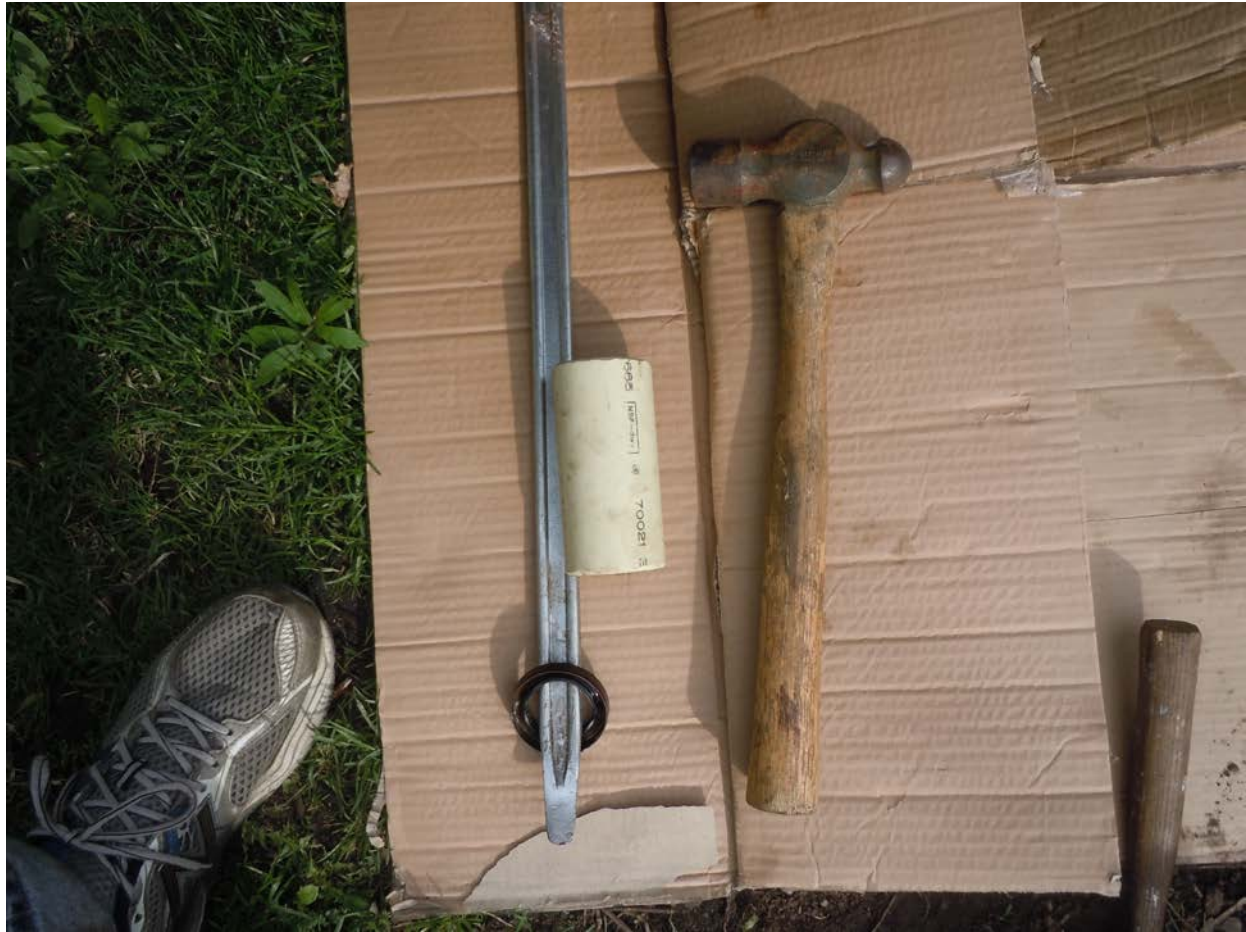
To install the circlip (and to remove it, too), the outer bearing face needs to be slightly back of the circlip groove (see picture below). Reinstalling the pulley with new bearing, I had tapped it on a mm too far so the "adjusted" clutch gap was huge. I used a new circlip (which I recommend). With that installed, I used the puller to snug the bearing forward against the circlip—that done, the clutch gap was now exactly .3 mm.

In the picture below the damaged grease seal on the face of the bearing is visible; that's why I replaced the bearing. A block of wood was used to drive the bearing/pulley assembly back onto the casting nose until the face of the bearing was flush. Then the PVC stub was used to drive it the remaining distance.
