# STIMULAN<sup>®</sup>

POWER TO TRANSFORM<sup>™</sup>

## Perfect partner for cases with an infected site

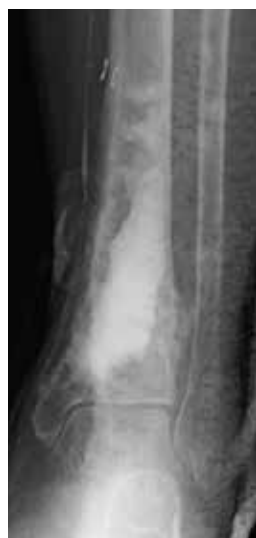
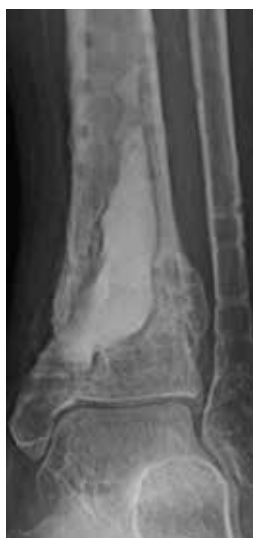
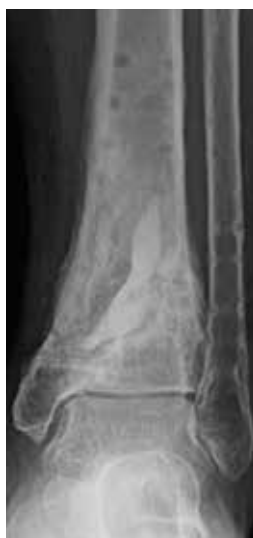
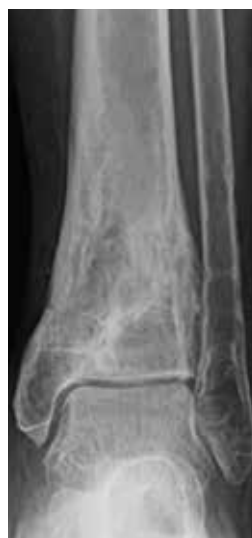
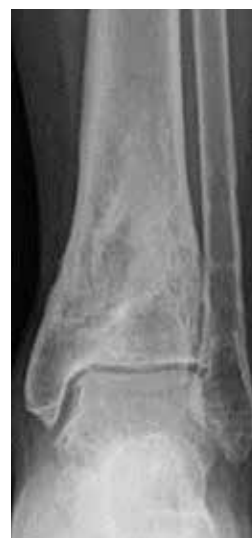
Truly absorbable and totally synthetic calcium sulfate — absorbs at an optimal rate<sup>8</sup>

Post-operative

1 month

11 weeks

6 months

15 months

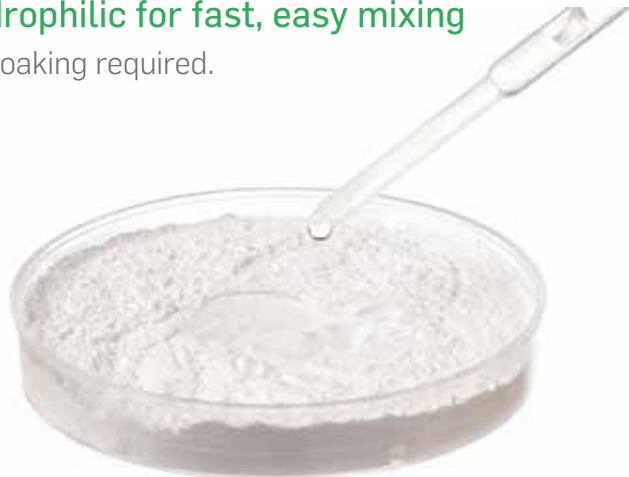
## Hydrophilic for fast, easy mixing

No soaking required.

STIMULAN — mixes with liquid

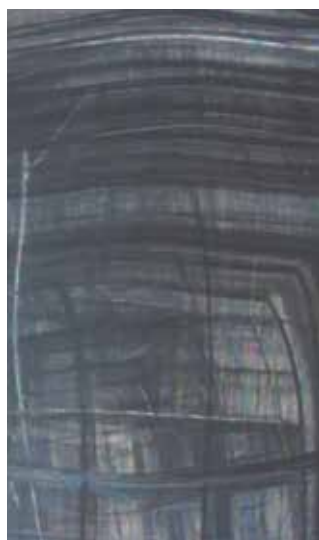
STIMULAN

Competitor calcium sulfate

Control

Microscope images (x6.5) of a cobalt chrome plate following damage simulation (360,000 cycles) with third body particles trapped between it and an articulating UHMWPE pin

STIMULAN does not damage total knee replacements when trapped between the articulating surfaces of the implant.

## No third body damage to articulating surfaces<sup>19, 20</sup>

Less scratching than competitor calcium sulfate.<sup>21</sup>

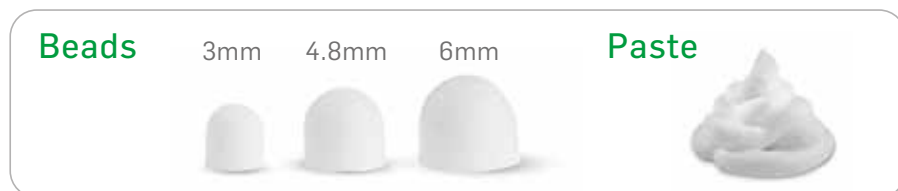
Bead mat available with **STIMULAN** Rapid Cure and **STIMULAN** Kit

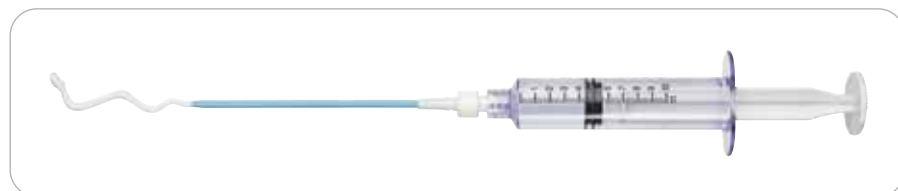
Syringe available with **STIMULAN** Kit

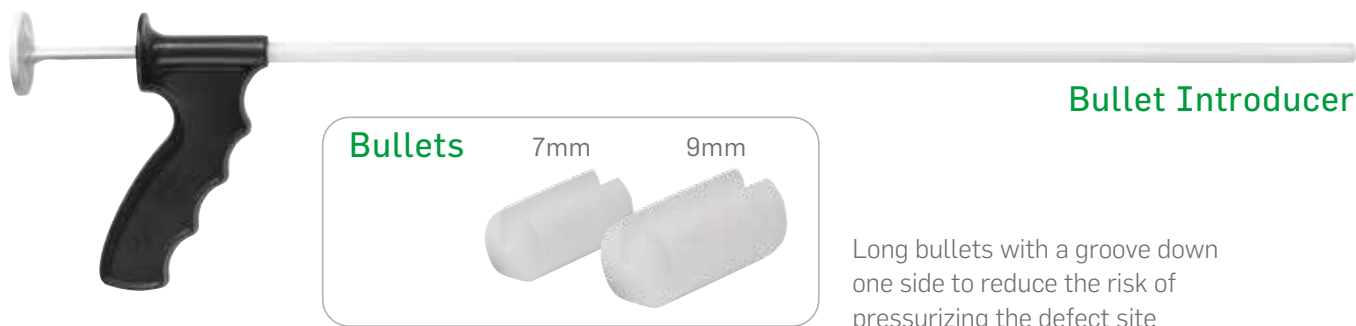
### **STIMULAN** Bullet Mat and Introducer

Streamlined, flexible design that simplifies the delivery of **STIMULAN** for deep defects.

### STIMULAN Bullet Mat and Introducer

| Bullet dimensions | Reamed diameter | In the pack | Order code |
| 7mm x 20mm | 10mm reamed diameter (minimum) | <ul style="list-style-type: none"> <li>• Bullet mat</li> <li>• 7mm (black) inserter</li> </ul> | 660-001 |
| 9mm x 20mm | 12mm reamed diameter (minimum) | <ul style="list-style-type: none"> <li>• 9mm (silver) inserter</li> <li>• Obturator</li> </ul> | |

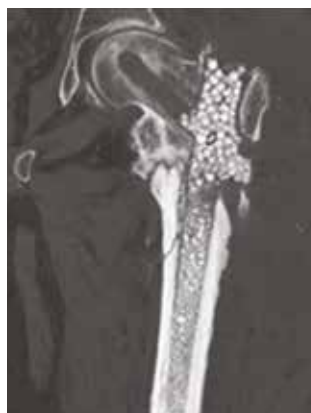
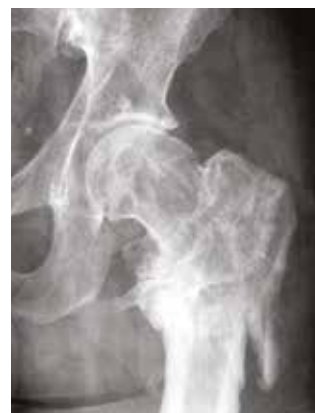
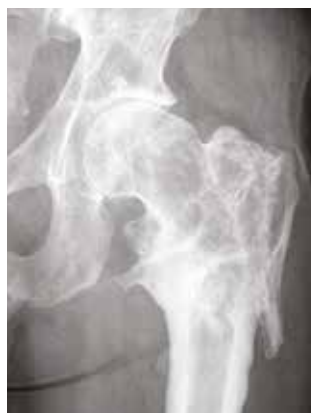
The femoral nail was removed, followed by reaming of the femoral canal and washout procedure. 40cc of **STIMULAN** beads were placed in the intramedullary canal. Cultures revealed infection to be *Staphylococcus aureus*. Antibiotics were administered to treat the infection.

2.5 months' post-operative x-rays showed almost complete absorption of the **STIMULAN** beads and at 7 months there was complete healing of the non-union.

Pre-operative x-ray showing non-union

X-ray – 2 months

CT – 2 months

2.5 months

1 year

### Infected subtrochanteric fracture<sup>9</sup>

**Patient presented with:** infected femoral nail and non-union of left femur with persistent discharging wounds proximally and distally.

**Outcome:** at 7 months' follow-up there was complete healing of the non-union and at 1 year patient remains infection free, walking with no pain.

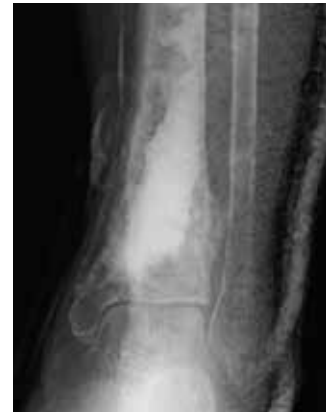
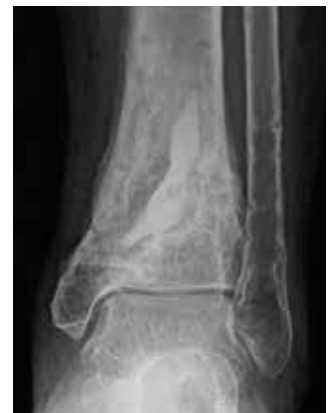
Hardware removal and repeat debridement on the medial side of the ankle resulted in a large dead space which was managed using **STIMULAN** paste. Antibiotics were administered to treat the infection.

6 months after treatment the patient was free from infection, fully weight bearing and without restrictions on activity – with complete absorption of **STIMULAN** paste.

Presentation

Post-operative

1 month

11 weeks

6 months

15 months

### Osteomyelitis caused by group B *Streptococcus* and MRSA<sup>10</sup>

**Patient presented with:** drainage issues 1 year after pilon fracture repair and then 2 weeks after hardware removal.

**Outcome:** 6 months after treatment the patient was fully weight-bearing and without restrictions on activity – with complete absorption of STIMULAN.

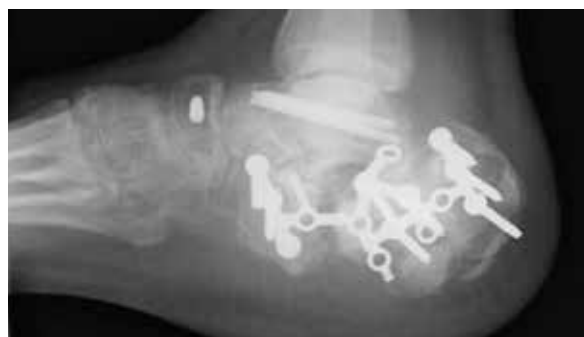
Presentation

40-year-old male sustained an open calcaneus fracture after a 20 foot fall. Initial surgery was an irrigation and debridement with definitive fixation 10 days after injury. 6 months later patient presented with an infected non-union and hardware failure. Cultures were positive for MRSA.

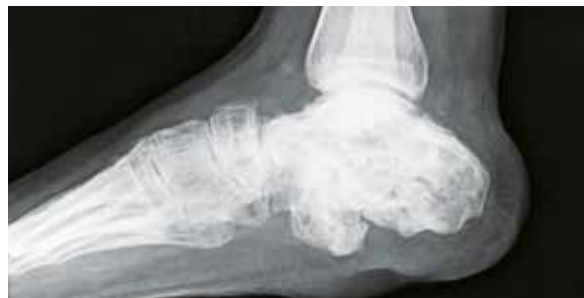
13 months after subtalar fusion,  
11 months after hardware removal

This patient is now weight bearing as tolerated and clinically no signs of infection. Infection in open calcaneus fractures is common and in some series amputation rates exceed 50%. For this patient a 2 stage approach was utilized to treat the infected non-union. Removal of hardware and aggressive debridement of the bone. The dead space was managed with **STIMULAN**.

### Open calcaneus fracture infected with MRSA<sup>10</sup>

**Patient presented with:** infected, MRSA positive non-union and hardware failure 6 months after treatment for an open calcaneus fracture.

**Outcome:** at 13 months the absorption of **STIMULAN** was complete, the patient was weight-bearing and without sign of infection – amputation was avoided.

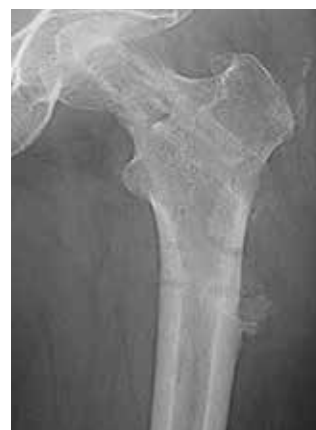
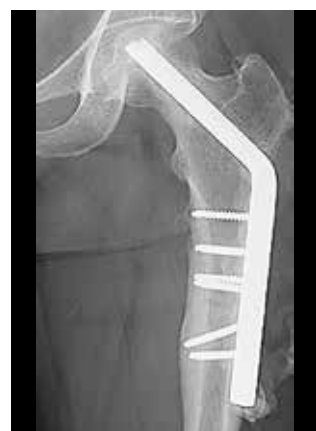
The sliding hip screw was removed from the left femur and multiple meticulous excisional debridements were performed. 20cc of **STIMULAN** paste was injected into the proximal femur bone void. Bacterial cultures revealed *Propionibacterium Acnes*. Antibiotic treatment was administered based on the sensitivities of the organism and I.V. antibiotics were administered for 6 weeks following surgery.

At 6 weeks, autologous bone graft and 10cc of **STIMULAN** paste were placed at the femoral neck non-union site. Internal fixation was performed with a blade plate device.

6 weeks after stage 1 treatment, the patient was free from infection with complete absorption of **STIMULAN** paste. 4 months after stage 2 treatment, the non-union site appeared to be healed with no hardware failure and complete absorption of **STIMULAN**. Imaging at 1 year after stage 2 treatment confirmed consolidation at the non-union site and stable hardware.

Initial post-operative

Stage 1 – post-operative

Stage 1 – 6 weeks post-operative

Stage 2 – 4 months

Stage 2 – 2 years
