Areas of San Diego Bay with Copper Pollution

The Port of San Diego has developed a Copper Reduction Program to reduce copper pollution in San Diego Bay. To learn more about the program, alternative paints and incentives for boaters to make the switch, visit:

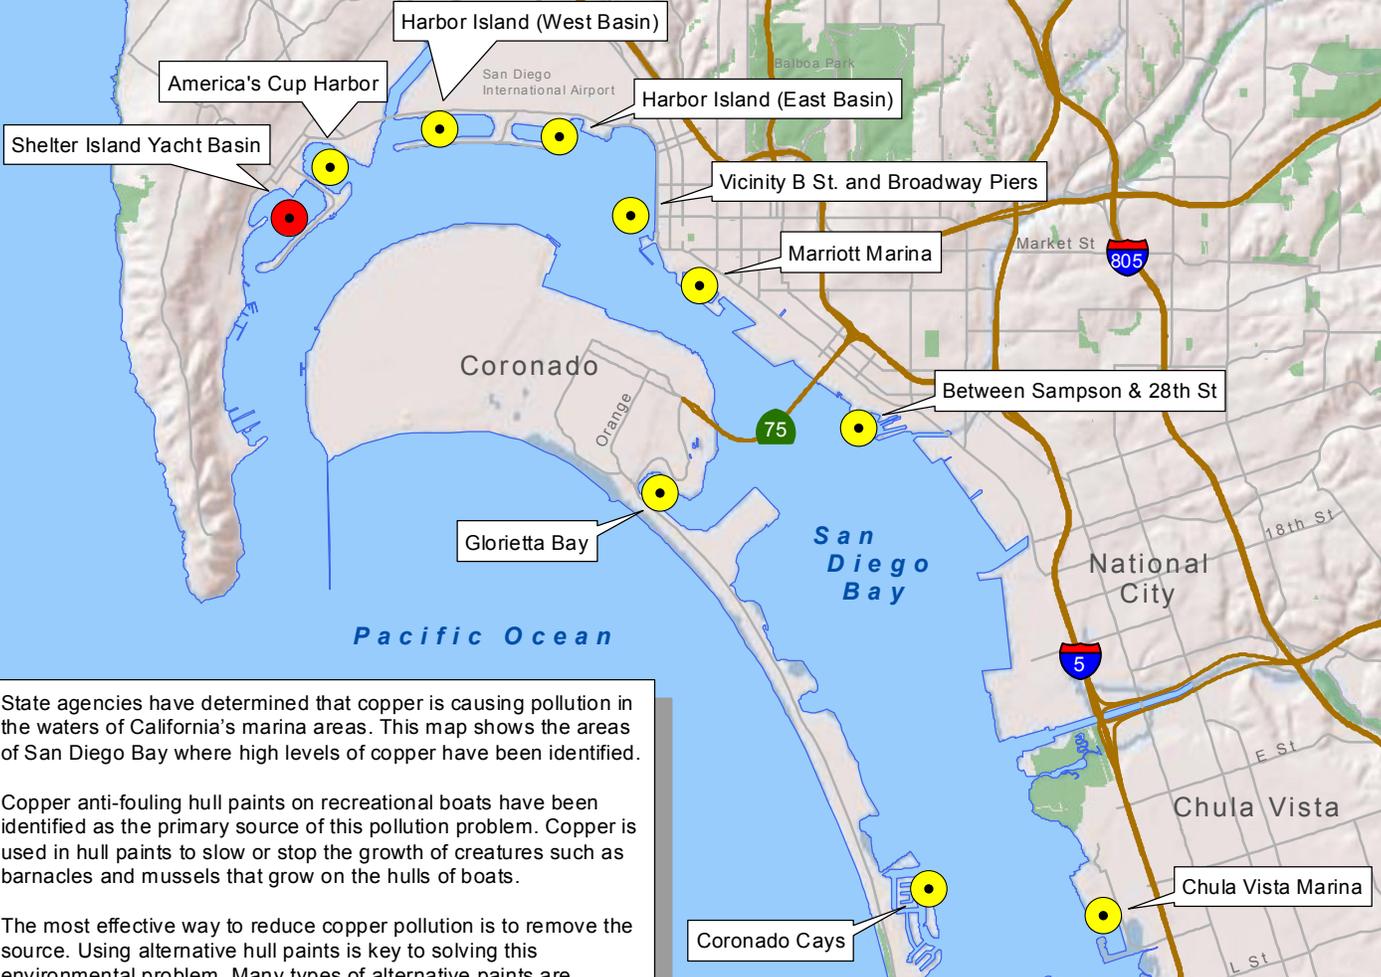
State agencies have determined that copper is causing pollution in the waters of California's marina areas. This map shows the areas of San Diego Bay where high levels of copper have been identified.

- These areas have been found to have copper pollution. Using alternative hull paints in these areas may help prevent the need for future regulations.
- This area has high copper pollution. Regulations are in place mandating the Port to reduce copper in this area

- Locations depicting copper pollution are derived from the 2010 Integrated Report (Clean Water Act Section 303(d) List/305(b) Report) for the San Diego Region.
- Ocean, Roads, Parks: SanGIS
- Hill Shade: ESRI 2011.
