## PTW-WDT2 PASS-THROUGH WINDOW

Dwg. No. : CUT-PTW-WDT2 Rev. : A

Typical PTW-WDT2 Pass-Through Window.

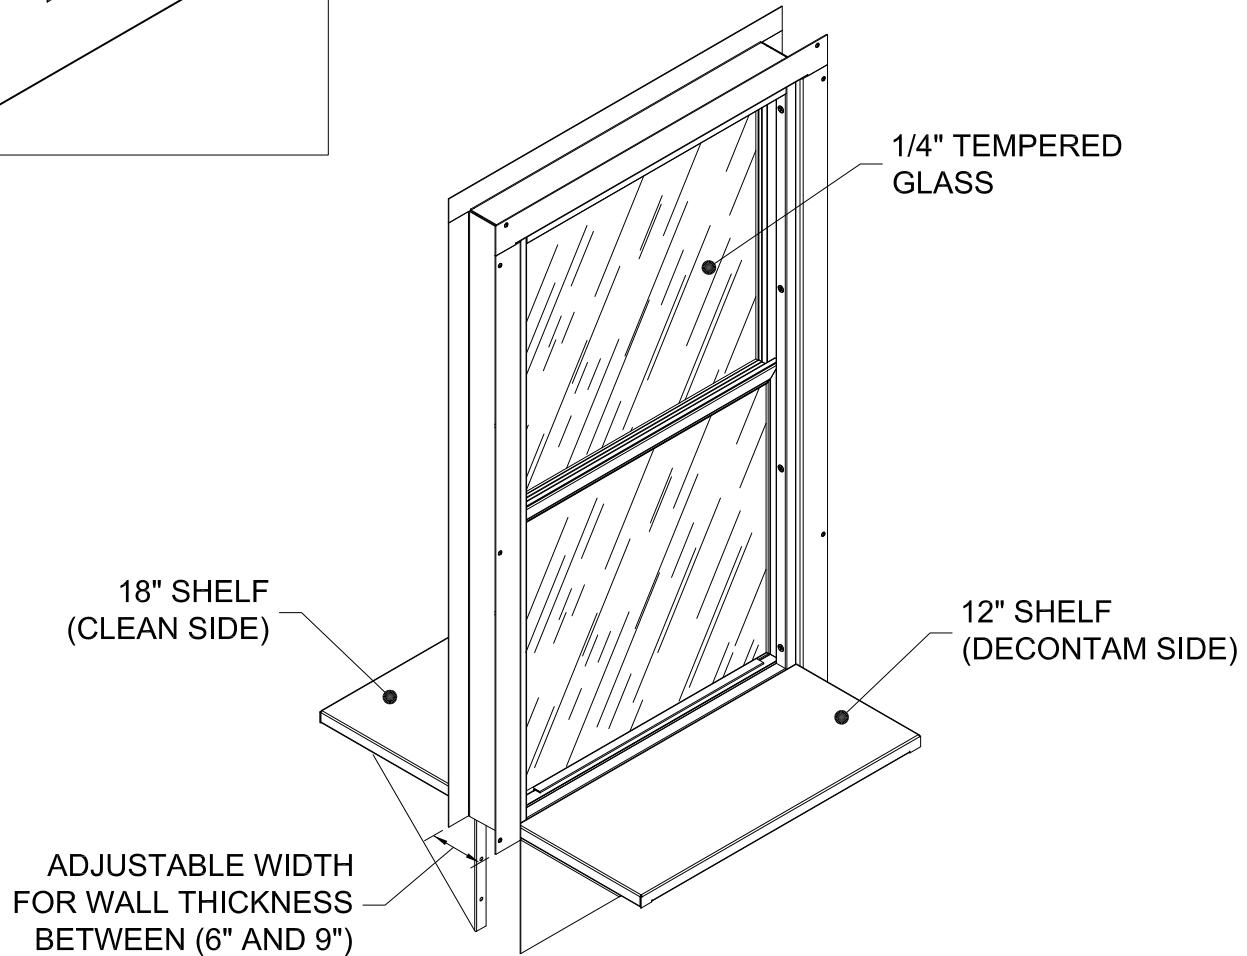
ISOMETRIC VIEW

Note: Pass-through window is not designed for instrument washer rack return.

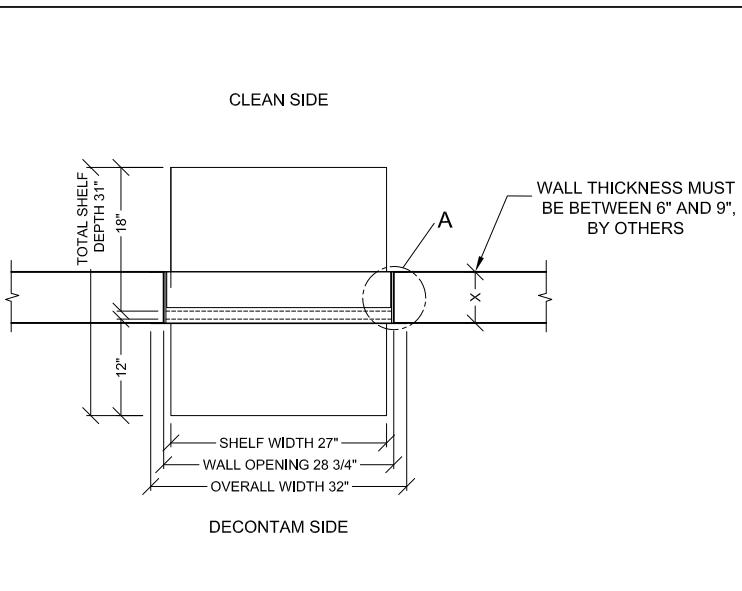
## PLAN VIEW

### PTW-WDT2 PASS-THROUGH WINDOW

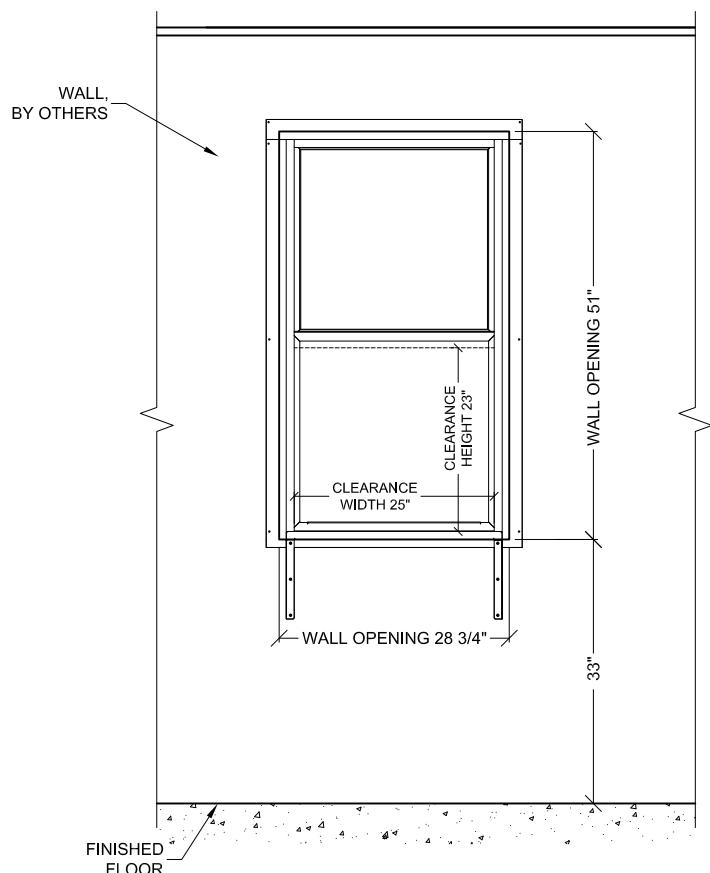
# FRONT ELEVATION

**CUSTOMER TO PROVIDE FINISHED WALL OPENING**
