# A Survey of Multi-View Photogrammetry Software for Documenting Vehicle Crush

2016-01-1475

**Toby Terpstra, Tilo Voitel, and Alireza Hashemian**

Kineticorp LLC

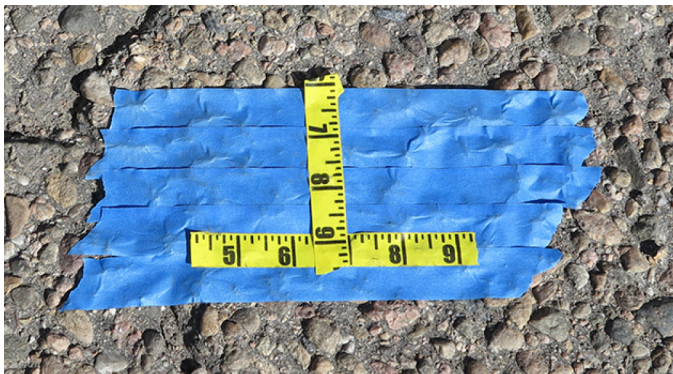
Figure 1. Blue and yellow reference tape marker.

Automated multi-view 3D photogrammetry solutions do not have an inherent real world scale. To provide this real world scale within the data sets, reference tape markers were setup at 0, 10 and 20 feet distances along the length of the vehicle, with an additional reference tape marker at 10 feet along the width of the vehicle. Blue and yellow tape was used to insure high contrast and good visibility. These were placed on the ground alongside the vehicles so as to be visible in photographs and video passes (Figures 1 and 2). The markers were approximately 4 inches by 7 inches in length and were placed with the center of the yellow tape at the set distances using a tape measure. These reference tape markers were not moved during the photograph and video documentation process. They were visible within the resulting photogrammetry point clouds and were used to determine a scale factor for each individual set.

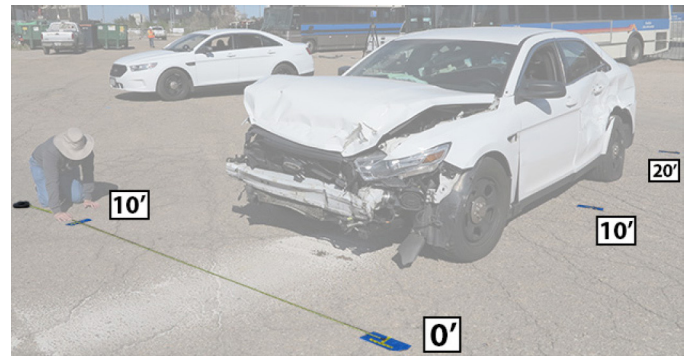
Figure 2. Placement of reference markers at specific distances alongside the vehicles.

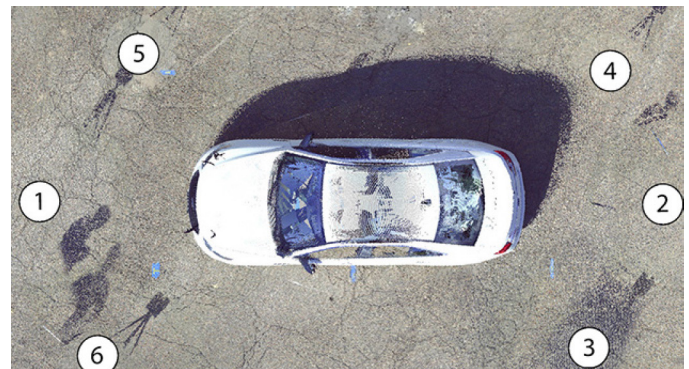
Figure 3. An orthographic top view of the resulting LiDAR point cloud. Numbers indicate 3D scanner placement for overall coverage of test vehicles.

The 3D Laser scanner used in this study for creating the LiDAR point clouds was a FARO Focus 3D X 330. The X 330 has a specified accuracy of  $\pm 2\text{mm}$  [15]. It is likely that all similar classed laser scanners on the market would have performed comparably. To achieve good overall coverage of the vehicles, two scans were completed at approximately 6.3 feet off of the ground, centered in front and behind the vehicle, and another four scans at approximately 3.4 feet above ground off of each corner of the vehicle, for a total of 6 scans per vehicle (Figure 3). The scans were 360° complete scans with settings of 1/5 for resolution and level 4 for quality. Each scan recorded approximately twelve million points and took approximately 8 minutes to complete. Four different cameras were chosen for this study to evaluate software limitations based on image sensor size and resolution. The first is a Canon EOS 5 Mark II. The Mark II is a professional DSLR, full frame camera; meaning that the CMOS (complementary metal-oxide semiconductor) image sensor size has physical dimensions analogous to 35mm film. It also offers the largest resolution of the four at 21.1 Megapixels. The second camera is a Canon PowerShot G16. This camera falls within the "Point-and-shoot" category. It has the second largest image sensor, a BSI-CMOS sensor (Backside illuminated) and is much less expensive. The third camera is a GoPro Hero4 Black. This camera is capable of recording ultra HD video and was chosen for the study because of its popularity and versatility. GoPro cameras are very popular in action sports and UAV (Unmanned Aerial Vehicle) communities because of the size, durability and resolutions offered. The fourth camera is from a Samsung Galaxy S6 Active cell phone. This camera also has a BSICMOS sensor but has the smallest images sensor size in the study (Table 1).

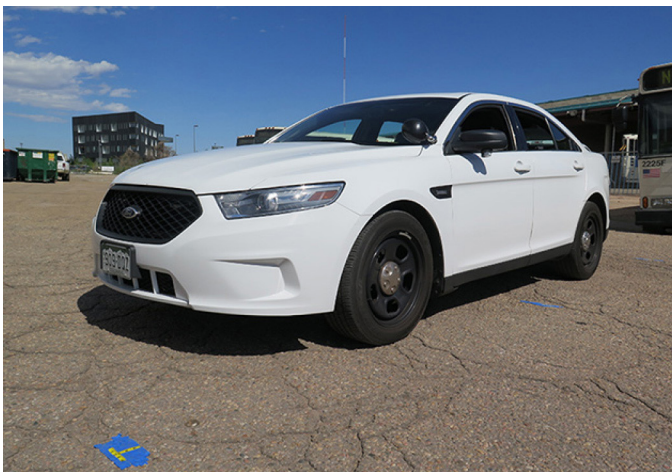
Figure 4. Example of vehicle framing within photographs and video.

Attention was given to the framing of the video as well as the photographs such that each photograph and frame of video would contain the entire vehicle without unnecessary amounts of the surrounding scene. The resulting imagery contains the reference tape markers setup alongside the vehicles. While the markers are not in every frame, they are contained within an adequate number of the complete photograph sets (~160 photographs) to allow for individual scaling of the resulting solution data using the markers within the data itself (Figure 4).

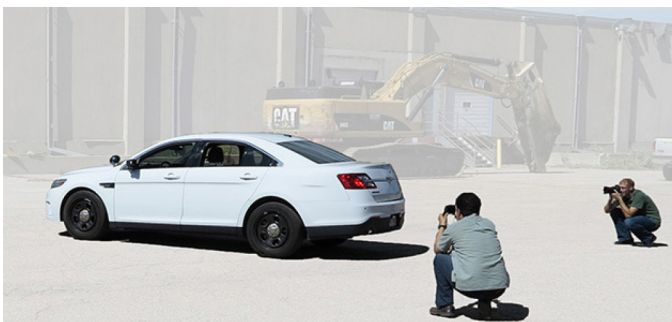
Figure 5. Photographing the undamaged vehicle.

Photograph sets were taken at two heights, the first being approximately 3.25 feet above ground and the second approximately 5.5 feet above ground to provide good overall coverage of the vehicle exterior (Figure 5).

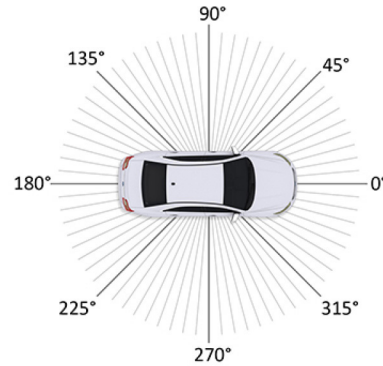
Figure 6. Incremental photographs taken at approximately 4.5° increments around the vehicles.

The vehicles were photographed walking around them at approximately 4.5° increments at both heights, resulting in approximately 80 photographs for each pass and approximately 160 photographs per camera, per vehicle. Tripods were not used in this process, however photograph locations were similar from camera to camera. Appendix A contains complete photo sets for each camera. Video passes were conducted with the Canon PowerShot G16 at similar heights walking around each vehicle. Each video pass was approximately 50 to 60 seconds in length equating to approximately 1650 frames at 30 frames per second (fps) for a total of approximately 3300 frames per vehicle (Figure 6).

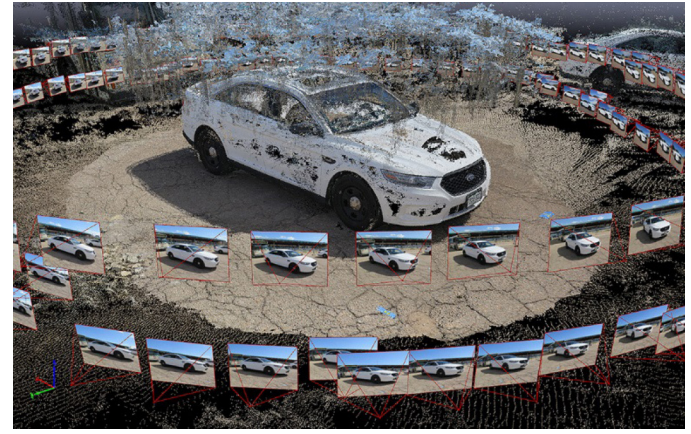
Figure 7. Photogrammetry point cloud solution with camera locations and photographs displayed. Canon PowerShot G16, 159 photographs processed in Pix4Dmapper.

The photographs and video were then run through each software title using software recommended settings. The processing was performed in a similar manner for each software title and generally took between 1 and 5 hours, depending on the number of photos or frames in the data sets. After the processing was complete, the data sets were exported from the photogrammetry software. A “.pts” file was exported from PhotoModeler Scanner and a “.ply” file was exported from Agisoft PhotoScan, Pix4Dmapper, as well as VisualSFM (Figure 7), (Table 4).

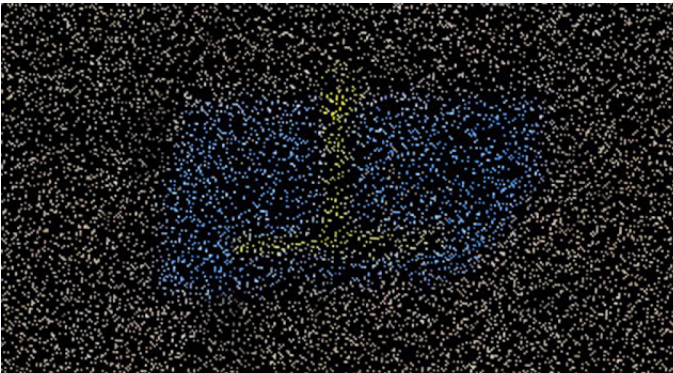
Figure 8. Photogrammetry point cloud of tape marker (Pix4Dmapper, Canon G16, entire photo set).

The overall accuracy of scaling the photogrammetry point cloud sets is dependent on several factors. These include the accuracy of the software data points at the tape marker locations, the number of points available for selection, the clarity of points such that the center of the tape can be visually determined, as well as the manual and subjective determination of what points are chosen as a basis for scaling the data set (Figure 8).

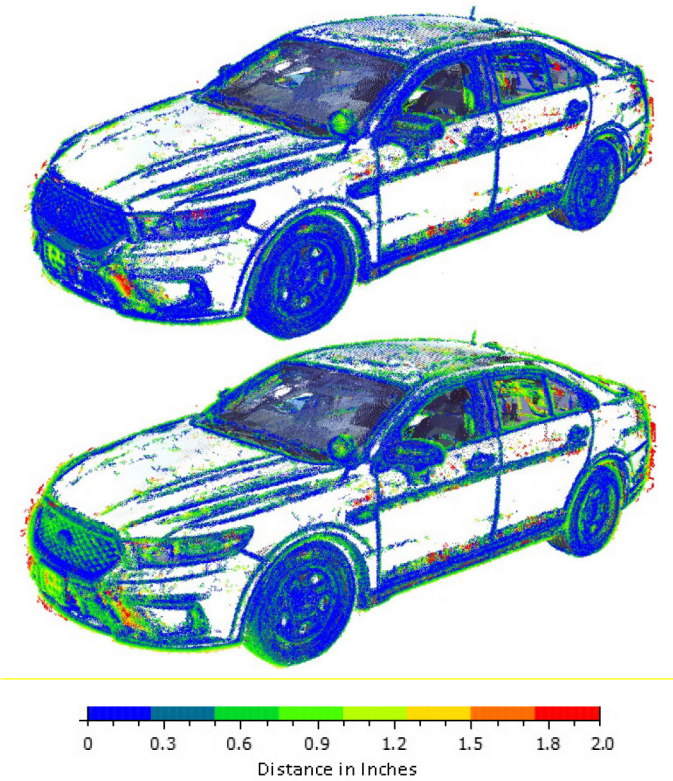
Figure 9. Undamaged vehicle LiDAR point clouds overlaid with photogrammetry point clouds. The LiDAR point clouds have typical photo coloring and the photogrammetry point clouds are colorized to represent point distance away from the LiDAR data. The photogrammetry point clouds on top vehicle are properly scaled and aligned. The photogrammetry point clouds on the bottom were scaled by a factor of 1.01.

Improper scaling of the point cloud affects alignment and overall accuracy. To illustrate this concept, a properly scaled photogrammetry data set was intentionally scaled again by a factor of 1.01, and a new alignment was attempted between the LiDAR data set and the photogrammetry set. The calculated alignment RMS (.92”) between the improperly scaled data set to the LiDAR data was approximately 8 times greater than the RMS (.11) calculated with the properly scaled photogrammetry data set. Figure 9 illustrates this by showing both the properly scaled photogrammetry point cloud (top) and the improperly scaled point cloud (bottom). The coloring of the photogrammetry based point clouds in Figure 9 is based on point distance away from the LiDAR data. Note how the improperly scaled data set has a different coloring. The overall length of this vehicle

being greater than the width makes the improper scaling more visually apparent on the front and back of the vehicle. In a similar way, if the data was scaled appropriately but not aligned well, these color differences would be apparent more in one area of the vehicle than another.

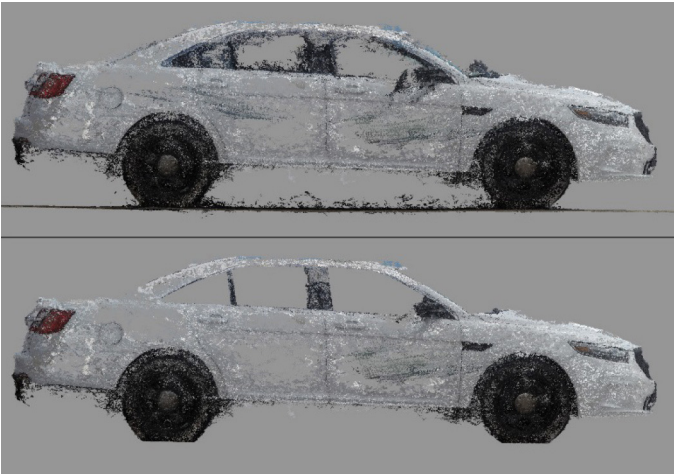
Figure 10. Photogrammetry point clouds before and after filtering out the ground under vehicle, isolated point groups, windows and interior. (PhotoScan, undamaged vehicle, Samsung Galaxy 6 Active, entire photo set).

Once a good alignment was achieved, the photogrammetry based point cloud was manually filtered in a similar manner to that of the scan data or LiDAR processing. This was done manually by removing noticeably errant points or islands of data points from the point cloud. In instances where the resulting data appeared to contain noticeably errant points, but no clear line could be determined for separating the errant points, no points were removed from the data set. These points could be considered more of a peninsula than an island. CloudCompare (v. 2.6.2) has a filtering option called ‘SOR’ or Statistical Outlier Removal. This filter was run on all photogrammetry data sets with default software values of ‘10’ for the number of points used in mean distance estimation and ‘1.00’ for the standard deviation multiplier threshold. Additionally, because 3D scanners are known to have difficulty in returning accurate data on and through windows, and because these points are generally not the focus of exterior vehicle documentation, points in the area of the windows and vehicle interior were removed from the photogrammetry based data sets (Figure 10).

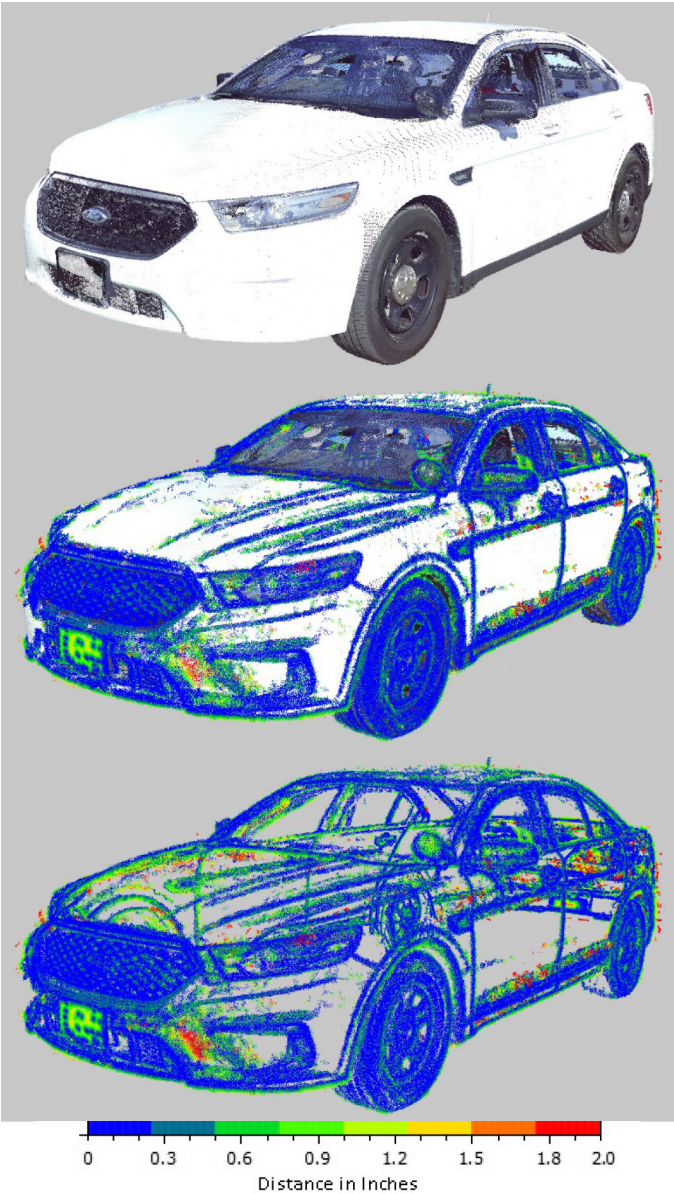
Figure 11. Undamaged vehicle point clouds. Top: LiDAR point cloud. Middle: LiDAR point cloud with photogrammetry point cloud aligned. Bottom: Photogrammetry point cloud with the same distance based colorization. (PhotoModeler Scanner, Canon G16, entire photo set).

The photogrammetry point clouds were then individually compared to the LiDAR data sets within Cloud Compare. The “Compute cloud/cloud distance” tool was used, which calculates distances from one data set to the other based on the nearest neighbor. The results were separated into nine data sets for each point cloud, points found to be within 0 to .25 inches, 0 to .25 inches, 0 to .5 inches, 0 to .75 inches, 0 to 1 inch, 0 to 1.25 inches, 0 to 1.5 inches, 0 to 1.75 inches, 0 to 2 inches, and points equal to or greater than 2 inches (Figure 11).

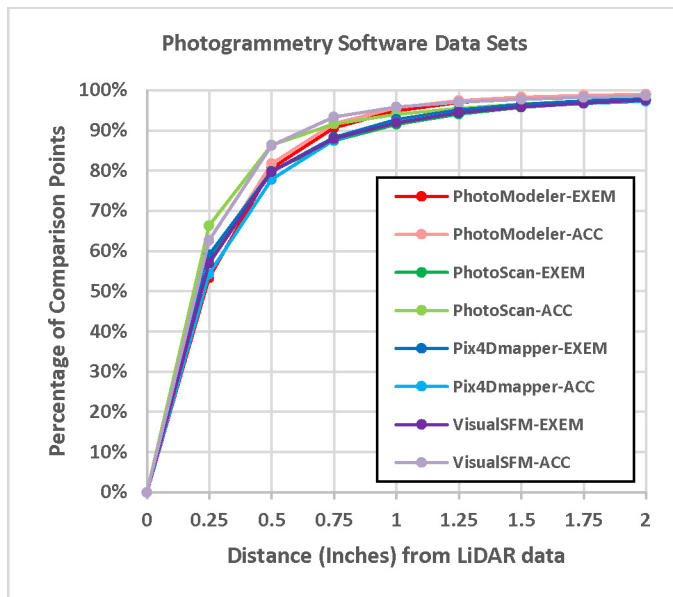
Figure 12. A cumulative probability plot of data from Table 7 with percentage of points over specific distances.

Distances were then evaluated between the photogrammetry point clouds and the LiDAR point clouds. The photogrammetry point clouds were found to have an average of 59% of their points within .25 inches of the LiDAR data, with a standard deviation of 4%. An average of 82% of the points were located within .5 inches with a standard deviation of 3%. An average of 90% of the points were located within .75 inches, with a standard deviation of 2%. An average of 94% of the points were located within 1 inch, with a standard deviation of 2%. An average of 96% of the points were located within 1.25 inches, with a standard deviation of 1%. An average of 97% of the points were located within 1.5 inches, with a standard deviation of 1%. An average of 98% of the points were located within 1.75 inches, with a standard deviation of 1%. (Table 7, Figures 12, 13, and 14). Appendix B contains data distribution histograms for each of the software data sets.

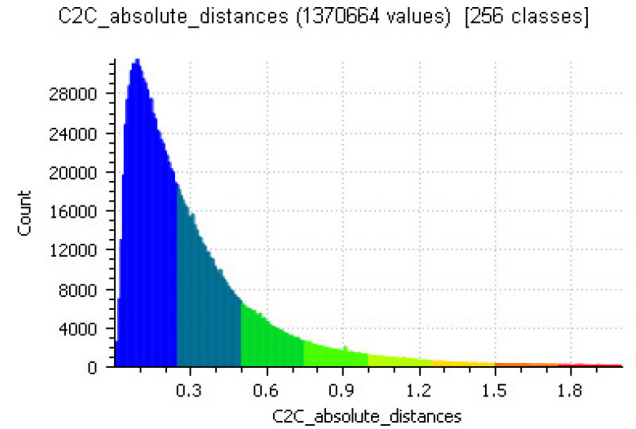
Figure 13. A histogram of the first row of data in Table 7. The colorization is based on .25 inch increments. 13,719 or approximately 1% of the points were at a distance greater than 2 inches, with a maximum distance of 14.6 inches. For clarity this is the PhotoModeler Scanner, Canon G16, undamaged vehicle, entire photo set. Appendix B contains similar histogram data for all rows within Table 7.

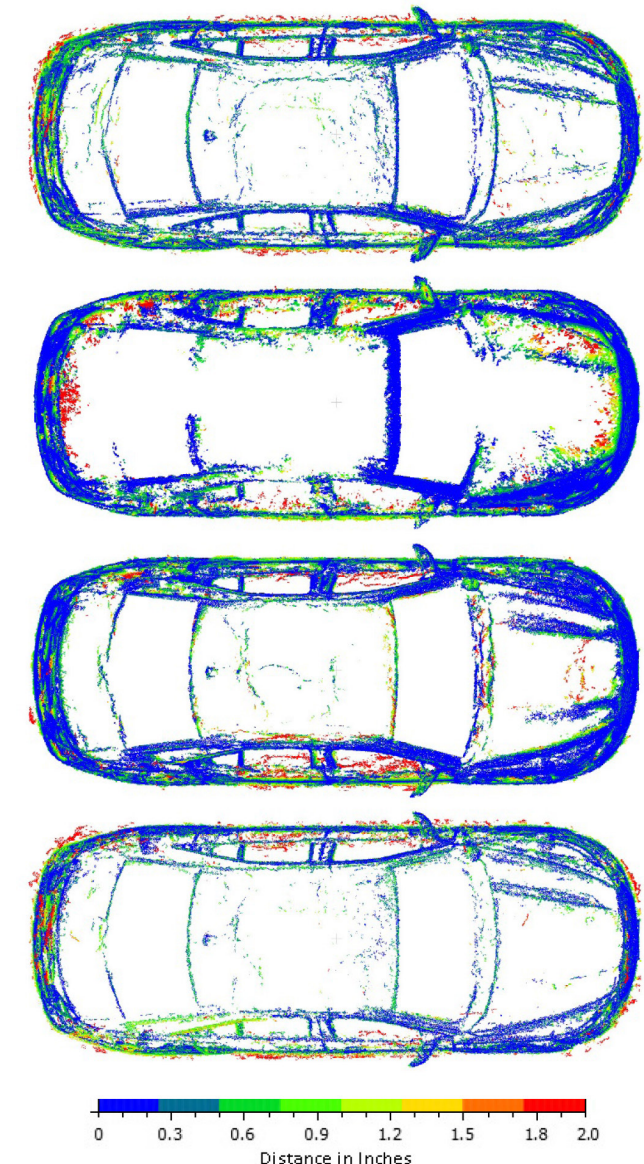
Figure 14. An orthographic top view of the photogrammetry software based point clouds taken with the Canon G16, full photograph set. In order from top to bottom: PhotoModeler Scanner, PhotoScan, Pix4Dmapper, and VisualSFM. Colorization is based on distance from LiDAR data.

A pattern appears visually within the data such that the photogrammetry points located closer to the LiDAR points are concentrated around areas with more contrast within the photos. For instance, there are more photogrammetry points, within the 0 to .25" range, near body panel seams and edges of geometry (Figure 15). Where the software has limited unique values or higher contrast between adjacent pixels, greater inaccuracies exist and there are limited resulting points. This is most visible in the center of larger vehicle body panels, such as the middle of the driver's door.

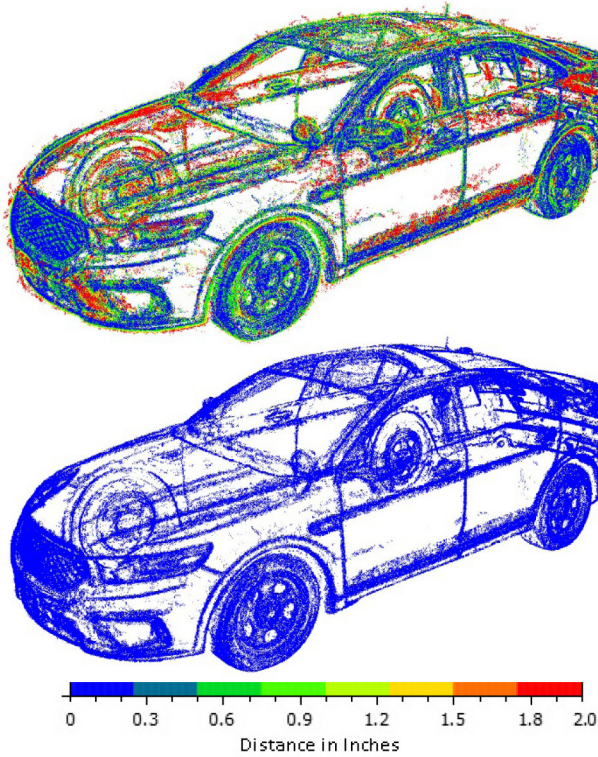
Figure 15. PhotoModeler Scanner, Canon G16, undamaged vehicle, entire photo set. The top vehicle shows photogrammetry data at all distances from the LiDAR point cloud. The bottom vehicle shows only points located within .25 inches of the LiDAR data. Colorization is based on distance from LiDAR data.

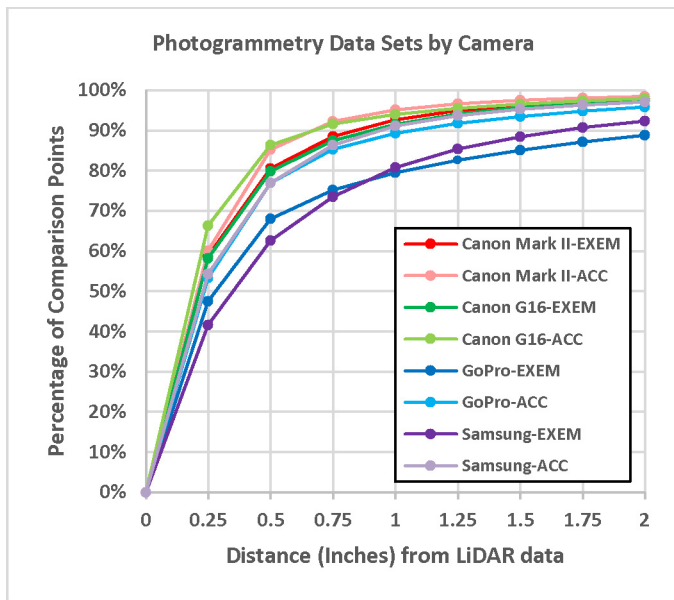
Figure 16. A cumulative probability plot of data from Table 10 with percentage of points over specific distances.

Distances were then evaluated between the photogrammetry point clouds and the LiDAR point clouds. The photogrammetry point clouds were found to have an average of 55% of their points within .25 inches of the LiDAR data, with a standard deviation of 8%. An average of 77% of the points were located within .5 inches with a standard deviation of 8%. An average of 85% of the points were located within .75 inches, with a standard deviation of 7%. An average of 89% of the points were located within 1 inch, with a standard deviation of 6%. An average of 92% of the points were located within 1.25 inches, with a standard deviation of 4%. An average of 94% of the points were located within 1.5 inches, with a standard deviation of 4%. An average of 95% of the points were located within 1.75 inches, with a standard deviation of 4%. An average of 96% of the points were located within 2 inches of the LiDAR data, with a standard deviation of 3%. (Table 10, Figures 16 and 17).

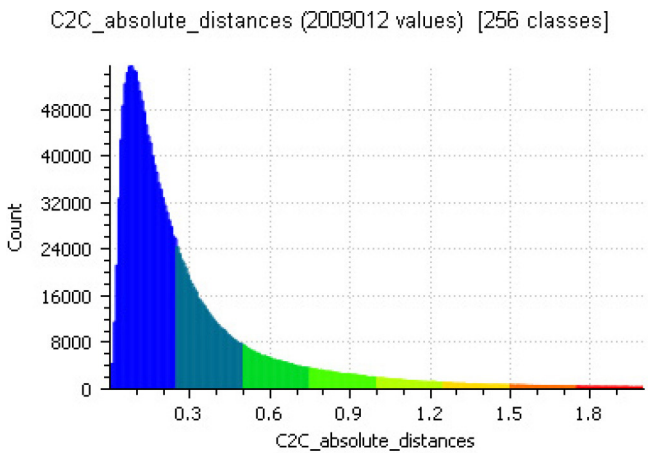
Figure 17. A histogram of the first row of data in Table 10. The colorization is based on .25 inch increments. 43,194 or approximately 2.2% of the points were at a distance greater than 2 inches, with a maximum distance of 7.7 inches. For clarity this is the Canon Mark II undamaged vehicle, entire photo set. Appendix C contains similar histogram data for all rows within Table 10.

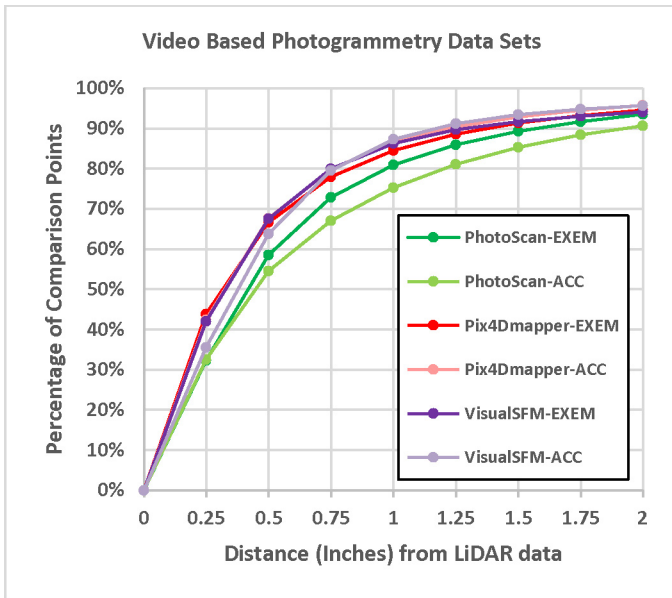
Figure 18. A cumulative probability plot of data from Table 12 with percentage of points over specific distances.

Distances were evaluated between the video photogrammetry point clouds and the LiDAR point clouds. The photogrammetry point clouds were found to have an average of 38% of their points within .25 inches of the LiDAR data, with a standard deviation of 5%. An average of 63% of the points were located within .5 inches with a standard deviation of 5%. An average of 76% of the points were located within .75 inches, with a standard deviation of 5%. An average of 84% of the points were located with 1 inch, with a standard deviation of 5%. An average of 88% of the photogrammetry points were located within 1.25 inches, with a standard deviation of 4%. An average of 91% of the points were located within 1.5 inches with a standard deviation of 3%. An average of 93% of the points were located within 1.75 inches, with a standard deviation of 2%. An average of 94% of the video photogrammetry points were located within 2 inches, with a standard deviation of 2%. (Table 12, Figures 18, and 19).

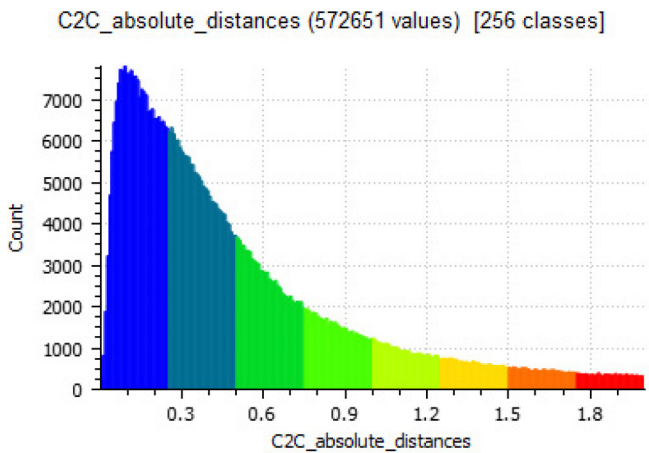
Figure 19. A histogram of the third row of data in Table 10 (Canon PowerShot G16, video set, undamaged vehicle, Agisoft PhotoScan). The colorization is based on .25 inch increments. A total of 39,667 or approximately 6.9% of the points were at a distance greater than 2 inches, with a maximum distance of 16.9 inches. Appendix D contains similar histogram data for all rows within Table 12.

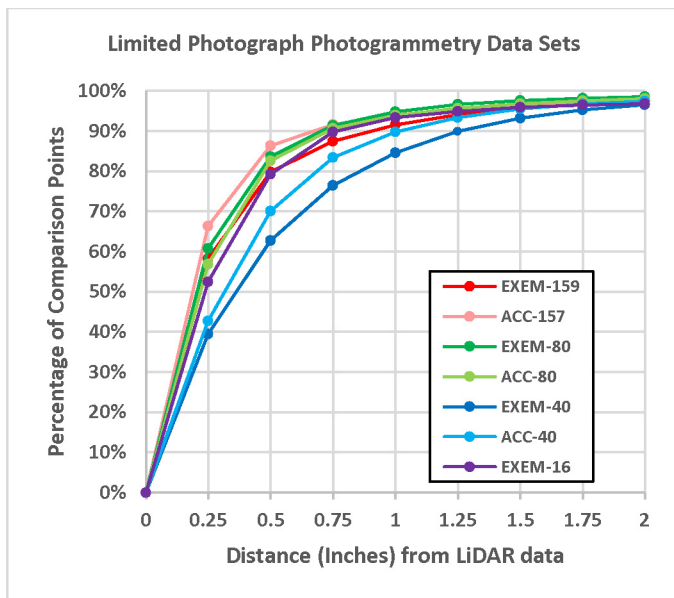
Figure 20. A cumulative probability plot of data from Table 14 with percentage of points over specific distances.

For the 16 photograph sets, only the undamaged set was able to be processed in PhotoScan. It was found to have of 52% of the points within .25 inches of the LiDAR data, 79 % of the points within .5 inches, 90% of the points within .75 inches, 93% of the points within 1 inch, 95% of the points within 1.25 inches, 96% of the points within 1.5 inches, and 97% of the points within 1.75 and 2 inches of the LiDAR data. (Table 14, Figures 20, 21, and 22).

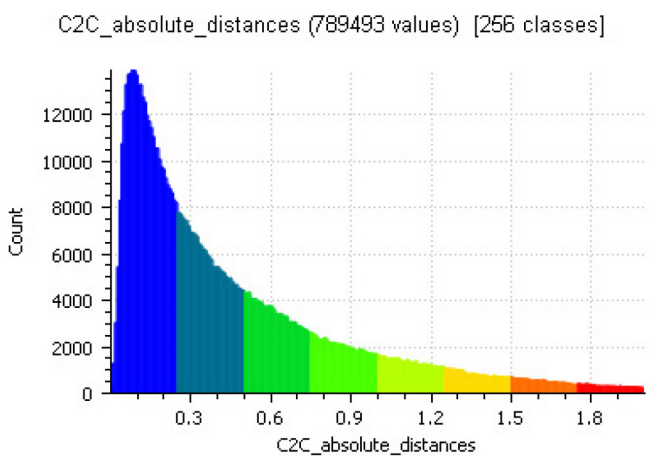
Figure 21. A histogram of the fifth row of data in Table 14 (Canon PowerShot G16, 40 photos, undamaged vehicle, Agisoft PhotoScan). The colorization is based on .25 inch increments. A total of 27,938 or approximately 3.5% of the points were at a distance greater than 2 inches, with a maximum distance of 9.8 inches. Appendix E contains similar histogram data for all rows within Table 12.

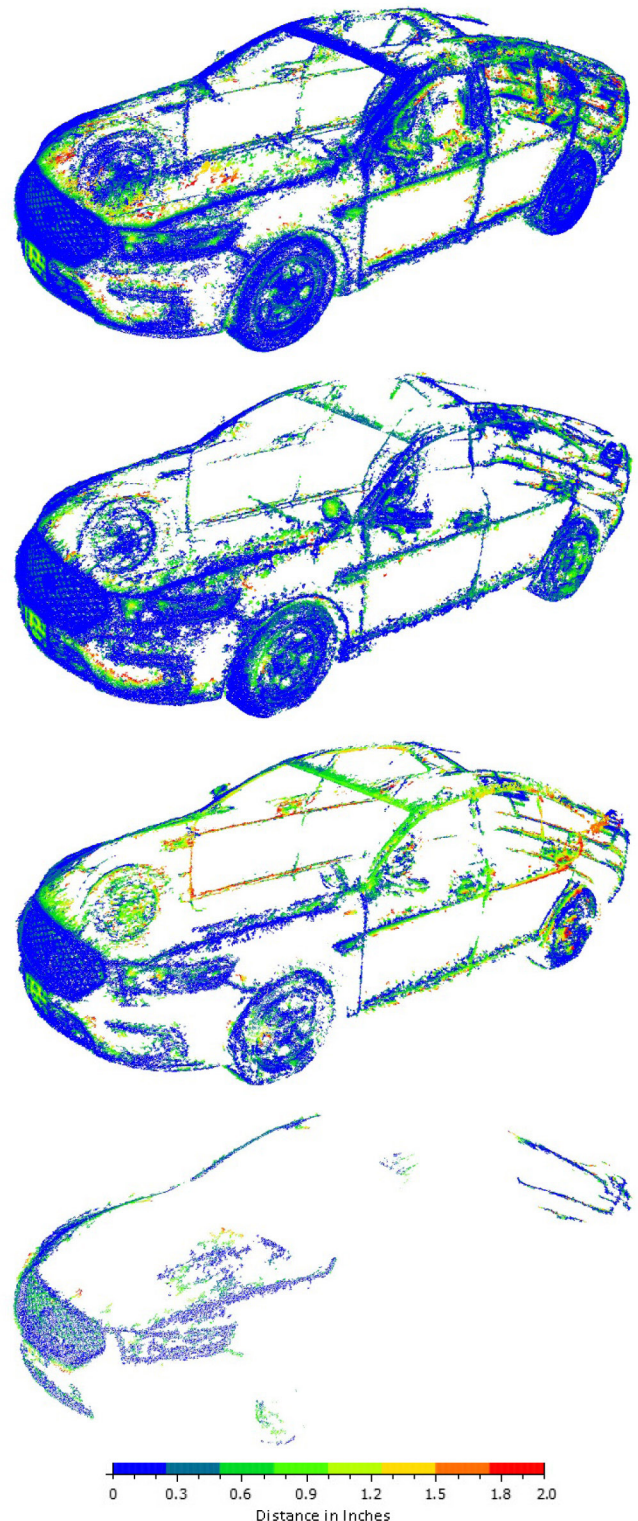
Figure 22. Exemplar vehicle photogrammetry data from Agisoft PhotoScan, Canon PowerShot G16. Top to bottom: 159 photo set, 80 photo set, 40 photo set, and 16 photo set. Colorization is representative of distance from LiDAR data. (Points beyond 2" are not shown)

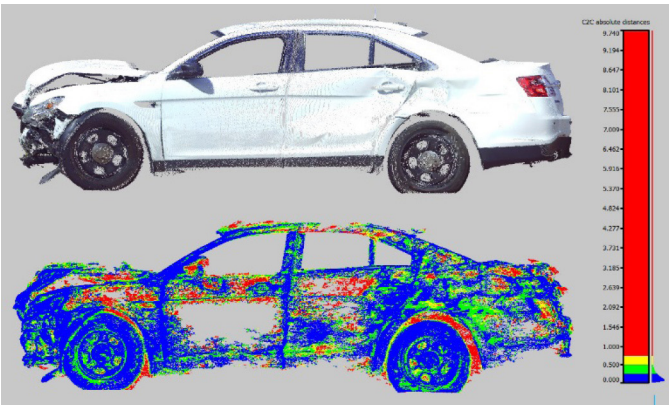
Figure 23. Areas of damage such as the driver’s side rear door and the driver’s side quarter panel exhibit more accurate data points than body panels that do not, such as the middle of the driver’s door. The top vehicle with standard coloring is the LiDAR point cloud and the bottom vehicle is the photogrammetry point cloud. The colorization is based on distance with 0 to .25 inches shown in blue, .25 to .5 inches shown in green, .5 to .75 inches shown in yellow and .75+ inches shown in red (PhotoScan, Canon G16, damaged vehicle, entire photo set).

The average number of points returned from all software titles for the undamaged vehicle was 1,354,098. The average for the damaged vehicle was 1,346,400. The difference between the two averages is just 7,698 points. This difference is small and was not consistent across all data sets (Table 6). The damaged vehicle data sets did show an increase in accuracy for points when compared to the LiDAR data set. A visual comparison of damaged areas also shows that more points within .25 inches of the LiDAR data could be seen in body panels where damage was present than in those without damage. This is evident where greater areas of blue colored points (points within .25 inches of the LiDAR data) are visible in the damaged areas (Figure 23).

When comparing the damaged and undamaged vehicle data sets, little difference was found in the number of comparison points returned by the photogrammetry software. The damaged vehicle sets did have a ~3% increase in accuracy within .25" of the LiDAR data over the undamaged data. A visual analysis of the damaged areas also revealed that more data points as well as data points with higher accuracy were present in areas where vehicle damage was present.

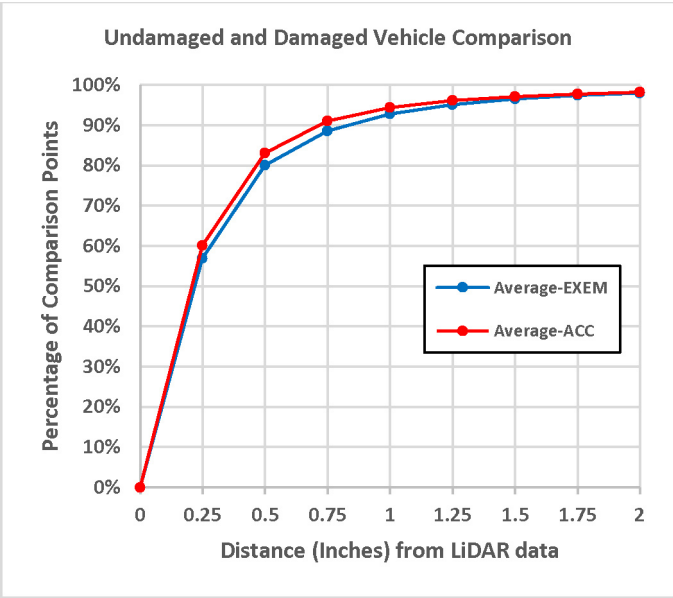
Figure 24. A cumulative probability plot of data from Table 15 with percentage of points over specific distances.

average of 80% of their data points located within .5 inches of the LiDAR data, while the damaged photogrammetry point clouds had an average of 83%. The undamaged photogrammetry point clouds had an average of 89% of their data points located within .75 inches of the LiDAR data, while the damaged photogrammetry point clouds had an average of 91%. The undamaged photogrammetry point clouds had an average of 93% of their data points located within 1 inch of the LiDAR data, while the damaged photogrammetry point clouds had an average of 94%. The undamaged photogrammetry point clouds had an average of 95% of their data points located within 1.25 inches of the LiDAR data, while the damaged photogrammetry point clouds had an average of 96%. Both the undamaged and damaged photogrammetry data sets had an average of 97% of their data points located within 1.5 inches. The undamaged photogrammetry point clouds had an average of 97% of their data points located within 1.75 inches of the LiDAR data, while the damaged photogrammetry point clouds had an average of 98%. Both the undamaged and damaged vehicle point clouds had an average of 98% of the points within 2 inches of the LiDAR data. (Table 15, Figure 24).

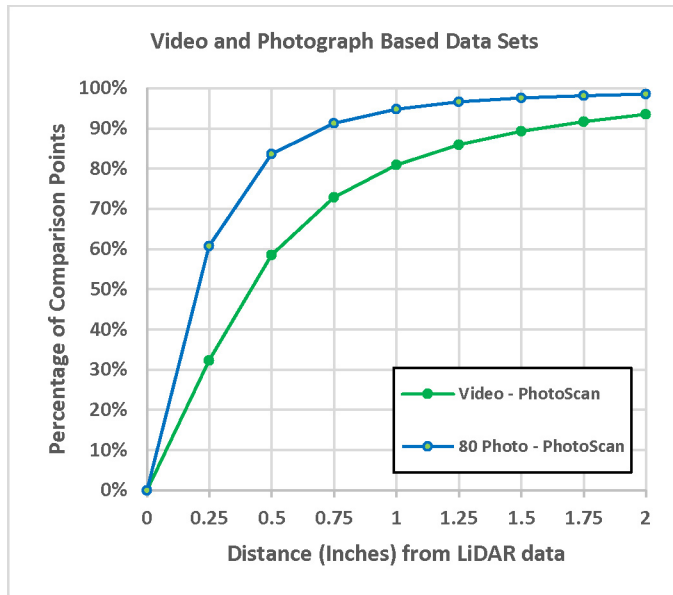
Figure 25. A cumulative probability plot of exemplar vehicle photogrammetry data from Agisoft PhotoScan, Canon PowerShot G16. Both the video and the photograph sets were taken with the Canon PowerShot G16 and processed in Agisoft PhotoScan. The photo set represented was processed with 80 photographs.

1,896,000,000. The average number of pixels used in the video sets was 821,145,600 or nearly half. Because of this difference in total pixels, the photograph data sets where the total number of photos was reduced from 160 to 80, and 40 were considered. The 40 photograph set had a total of 480,000,000 pixels used, or nearly half of the total pixels used in the video solution. The 40 photograph set returned an average of 1,027,802 total comparison points and the video sets returned an average of only 555,374 comparison points. The photograph point clouds were also shown to be more accurate (Figures 25 and 26).

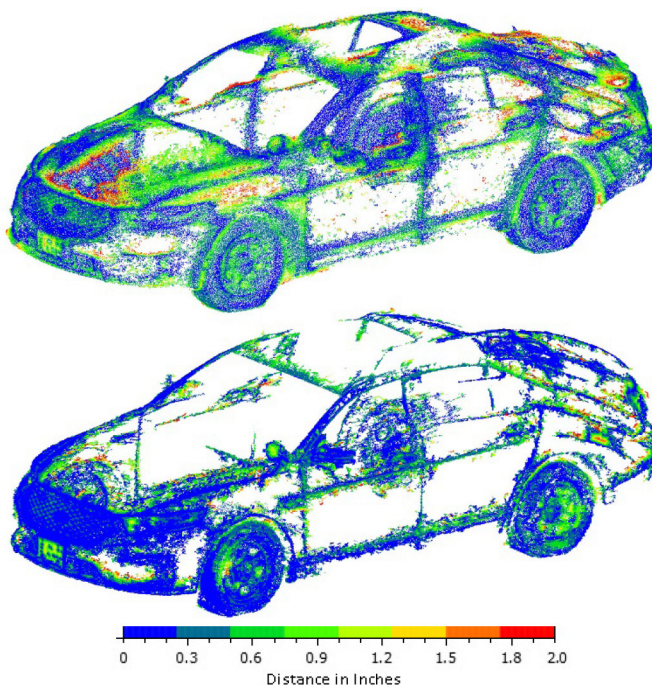
Figure 26. Exemplar vehicle photogrammetry data from Agisoft Photoscan, Canon PowerShot G16. Top: Photogrammetry point cloud from video. Bottom: 40 photo set. Colorization is representative of distance from LiDAR data. (Points beyond 2" are not shown)
