**DETERMINATION OF SIGNIFICANCE STAFF REPORT**

Site:	103 Washington Street
Case:	HPC 2017.027
Applicant Name:	WASHDEV LLC
Date of Application:	April 27, 2017
Recommendation:	Not Significant
Hearing Date:	June 27, 2017

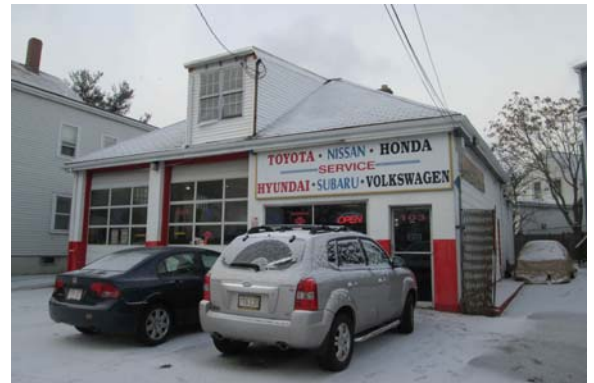
*Architectural Description:* The service station is 3 bays wide by a similar amount deep. It is built with concrete block. Modern garage doors enclose two bays while a shop window and office door are found on the east-most bay. The most unusual features are the hipped roof and the paired double hung windows in a central shed dormer on the main façade.

- a. Location: The building has not been moved. It is located as is typical for gas and service stations on a major local roadway
- b. Design: The design is a simple box with a hipped roof and a shed dormer.
- c. Materials: The building is mostly concrete block with modern metal doors and a modern storefront. The dormer is wood the roof shingles are 3-tab asphalt.
- d. Alterations: Alterations have been made but are un-dated.

*Evaluation of Integrity*: The building is recognizable as a service station through the oversized garage doors and their relative location to each other. The large asphalted surround ensures that cars have space to pull off the road and have plenty of parking while waiting for repairs or pick up. The office area with its storefront is also part of the architecture of service stations where goods and services could be advertised.
