STEP 1: DETERMINATION OF SIGNIFICANCE
STAFF REPORT

Site: 11 Chester Place

Case: HPC.DMO 2022.40

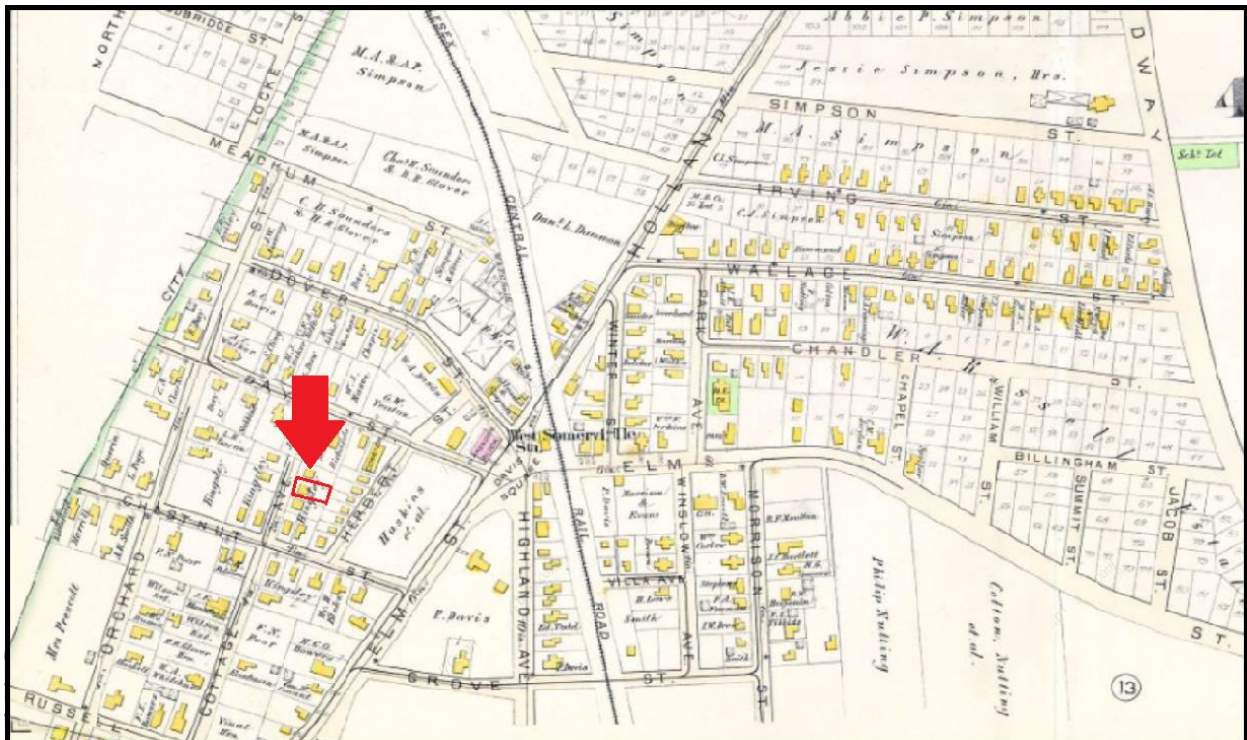
By 1874, Chester Place had not been paved nor were any lots platted. It is by 1884, that we first see Chester Place has been paved and the surrounding lots platted and developed as depicted in the map below. This is the first physical depiction we have of 11 Chester Place. It is shown as a simple square building and matches the same layout as that of the neighboring properties owned by Kingsley.

Above: 1884 Hopkins Map, Plate 14, specifying location of 11 Chester Place.

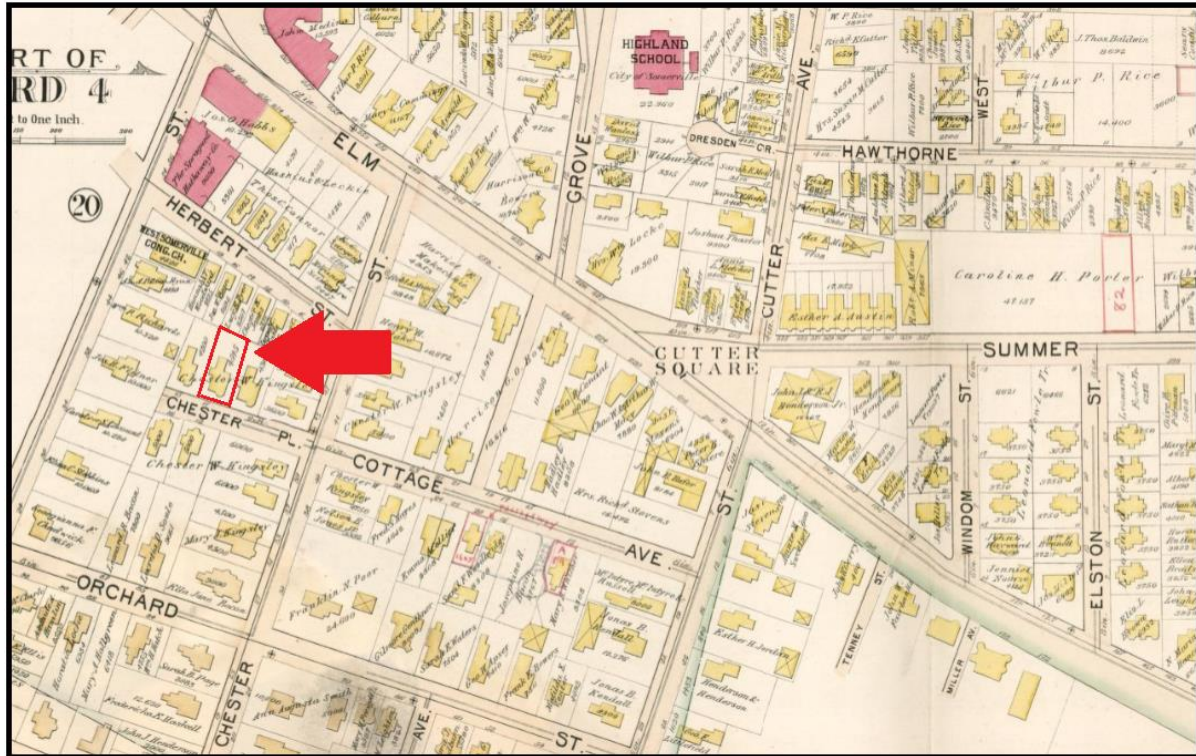
Above: 1895 Bromley Map, Plate 18, specifying location of 11 Chester Place.

The 1895 Bromley Map shows additions have been added to the left and rear elevations, and a bay has been added to the front elevation. These changes are also visible on the two neighboring properties, the properties across the Place, and four of the properties facing on to Chester Place. This indicates that Kingsley was improving his properties simultaneously.

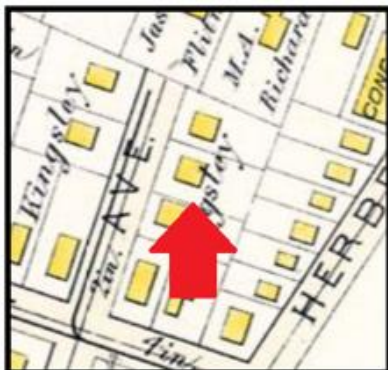
Above: Fig 1

Fig 1: 1884 Hopkins Map, close-up of 11 Chester Pl

- The 1884 Map is the first time the current structure is shown. It is a plain square building.

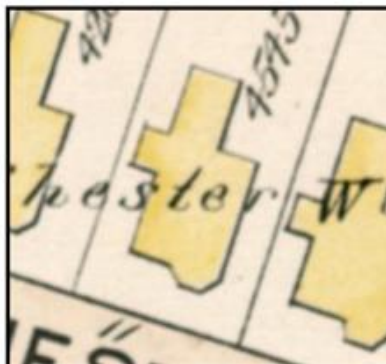
Above: Fig 2

Fig 2: 1895 Bromley Map, close-up of 11 Chester Pl

- A bay has been added on the front elevation.
- An addition on the left and rear elevations has been constructed.

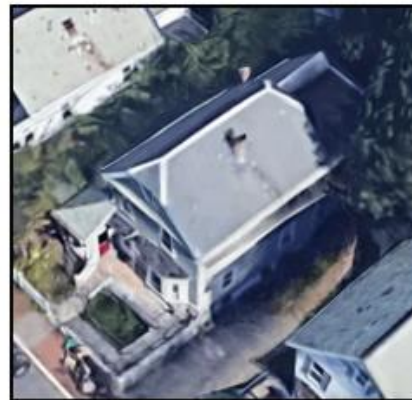
Above: Fig 5

Fig 5: Satellite image of 11 Chester Pl

- The porch on the left front of the building has been enclosed.
- No further additions are visible through these images, showing that the building largely retains the same massing as in 1933-1934.
