DETERMINATION OF SIGNIFICANCE STAFF REPORT

Site:	71 Bow Street
Case:	HPC 2018.72
Applicant Name:	Leins Family Realty Trust/ Luis E. Leins, Trustee
Date of Application:	July 3, 2018
Recommendation:	Significant
Hearing Date:	July 17, 2018

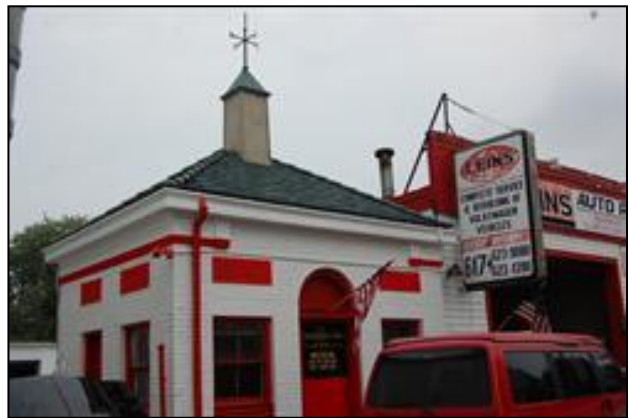
The site contains two structures: a small, one-story, brick, Colonial Revival-style structure (c.1925) and a larger, two-story concrete-block building with a clapboard façade.

The period of style for the c.1925 structure is Colonial Revival. The building serves as an excellent example of early 20th-century service station architecture. This building has a concrete foundation, white-painted brick walls, and a slate, hip-roof with a square cupola. The broken frieze beneath the slightly-projecting eaves features a tri-glyph motif, and decorative brickwork is arranged to simulate raised panels above the windows and doors. The cupola is topped by a slate, pyramidal roof and weathervane.

The center entrance on the three-bay facade (southeast) elevation consists of a replacement metal rectangular door set within a simple wood surround with a fanlight infilled by a wood panel. Two-over-two double-hung wood-frame windows above louvered vents fill the rectangular openings on either side of the entrance. A similar window is located in the east bay of the southeast elevation, and a secondary entrance has replaced the original window opening in the west bay.

- a. Location: This building has existed in its current location since its construction.
- b. Design: The c. 1925 building is Colonial revival in design. The 3-bay garage is a typical service station form.
- c. Materials: The materials (brick, concrete, slate) for the c.1925 building are remarkably intact. The materials for the 3-bay garage are largely intact but may have been altered over time.
- d. Evaluation of Integrity: The c.1925 structure, the more important of the two structures on the site, retains a significant degree of architectural integrity despite its age and the heavy use of the course of the 20th century.
