## Downtown Accessibility Navigator

### Rosa Parks Circle

135 Monroe Center St. NW, Grand Rapids, Michigan 49503

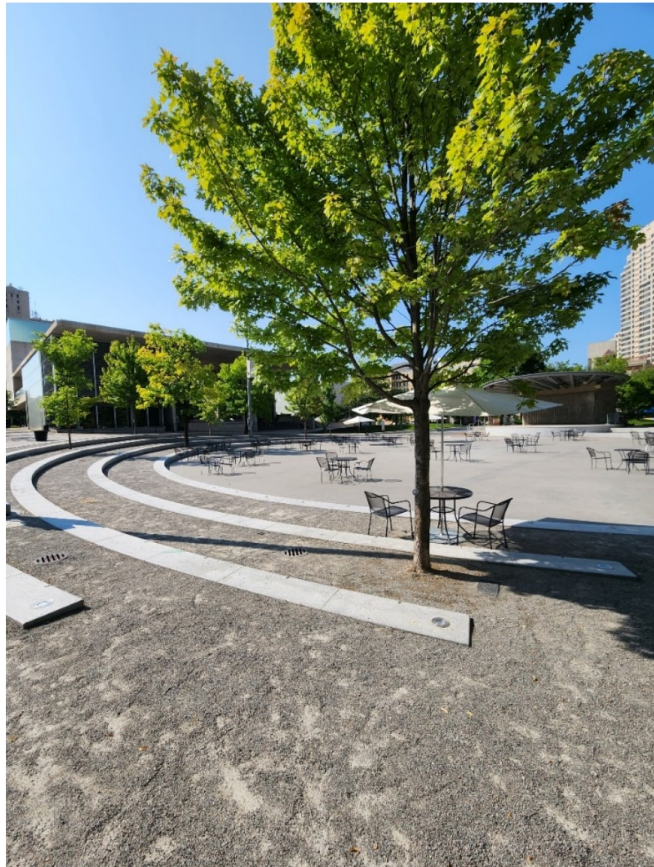
There are metered on-street parking spaces available along the north side of Monroe Center Street on the north side of the block. There is additional metered on-street parking along the north side of Louis Street on the south side of the block. There are no designated accessible on-street parking spaces near the park property.

There is an intersection at the southwest corner of the park, with painted brick crosswalks, curb ramps and detectible warning plates. There are perpendicular style curb ramps. The detectible warning plates do not directly face the curb ramps on the other side of the street.

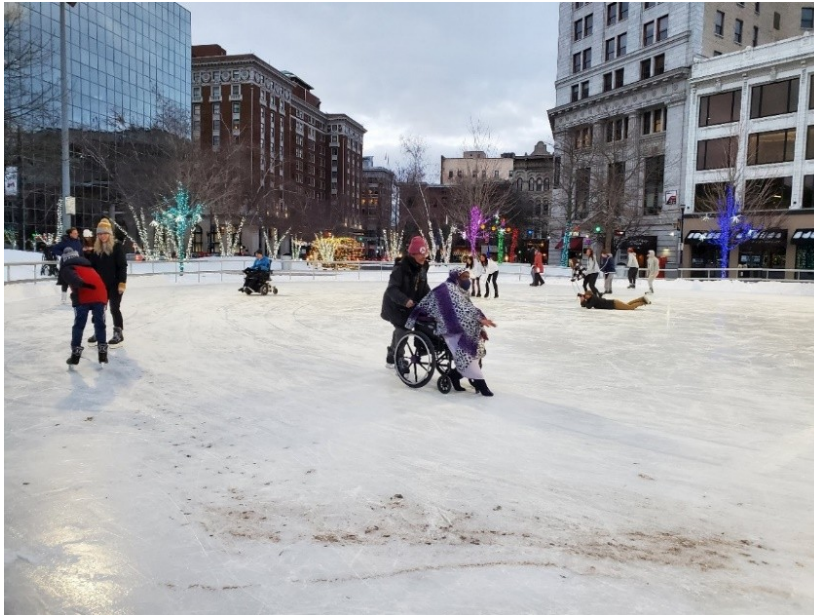
There is a mid-block crosswalk on the north side of the property. The crosswalk is a faintly contrasting brick, across a brick paved street. There are perpendicular style curb ramps. Only the curb ramp on the park side of the crossing has detectible warning. There are no audible cues for crossing the street at this intersection. The curb ramp and detectible warning plates directly face the other

curb ramp across the street.

There is an intersection at the northwest corner of the park, with painted brick crosswalks, curb ramps, and detectible warning plates. The intersection is a hub for three streets: Monroe Avenue, Monroe Center, and Pearl Street. There are diagonal style curb ramps. There are no audible cues for crossing the street at this intersection. The detectible warning plates curve to follow the curb, and only partially face the other curb ramp across the street.
