## Downtown Accessibility Navigator

### Chicago Beef Joint (last updated June 2025)

822 Ottawa Ave NW, Grand Rapids, MI 49503

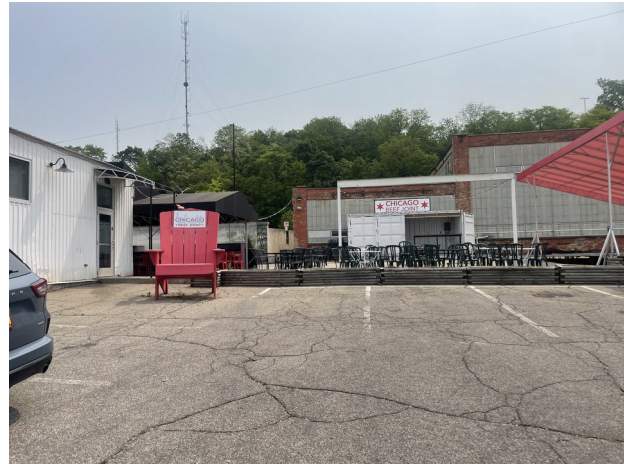
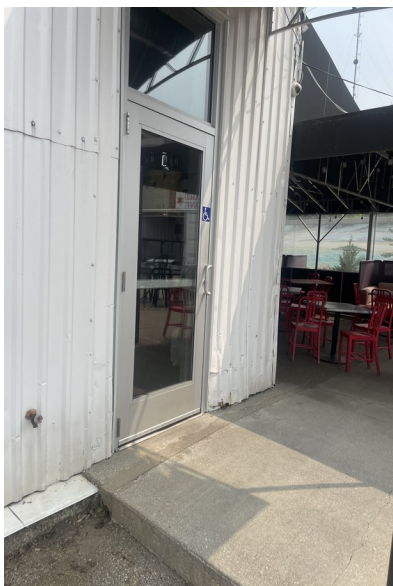
Chicago Beef Joint offers both on-street metered parking along Ottawa Avenue and a surface lot directly next to the building. The lot includes two designated accessible parking spaces located near the side accessible entrance, clearly marked with appropriate signage. There are no gate arms or barriers; instead, the lot is enclosed by a wraparound fence. Lighting is provided by overhead street lamps, offering adequate visibility during evening hours. The surface of the lot shows signs of wear, including visible cracking, which may present mild navigation challenges for some users.

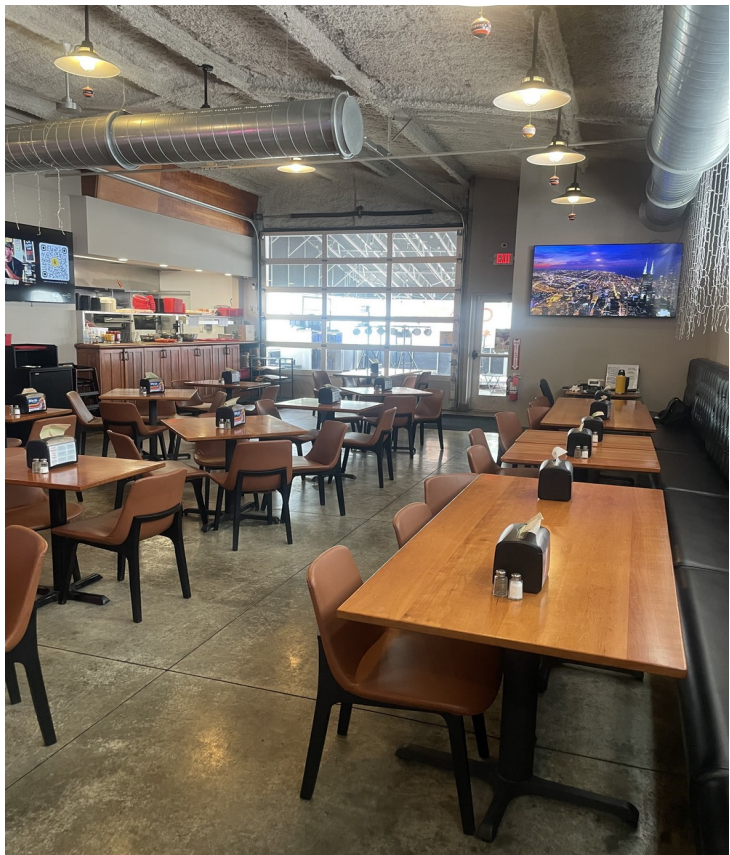
The interior of the restaurant is fully located on one level and is generally easy to navigate. Upon entering, guests are greeted by a service counter, which currently does not have a lowered section for accessibility. The seating throughout the space is varied, including a mix of bar seating, standard-height tables and chairs, low tables, and booth-style options. A wide aisle layout allows for good maneuverability, although some areas may become tighter depending on the number of patrons and table arrangements at the time of visit.

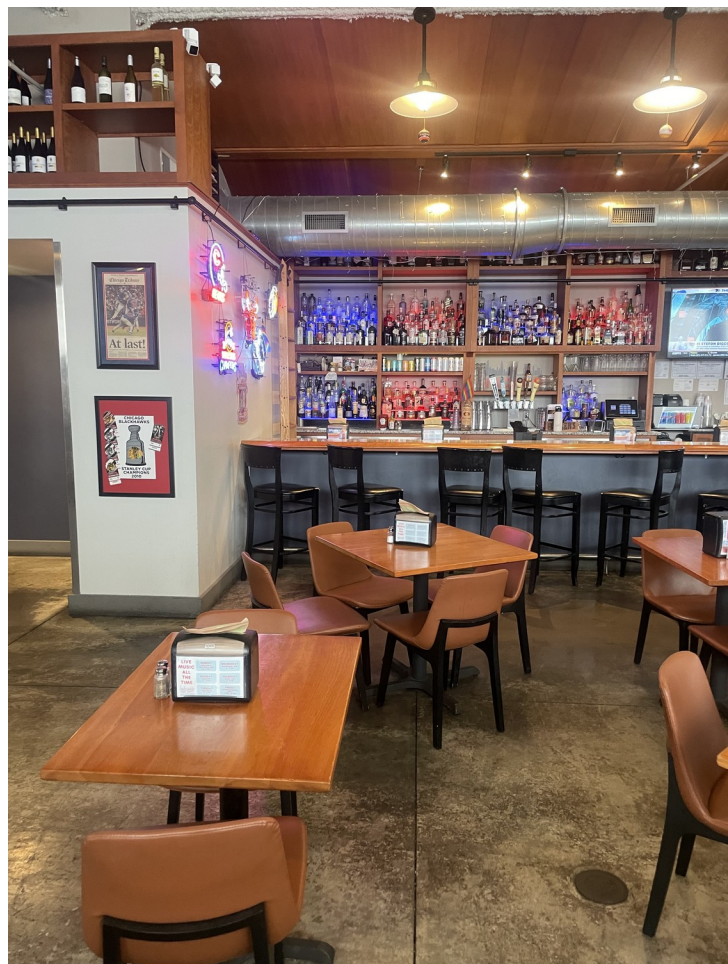
Lighting inside the Chicago Beef Joint is a combination of dim overhead fixtures with a warm yellow tone and natural daylight that enters through windows and doors. Additional ambient lighting includes neon signs and multi-colored LED accents around the bar area, creating a slightly darker, casual atmosphere. When visited, the space was relatively quiet, with soft background music playing, though the noise level could increase during peak hours. The environment had typical food-related odors but nothing overwhelming or outside normal expectations for a restaurant setting.
