OPERATIONAL & MANAGEMENT ASSESSMENT BALTIMORE CITY FIRE DEPARTMENT

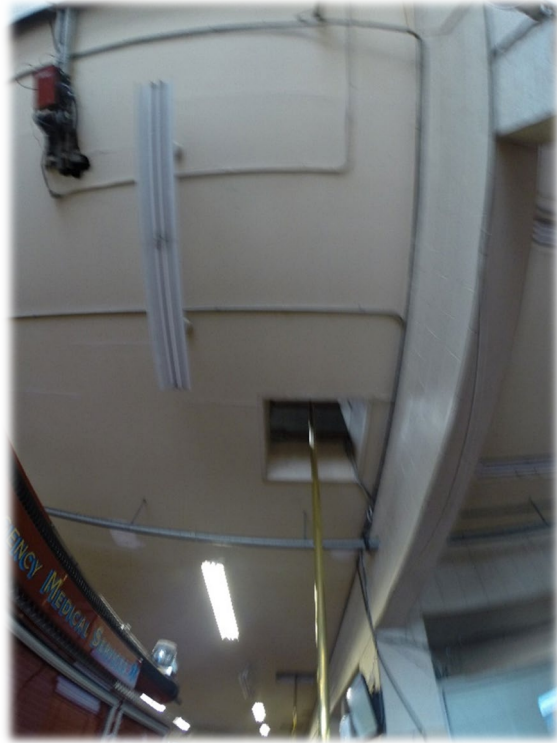
Pole hole “covers” are present but are not airtight. Pads exist and are in fair condition.

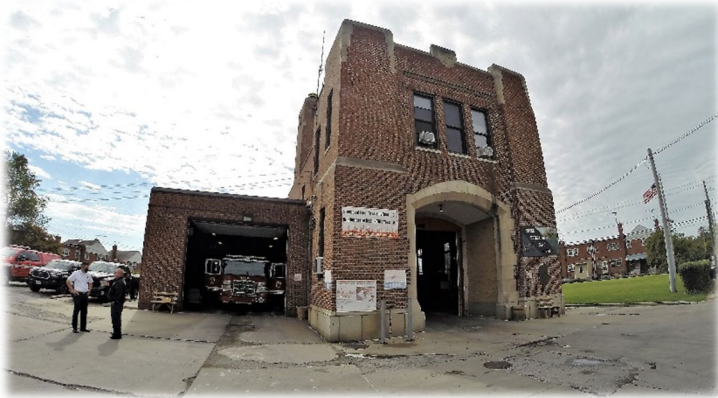
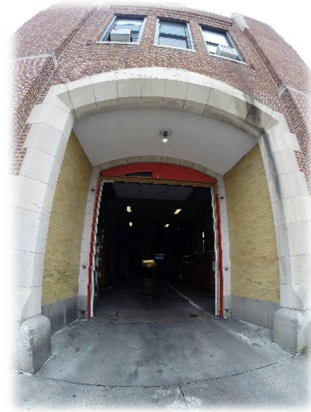
Station 27 opened in 1935 as a 2 story, one bay station.

The 2nd apparatus bay was added in the 1970s. Station 27 lacks a fire sprinkler system as well as a fire alarm system. HVAC, plumbing, and electrical systems could be updated.

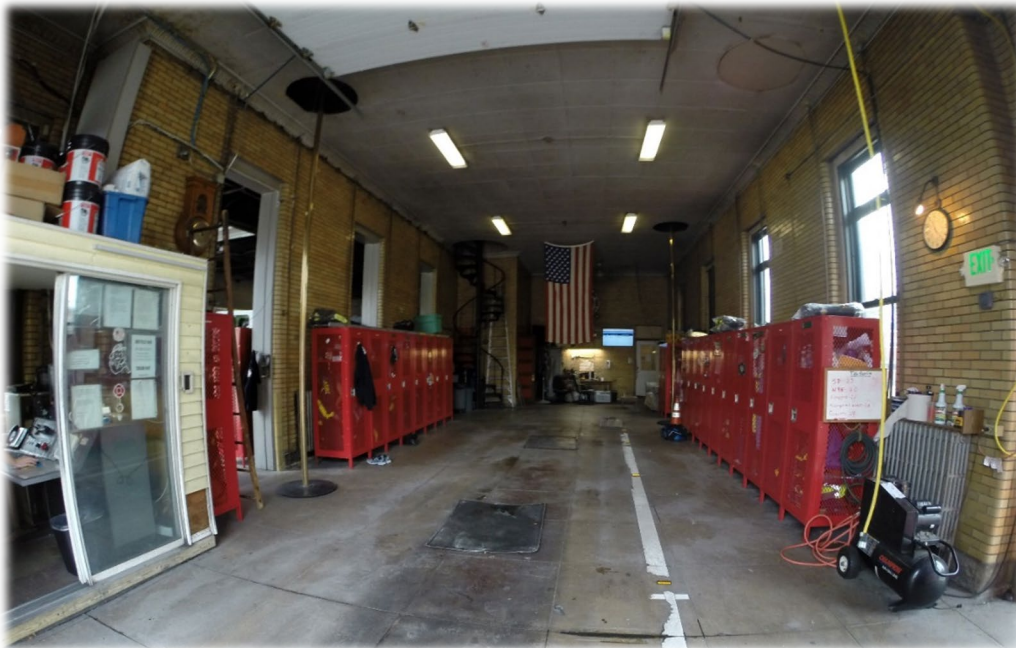
Front of apparatus bay looking in towards the back.

A.9.1.5 - NIOSH recommendations for limiting carcinogen exposure in apparatus bays: *Diesel exhaust removal system (Plymovent) in place, but not functional.*

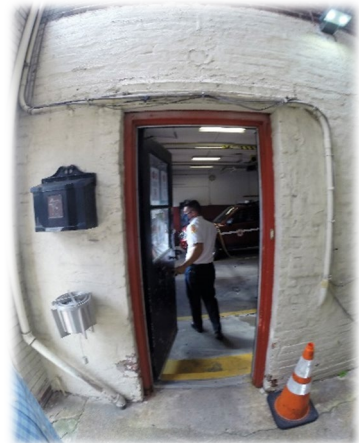
Station 41 opened in 1893; it is a 2 story station with 2 apparatus bays.

This station does not have the typical ornamentation common in firehouse construction in the late 19th century. The station has had the entire 2nd floor remodeled and it has been architecturally updated. The remodeling has definitely extended this station's functionality and useful life. It lacks a fire sprinkler system as well as a fire alarm system. HVAC, plumbing, and electrical systems could be updated.

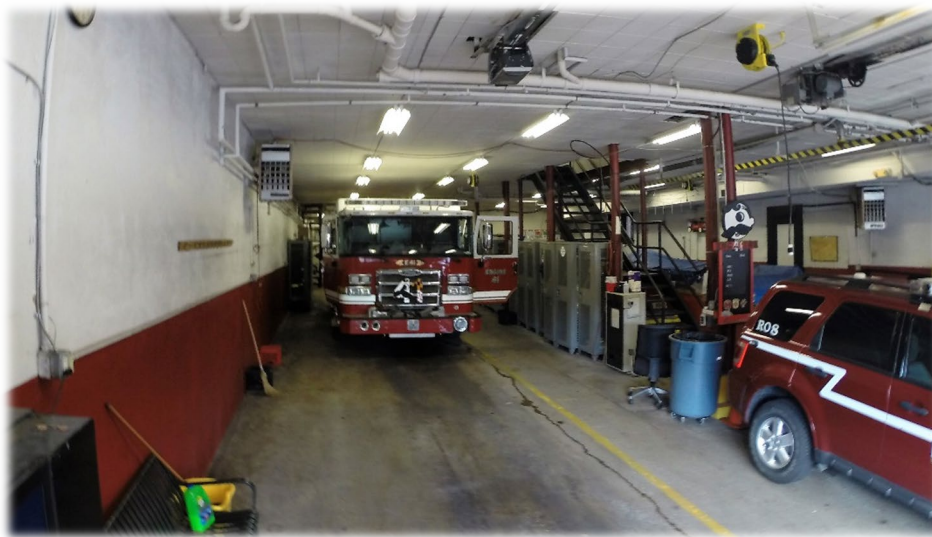
Front of apparatus bay looking in towards the back

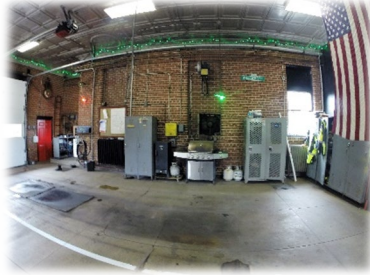
BBQ in the apparatus bay

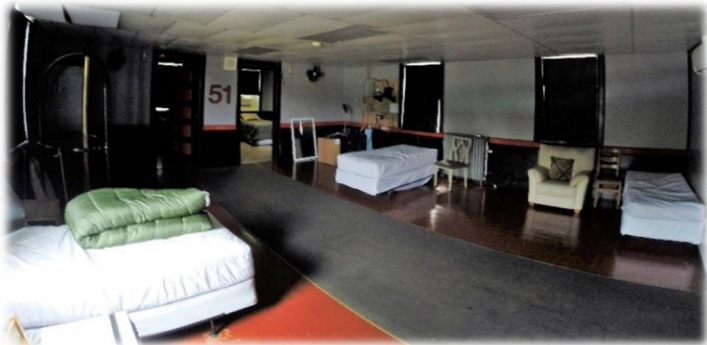
2nd floor bunk room and pole hole

Pole hole “covers” are present but are not airtight. Pads exist and are in fair condition.

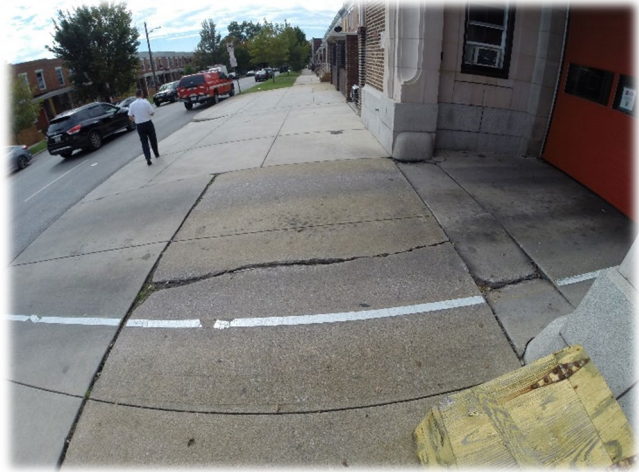
Concrete apron

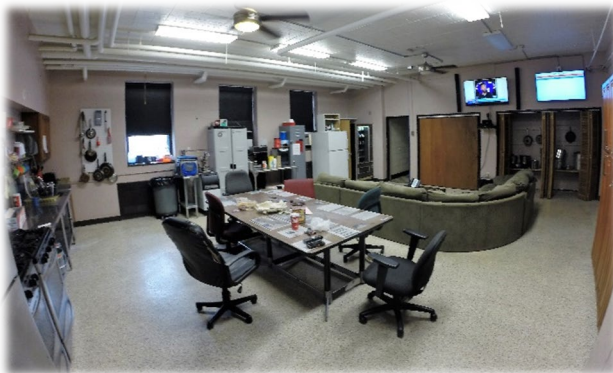
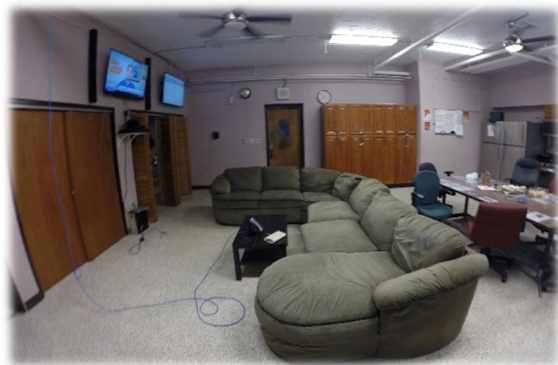
Kitchen/dining and day room also have immediate access off the apparatus bays

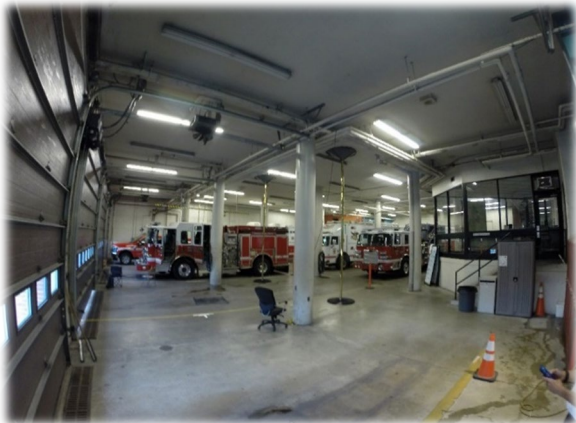
The first floor is the apparatus bays and ancillary spaces like turnout storage, the weight room, and utility spaces. The 2nd floor is the living quarters. This station also houses some BCFD IT functions and the Emergency Operations Center (EOC). The exterior is relatively low maintenance red brick. It lacks a fire sprinkler system as well as a fire alarm system. HVAC, plumbing, and electrical systems could be updated.

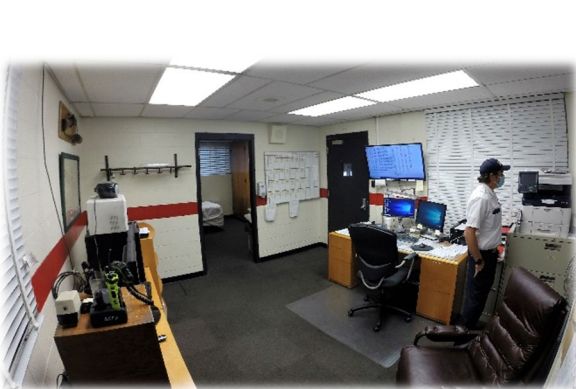
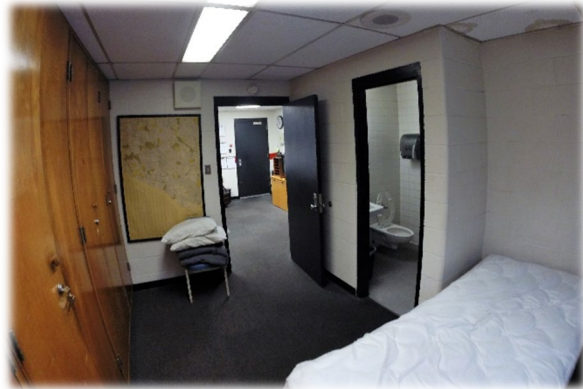
Hallway in IT office area

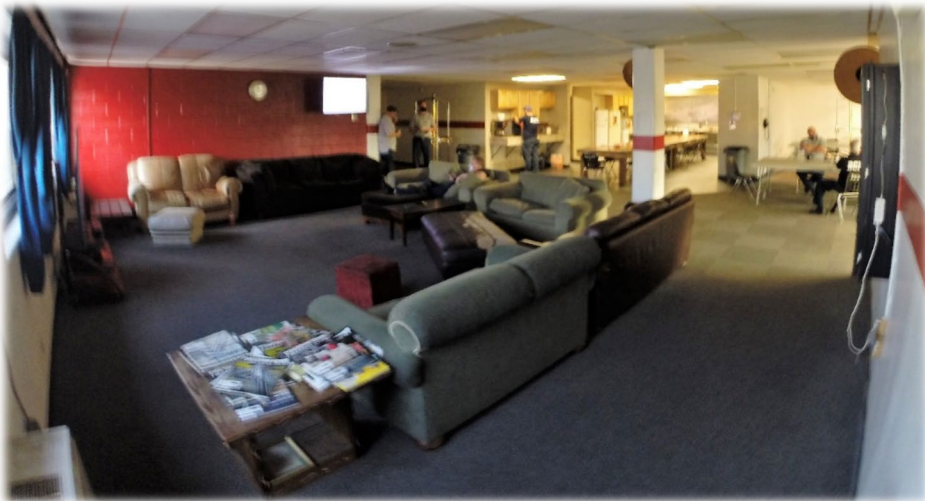
Day room

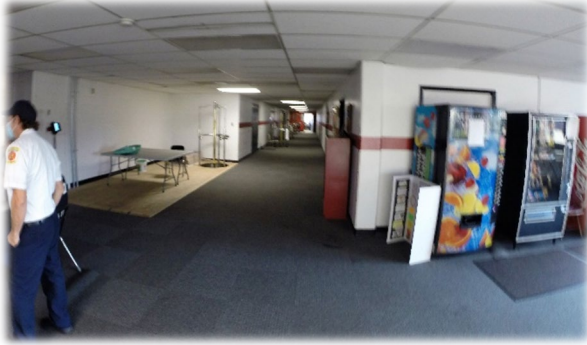
Hallway to offices and dorms

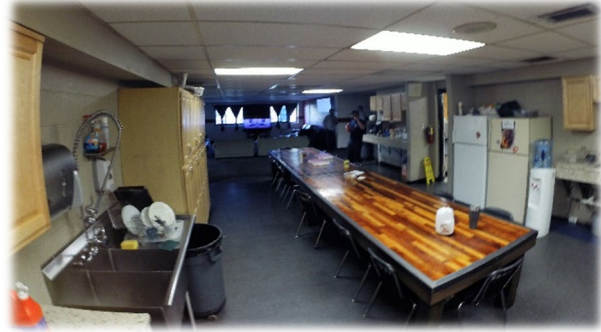
Kitchen and dining

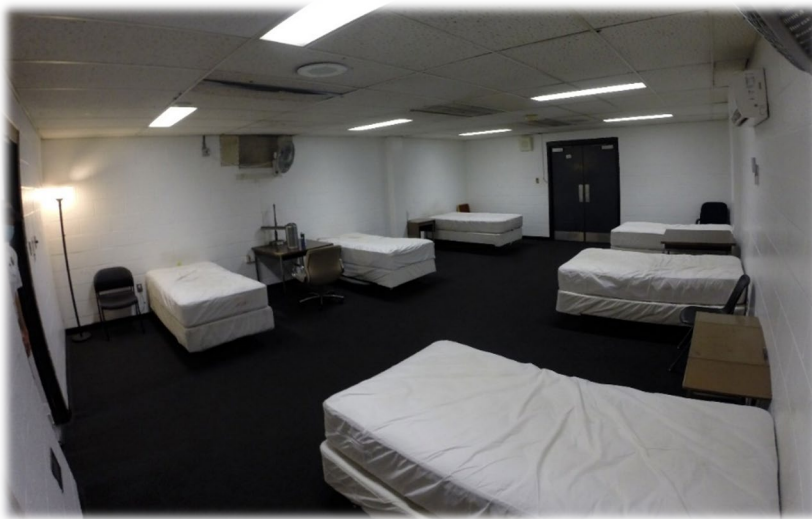
Bunk room

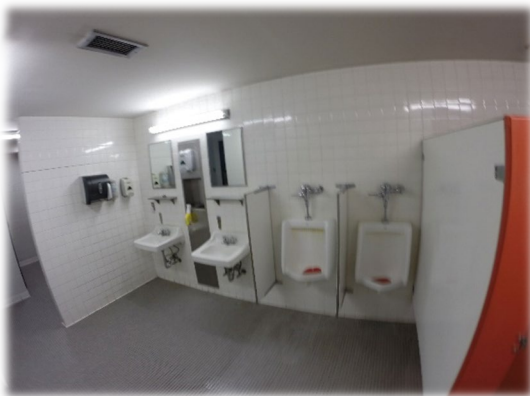
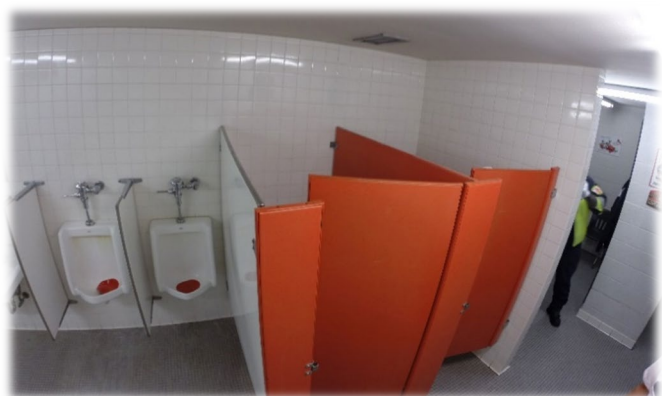
Restroom

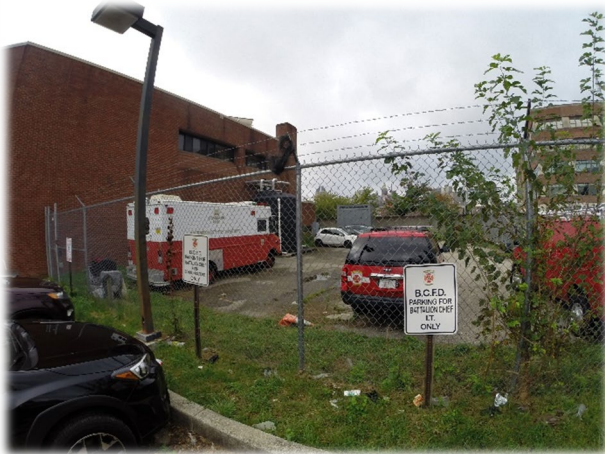
Back of station has secure parking lot

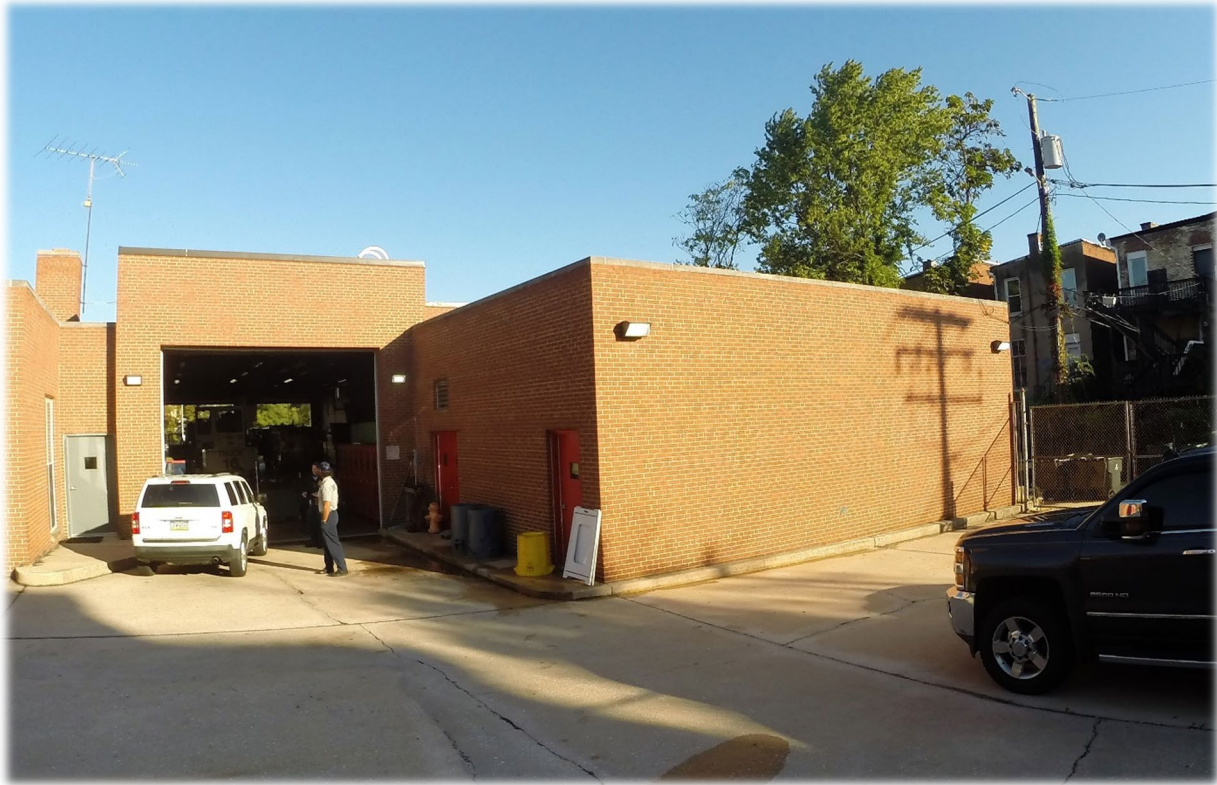
One bay has access from rear of station

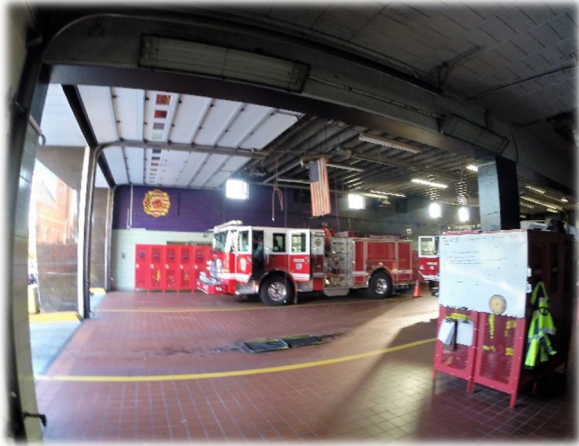
Turnout lockers are on sides of bays

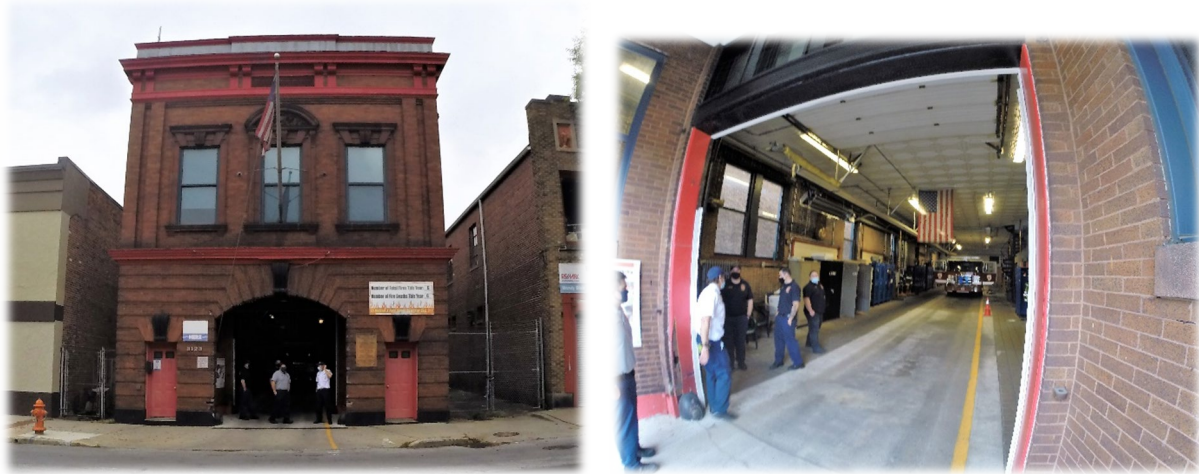
Station 31 is a beautiful example of a historic, red brick firehouse. The BCFD has had a complete renovation of the 2nd floor living spaces and restrooms. This renovation has injected new life into this very old station keeping it a viable part of the neighborhood. It lacks a fire sprinkler system as well as a fire alarm system. HVAC, plumbing, and electrical systems could be updated. However, the renovation has extended its useful life well into the future.

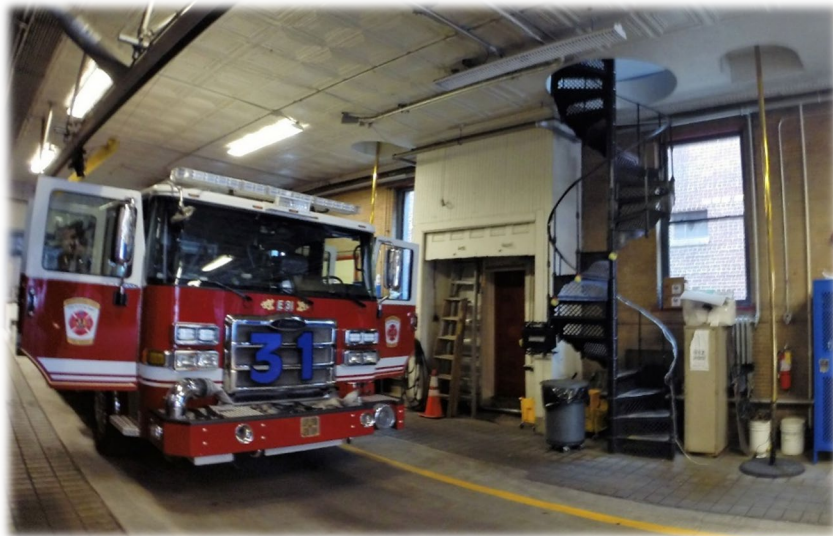
The circular stairs are in the middle of the bay at this station. They extend up to the hose tower which is the shed space left of the stairs. Note poles adjacent on either side.

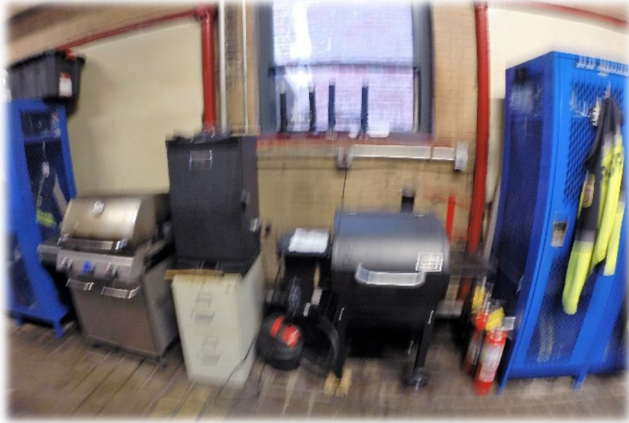
BBQ grills on bay floor near kitchen

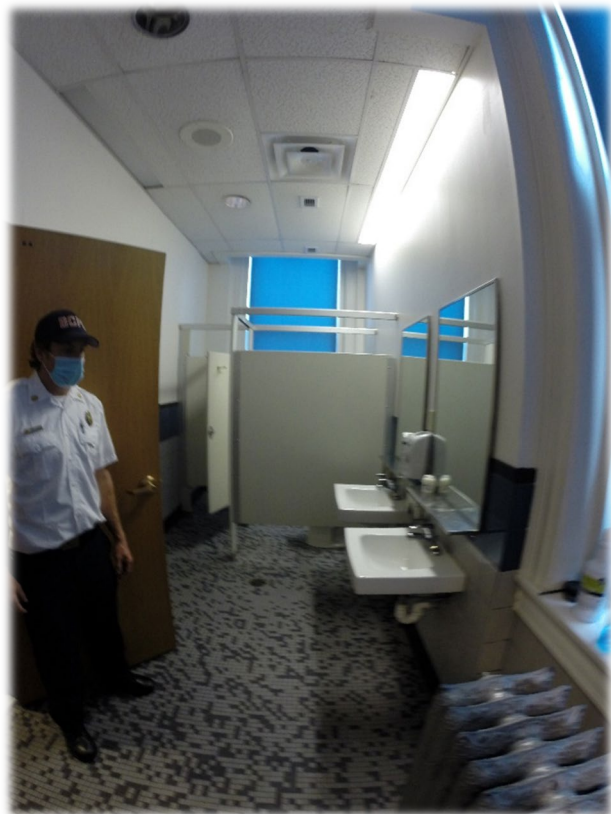
Renovated restroom

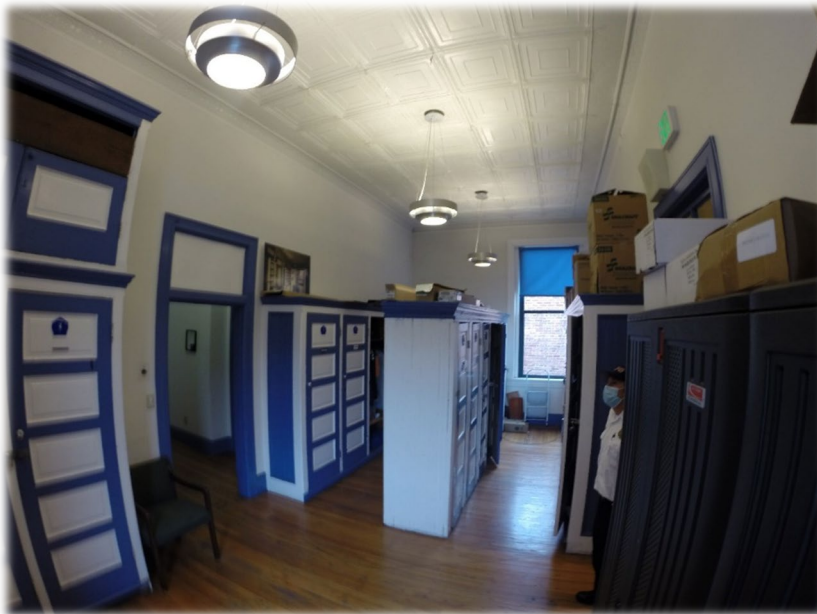
Renovated lockers reused originals. Note the remediated ceiling to remove old lead paint and add new modern LED light fixtures.

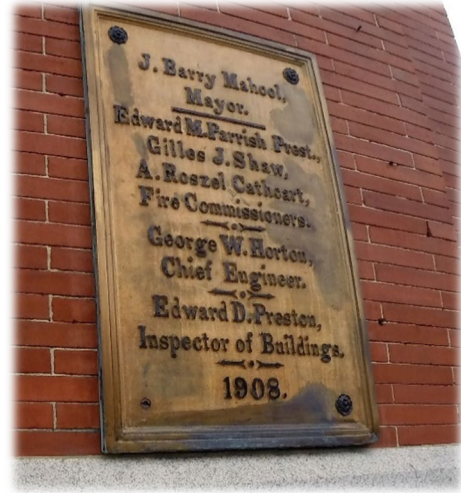
Station 33 is a historic, red brick firehouse. The BCFD has managed to keep this iconic station viable even in today's operational and deployment model requirements. It lacks a fire sprinkler system as well as a fire alarm system. HVAC, plumbing, and electrical systems could be updated.

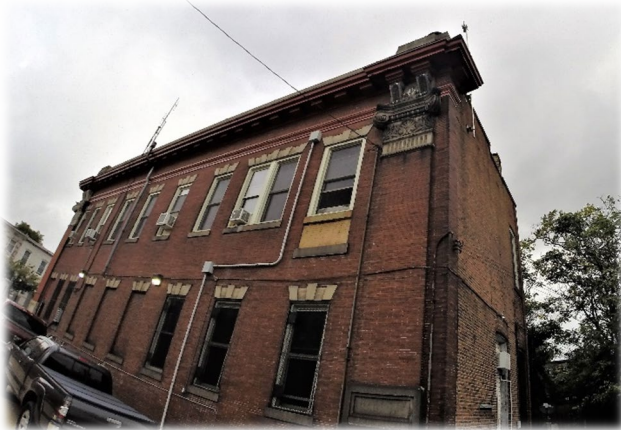
2nd floor windows are relatively new

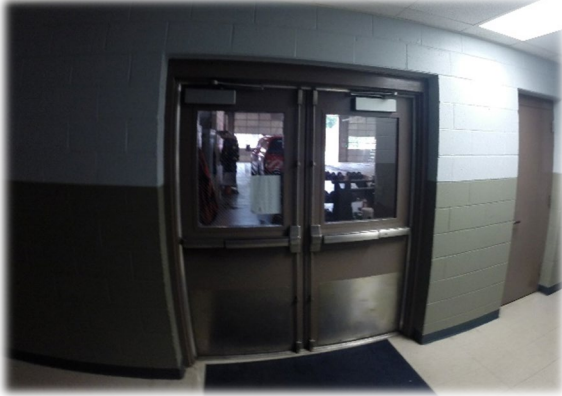
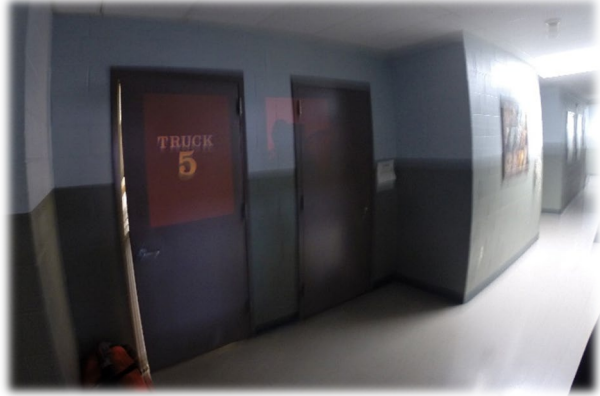
Doors to bay are directly across from the doors to the dorm rooms

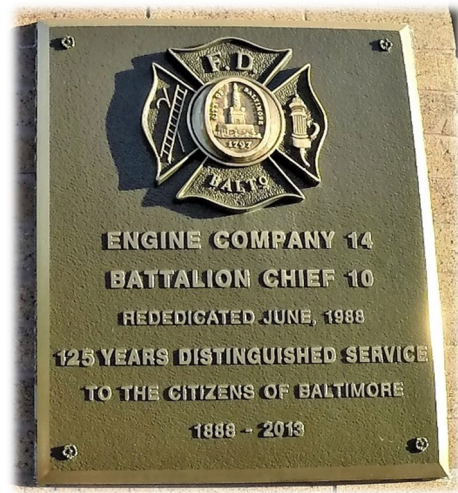
Station 14 is a historic, red brick firehouse. It lacks a fire sprinkler system as well as a fire alarm system. HVAC, plumbing, and electrical systems could be updated.

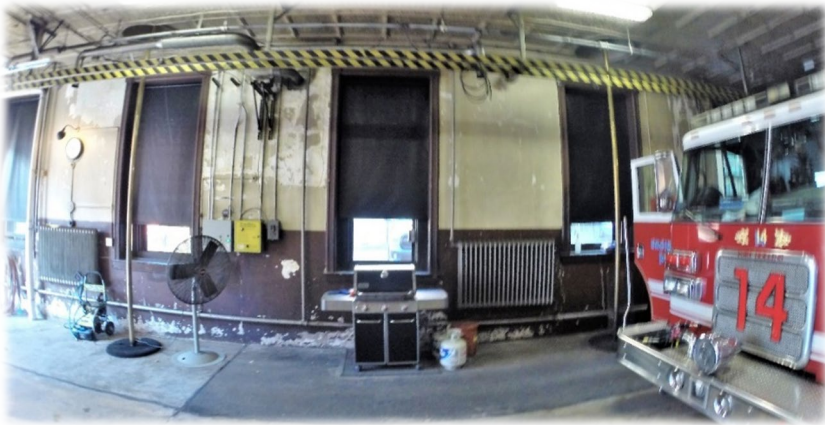
BBQ is in bay; no patio space near kitchen

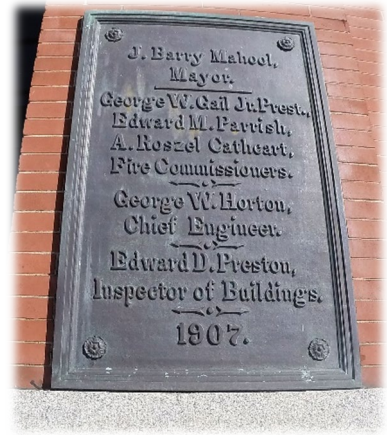
Station 30 is an ornate, historic, red brick firehouse. This station features stone accents in the masonry with arched windows and bay doors. It lacks a fire sprinkler system as well as a fire alarm system. HVAC, plumbing, and electrical systems could be updated.

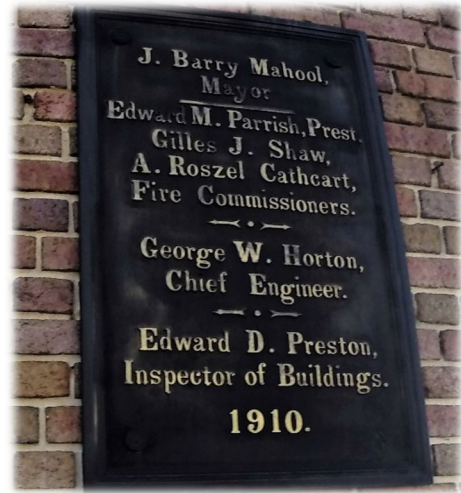
Station 36 is a historic, red brick firehouse. This station was once the training academy site. It lacks a fire sprinkler system as well as a fire alarm system. HVAC, plumbing, and electrical systems could be updated.

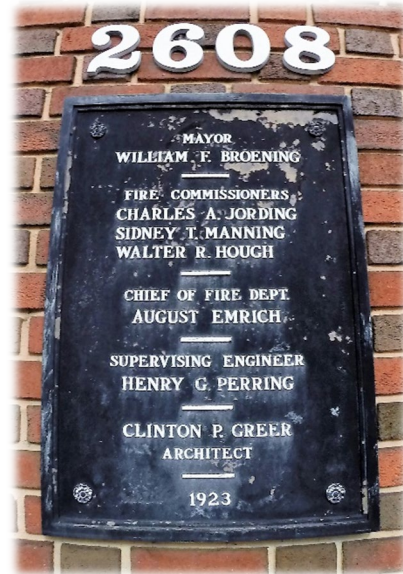
Station 47 is a historic, red brick firehouse. This station features stone masonry core with arched bay door and frames the windows above. It lacks a fire sprinkler system as well as a fire alarm system. HVAC, plumbing, and electrical systems could be updated.

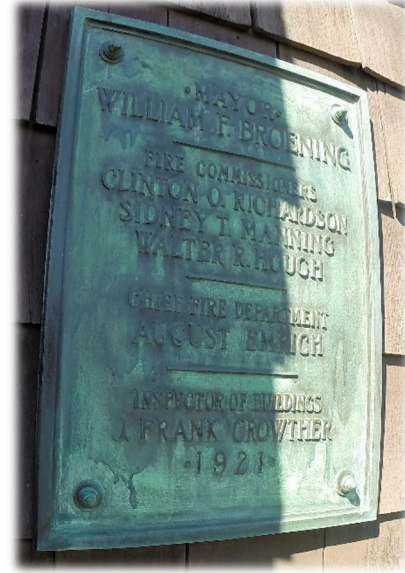
Station 53 is a historic, cedar shingle and stucco firehouse. This station features stone masonry core with arched bay door and frames the windows above. It lacks a fire sprinkler system as well as a fire alarm system. HVAC, plumbing, and electrical systems could be updated.

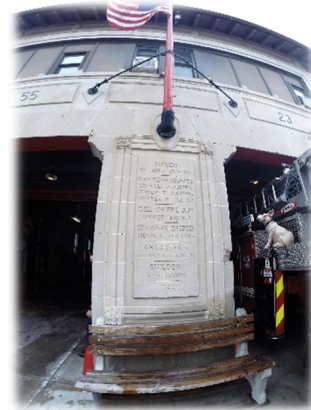
Station 55 is another historic, red brick firehouse. This station features stone masonry that included the engraved dedication plaque. It lacks a fire sprinkler system as well as a fire alarm system. HVAC, plumbing, and electrical systems could be updated.

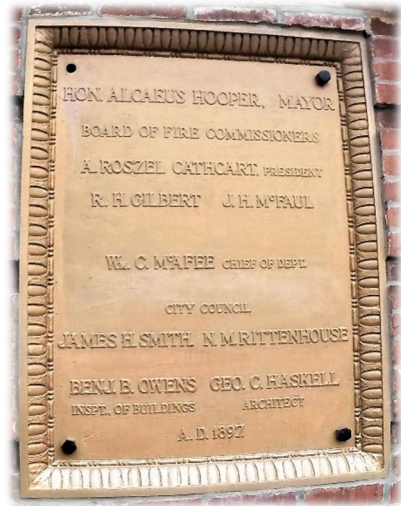
Station 21 is an ornate, historic, red brick firehouse. It lacks a fire sprinkler system as well as a fire alarm system. HVAC, plumbing, and electrical systems could be updated.

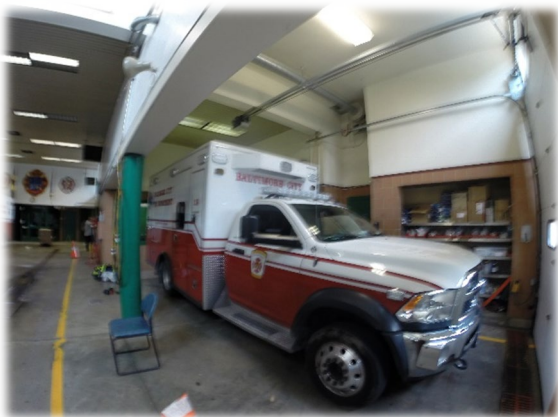
Medic unit in small bay on right side

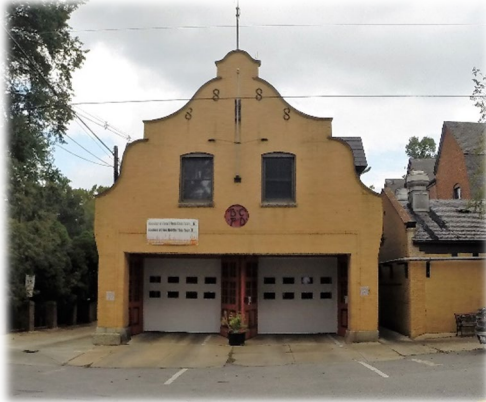
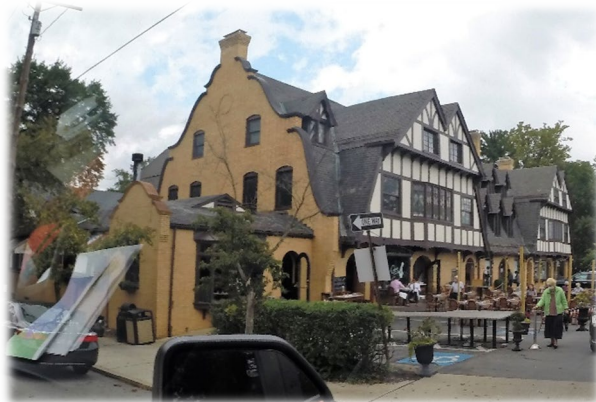
Station 44 is a historic, brick firehouse. Its design influenced the adjacent German-themed buildings. It lacks a fire sprinkler system as well as a fire alarm system. HVAC, plumbing, and electrical systems could be updated.

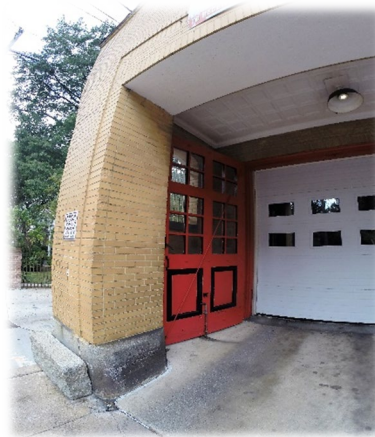
Original folding doors intact

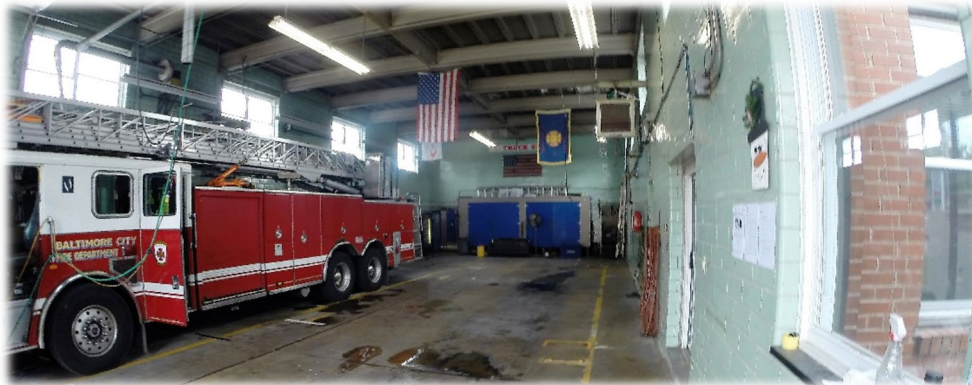
Front of bays looking towards the back

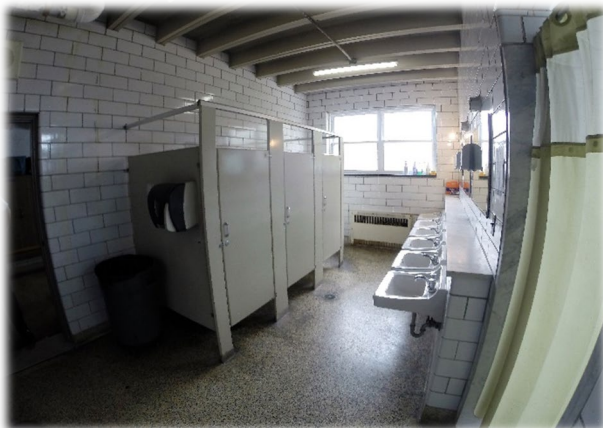
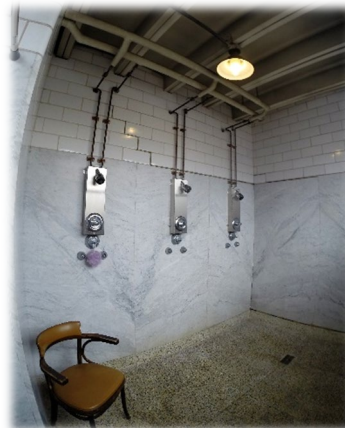
Restrooms and showers are also accessed directly from dorms and apparatus bays

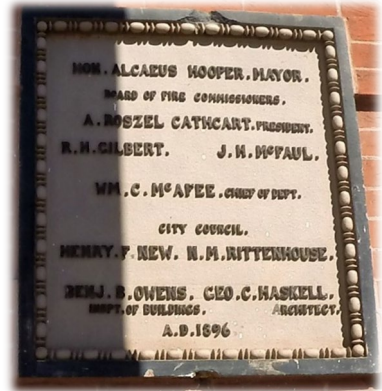
Station 20 is a historic, red brick firehouse. It lacks a fire sprinkler system as well as a fire alarm system. HVAC, plumbing, and electrical systems could be updated.

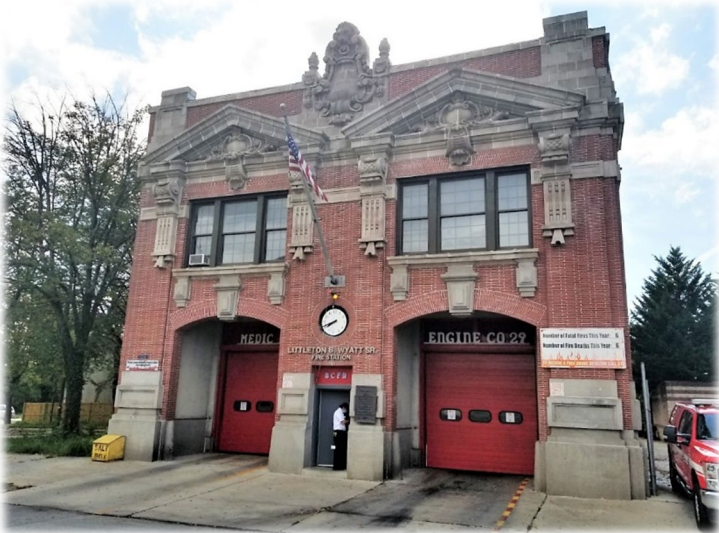
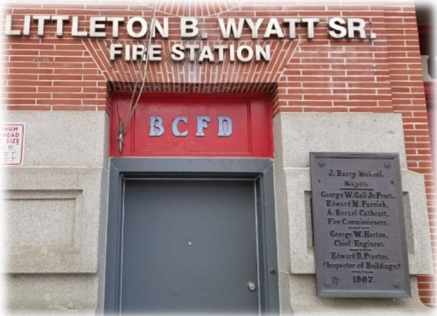
Station 29 is an ornate, historic, red brick firehouse. This station features incredible stone masonry that is highly detailed. It lacks a fire sprinkler system as well as a fire alarm system. HVAC, plumbing, and electrical systems could be updated.

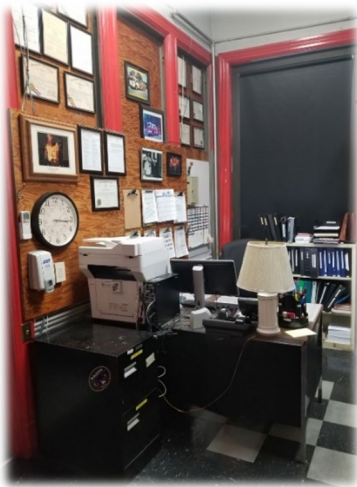
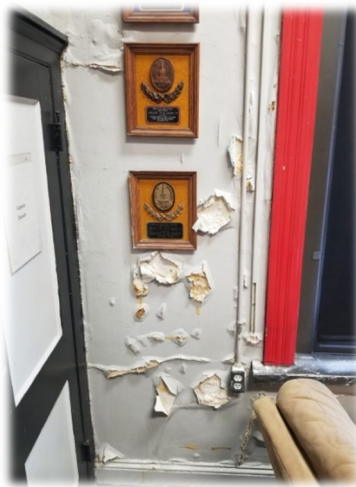
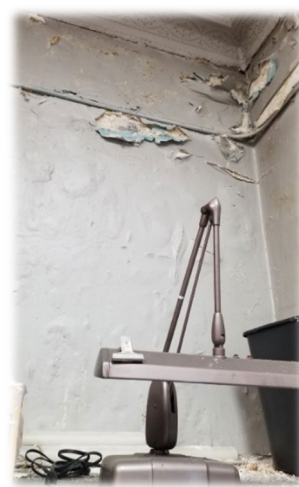
2nd floor bunk room and pole holes

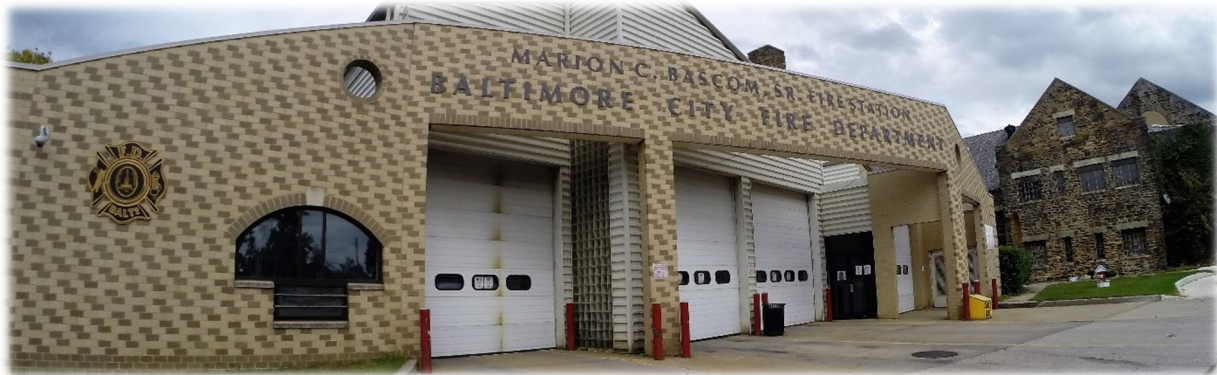
Station 40 is BCFD's 3rd newest station. It should be considered for renovations so that it can meet current NFPA and ADA requirements. It lacks a complete fire sprinkler system as well as a fire alarm system. HVAC, plumbing, and electrical systems could be updated.

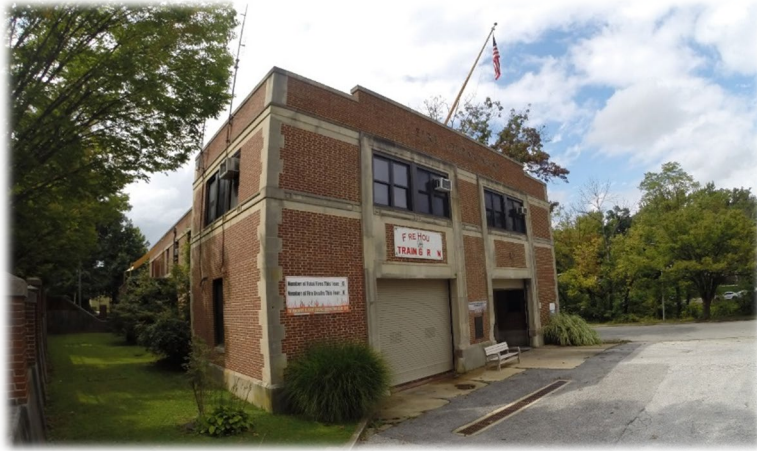
It lacks a fire sprinkler system as well as a fire alarm system. HVAC, plumbing, and electrical systems could be updated. One obvious structural condition was noted (below).

Water line leaked causing moisture to rust rebar reinforcing in slab and beam. Rust caused metal to swell spalling concrete surrounding rebar. Vehicle traffic above caused vibration in slab and beam causing additional cracking and spalling to the point of beam failure.

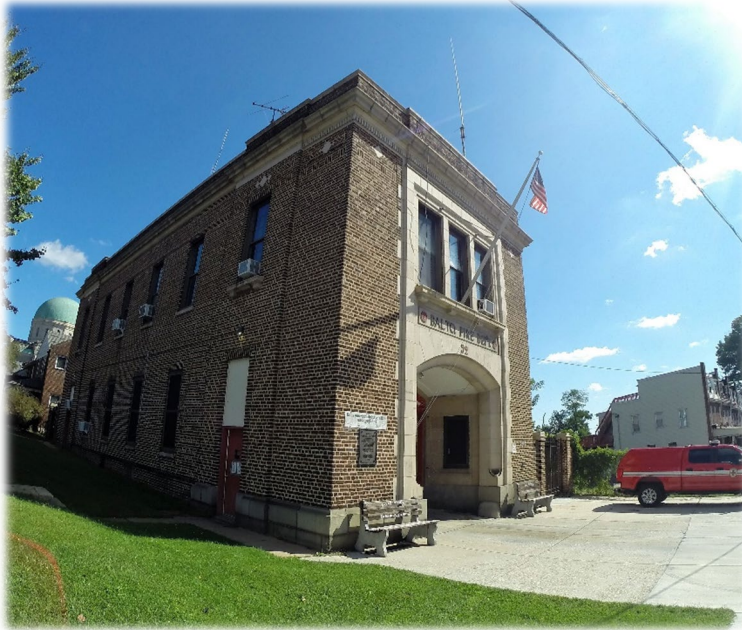
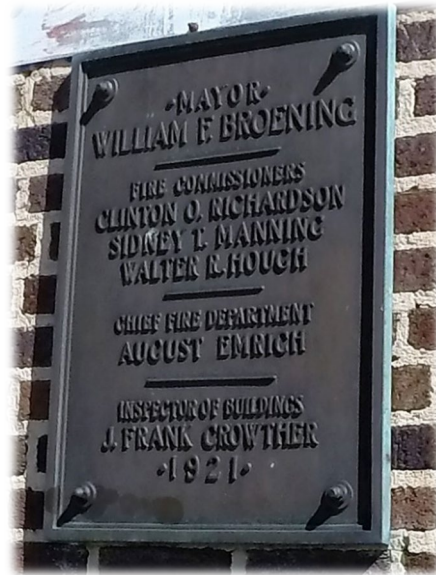
Station 52 opened in 1921; it is a 2 story station with a single apparatus bay.

Station 52 is a historic, red brick firehouse. This station features stone masonry core with arched bay door and frames the windows above. It lacks a fire sprinkler system as well as a fire alarm system. HVAC, plumbing, and electrical systems could be updated.

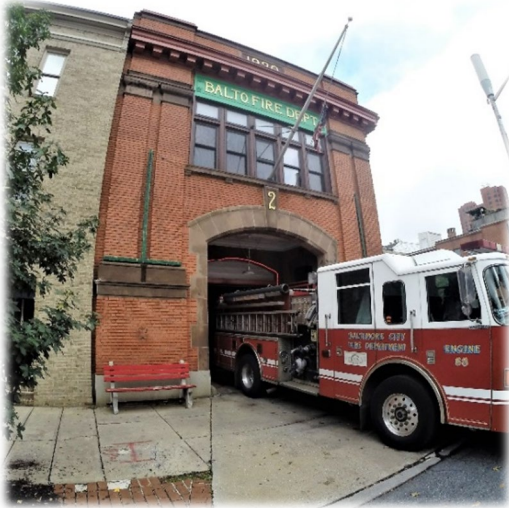
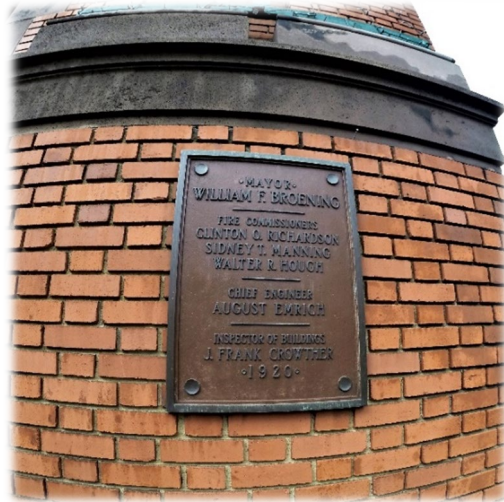
Station 2 opened in 1920; it is a 2 story station with 1 apparatus bay.

Station 2 is a beautiful example of a historic, red brick firehouse. It lacks a fire sprinkler system as well as a fire alarm system. HVAC, plumbing, and electrical systems could be updated.

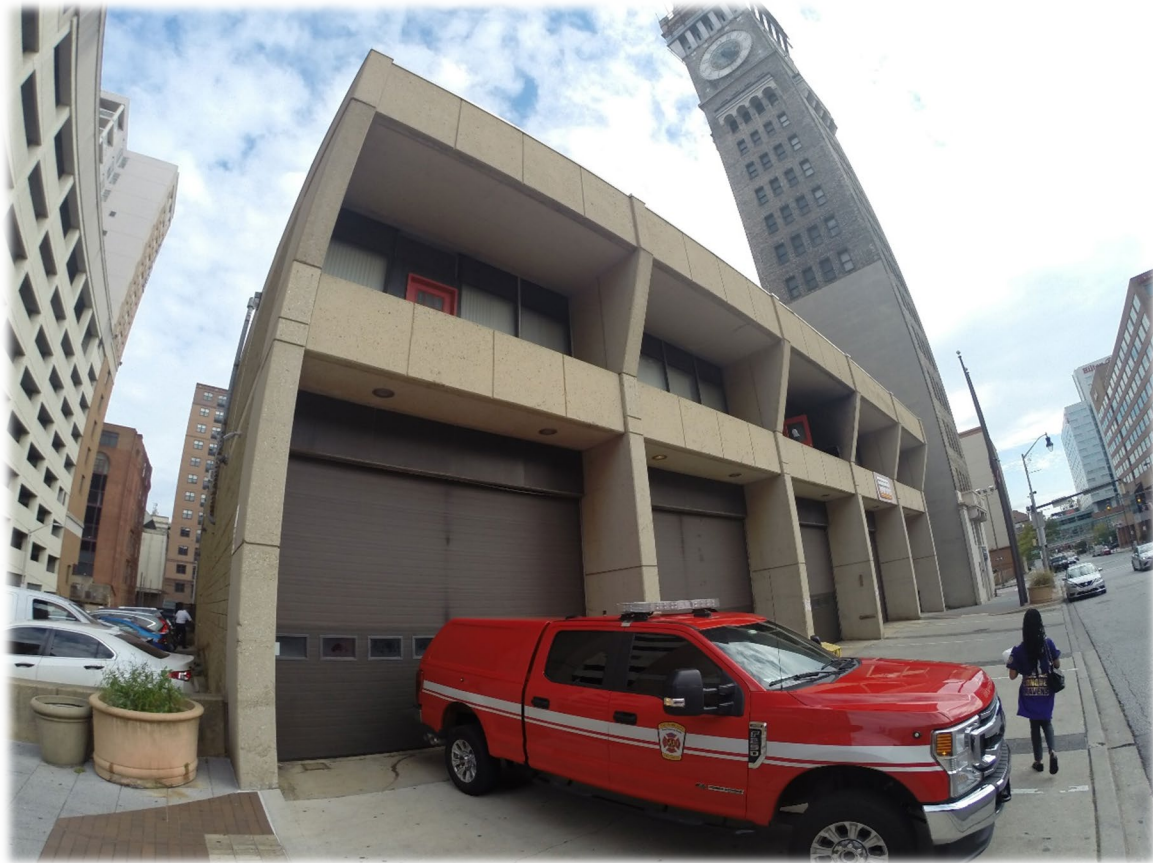
Station 23 is a very large downtown station on the corner with the historic Bromo Seltzer Tower. The entire ground floor is all apparatus bays and some support spaces with turnout storage, air compressor, and utility closets. There is also a watch room and public restroom at the front main entrance. All the station living spaces and offices are on the 2nd floor. It lacks a fire sprinkler system as well as a fire alarm system. HVAC, plumbing, and electrical systems could be updated. Staff parking is also a challenge at this facility.

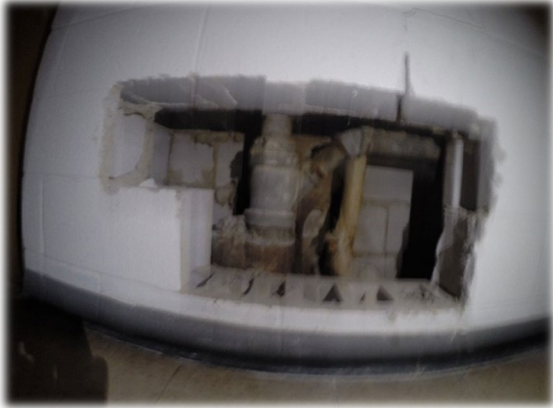
Unfinished repairs to plumbing and electrical

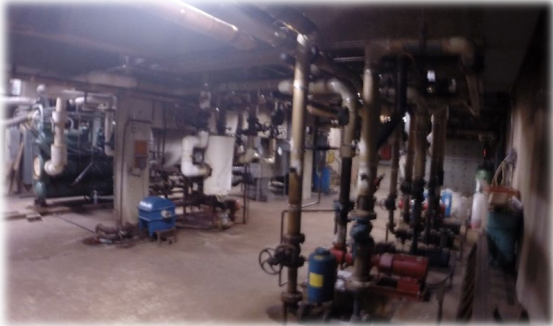
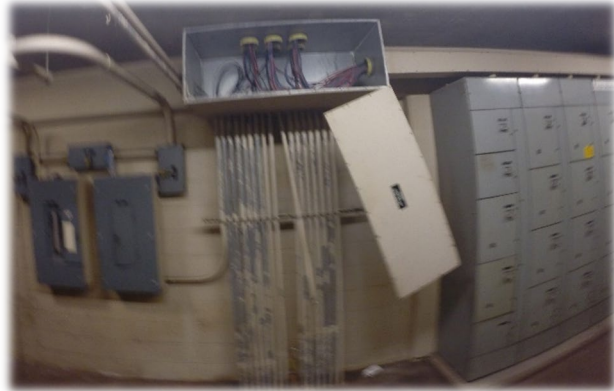
Main utility equipment and primary electrical service in basement

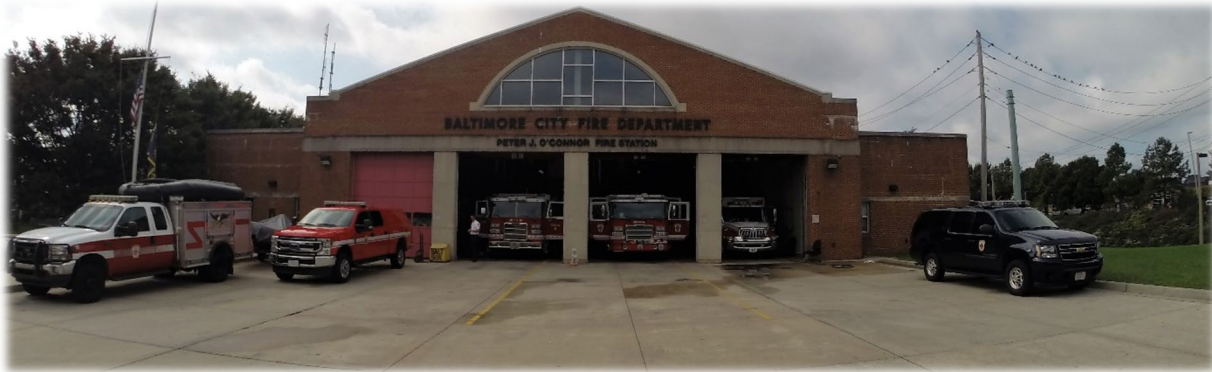
Station 26 is BCFD's newest station. It lacks a fire sprinkler system as well as a fire alarm system. HVAC, plumbing, and electrical systems could be updated.

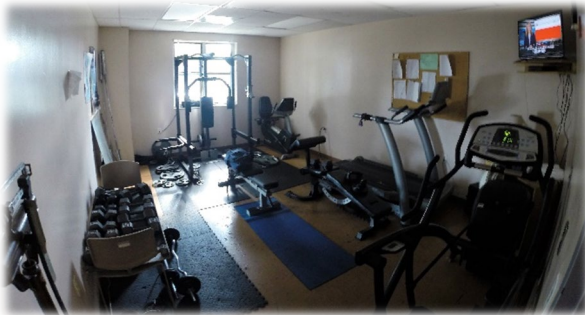
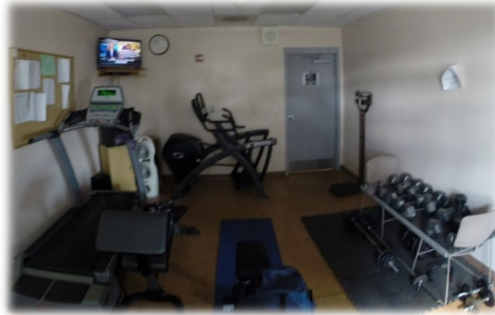
Weight room

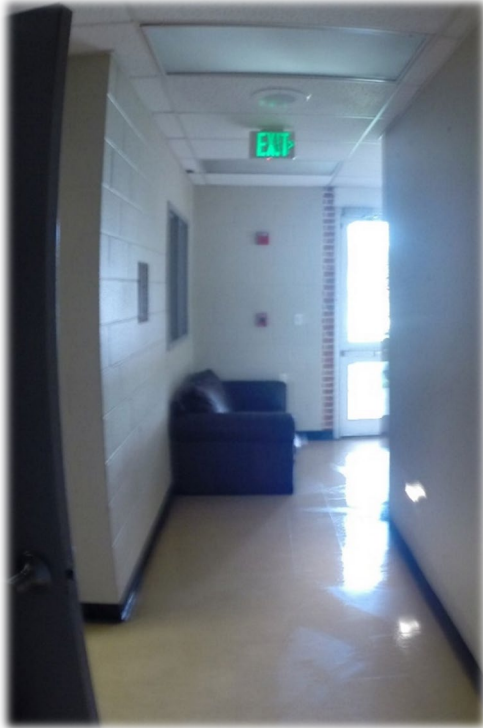
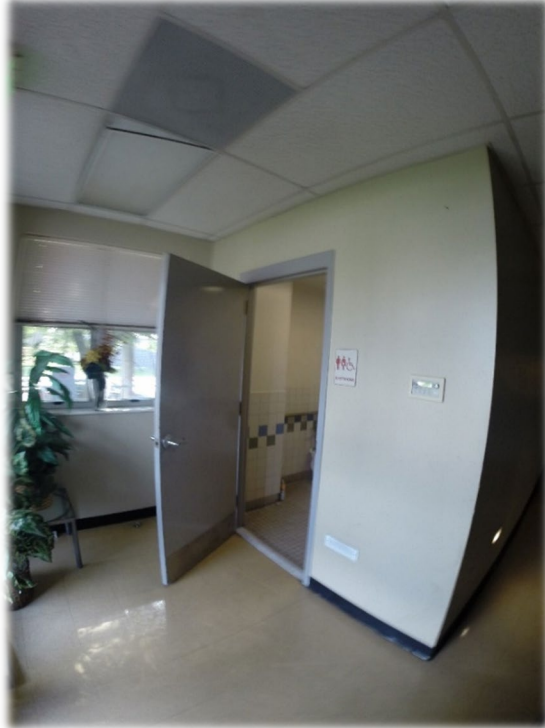
Hallway access open to front public entrance Public restroom in front entrance lobby

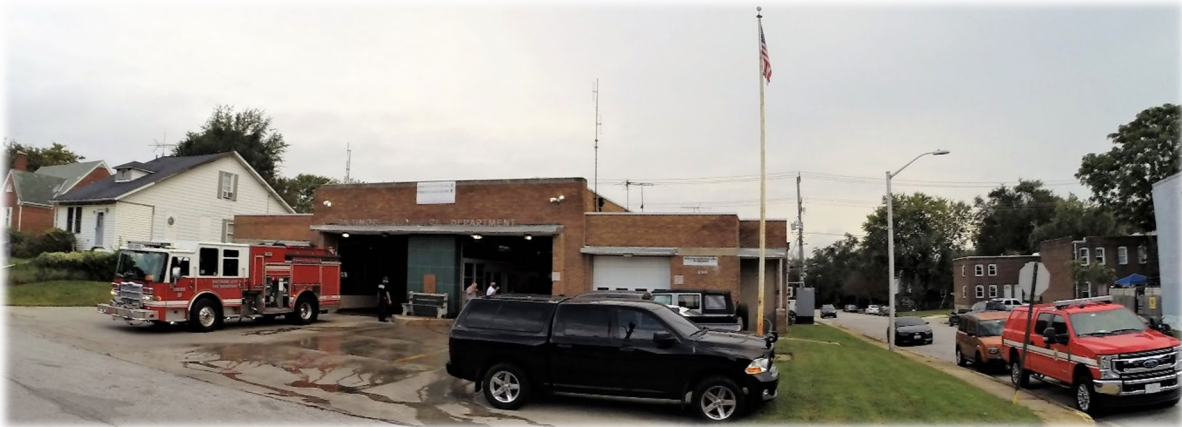
The two middle bays are “pull-through” and the station quarters flank the two middle bays, behind the two side bays. It lacks a fire sprinkler system as well as a fire alarm system. HVAC, plumbing, and electrical systems could be updated.
