OPERATIONAL & MANAGEMENT ASSESSMENT BALTIMORE CITY FIRE DEPARTMENT

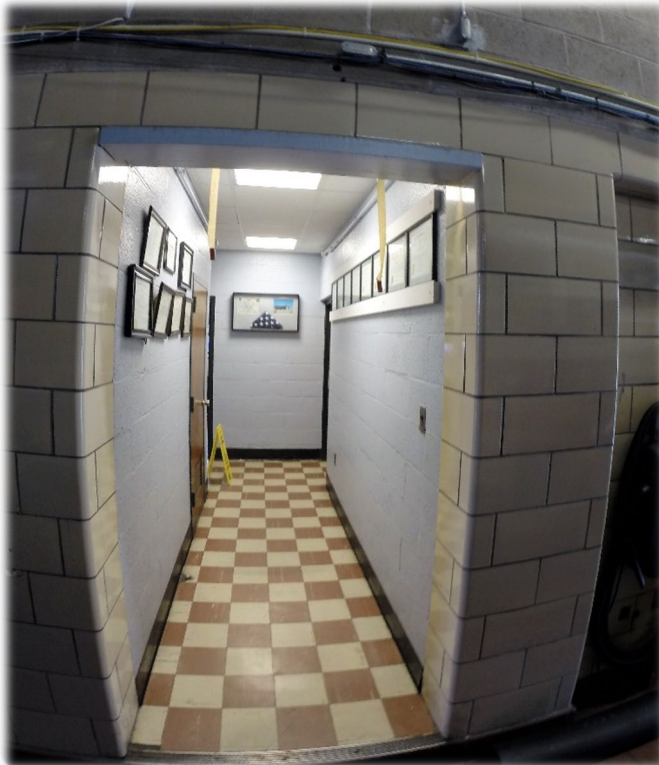
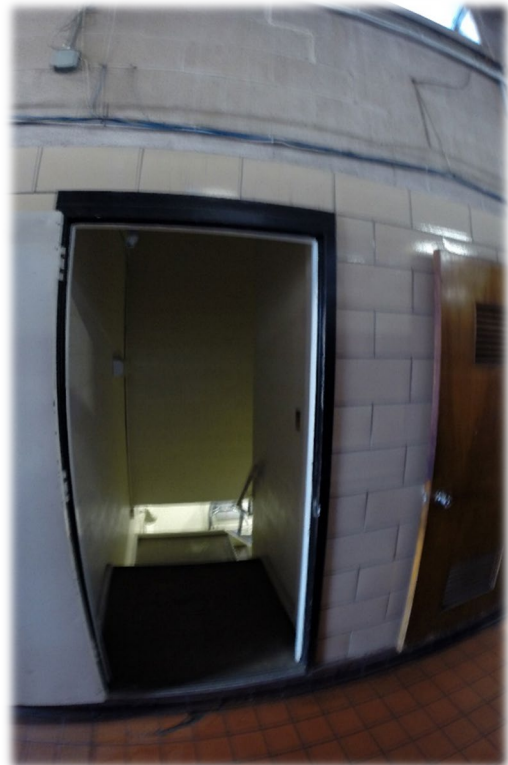
All spaces are accessed directly from bays without doors or seals

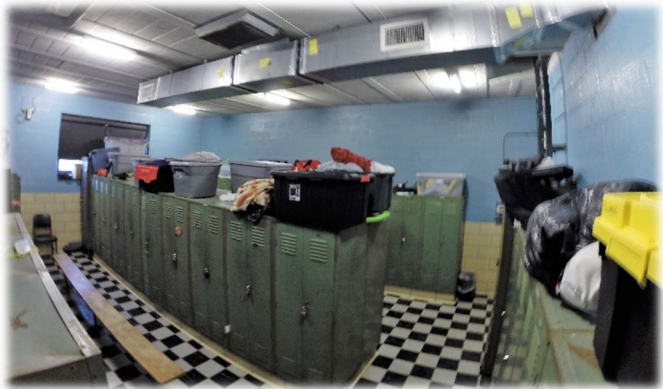
Staff lockers are adjacent restroom & bays

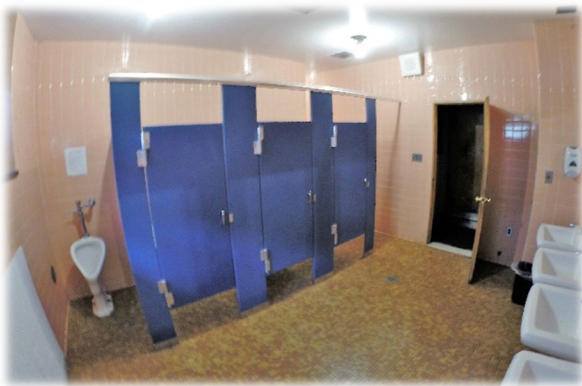
Restrooms and showers are also accessed directly from dorms and apparatus bays

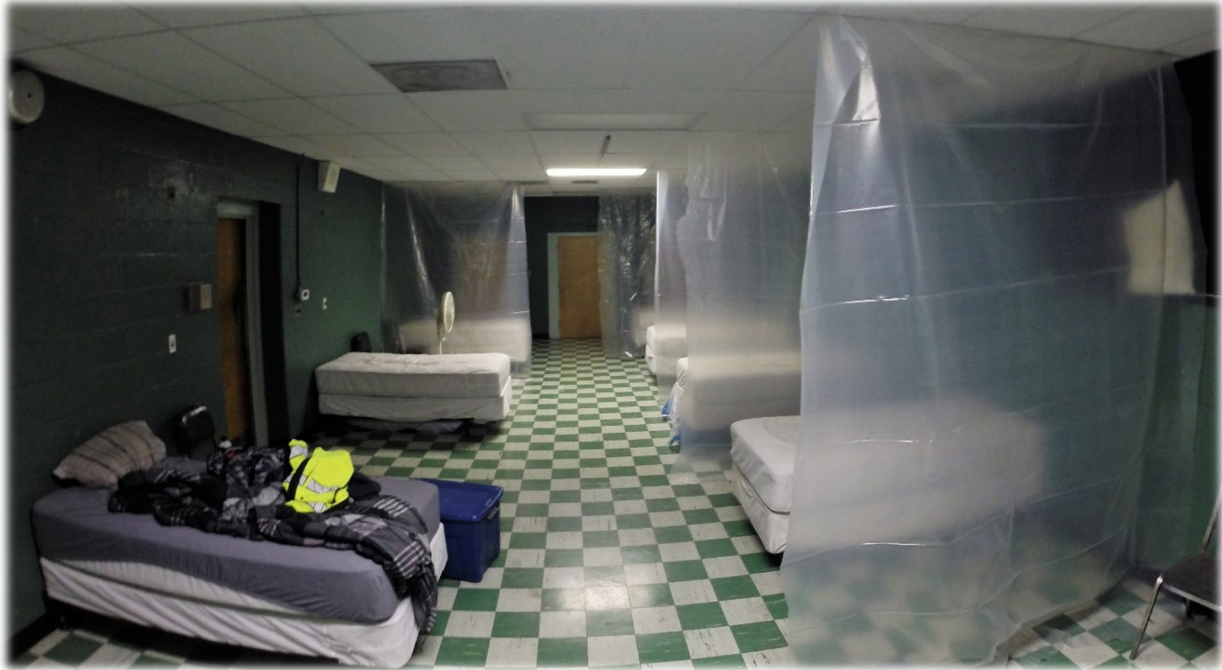
Dorms are located right off the apparatus bay, the door in the back corner leads to the restrooms/showers.

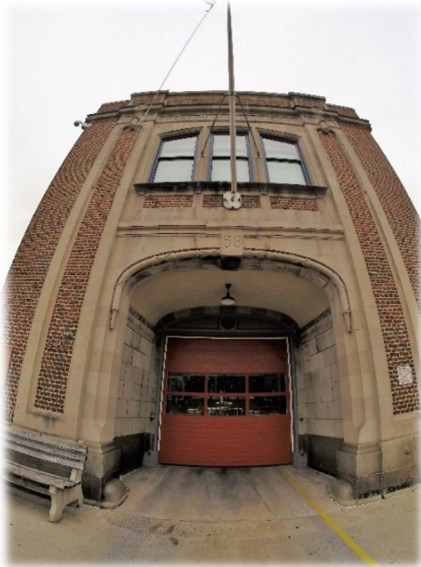
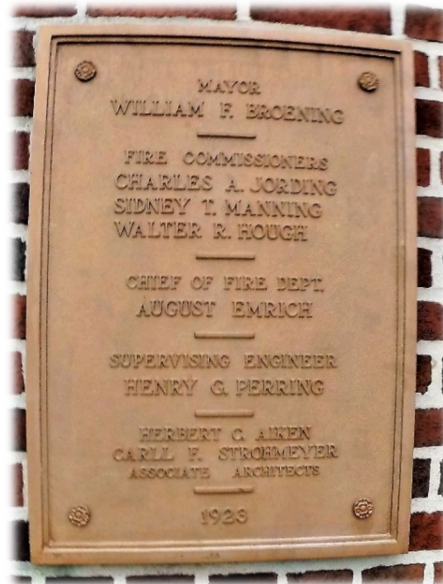
BCFD Fire Station 58 opened in 1923; it is a 2 story station with 1 apparatus bay.

Station 58 is a beautiful example of a historic, red brick firehouse. The BCFD has had a complete renovation of the entire interior of the station, on both floors. This renovation has injected new life into this very old station keeping it a viable part of the neighborhood. It lacks a fire sprinkler system as well as a fire alarm system. HVAC, plumbing, and electrical systems could be updated. However, the renovation has extended its useful life well into the future.

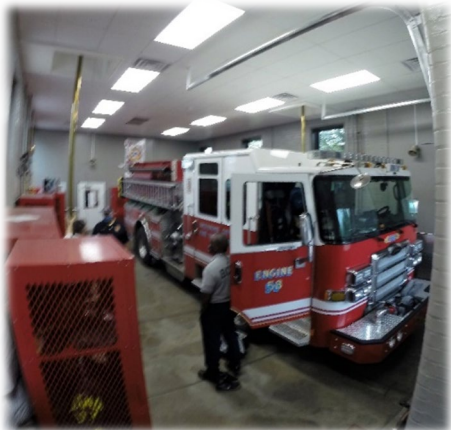
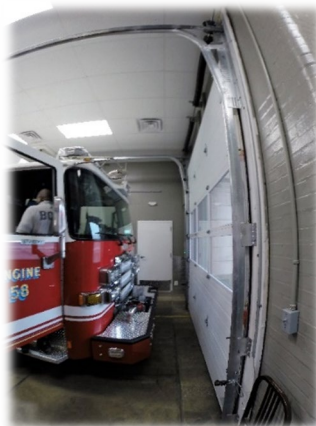
The apparatus bay has had all lead paint remediated, been freshly painted and had a suspended ceiling and ventilation system installed.

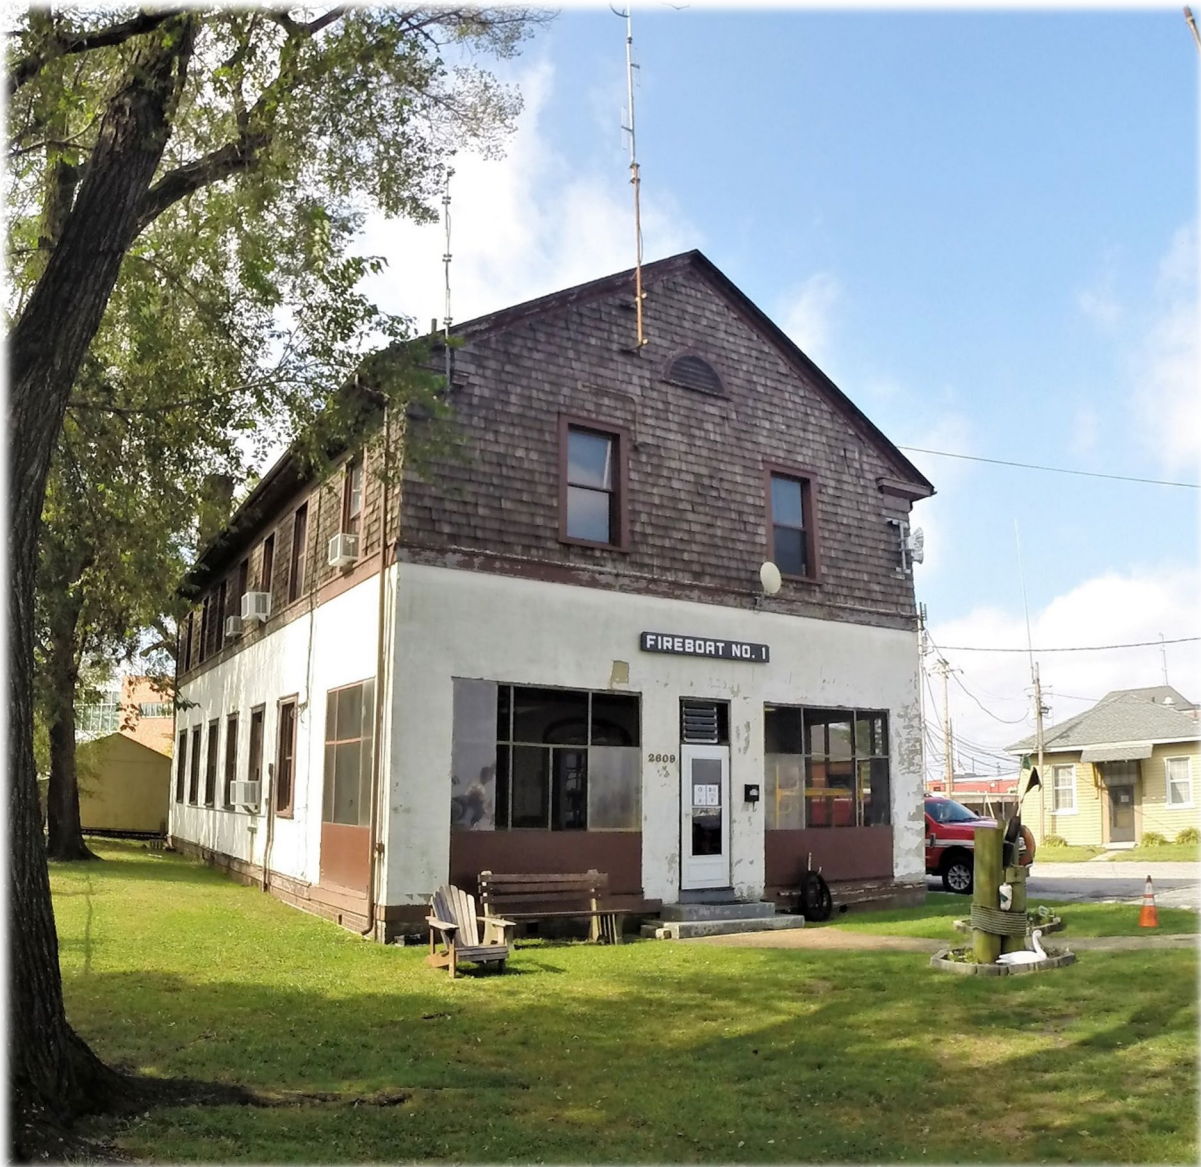
The BCFD Boat House was built in 1937 on historic Fort McHenry and is used as a base for Fire Boat 1.

It lacks a fire sprinkler system as well as a fire alarm system. HVAC, plumbing, and electrical systems could be updated.

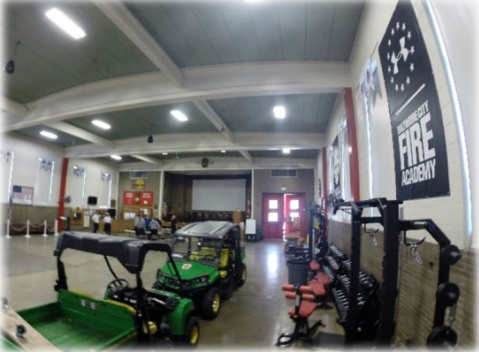
Auditorium looking south

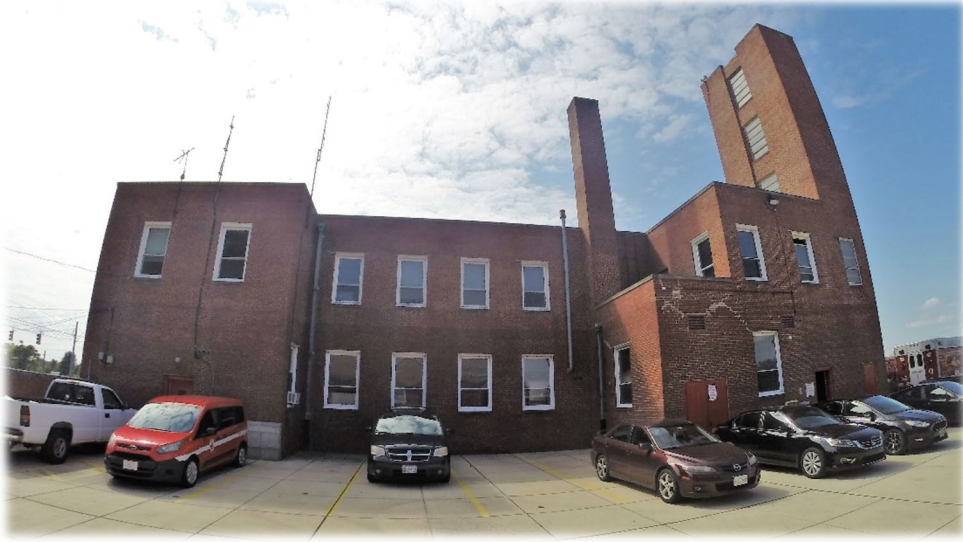
Main parking area for staff between buildings

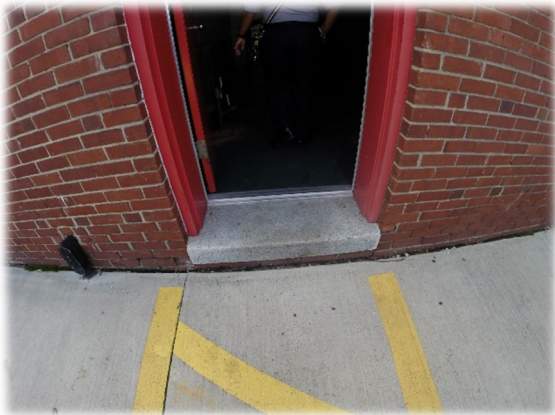
Door sill

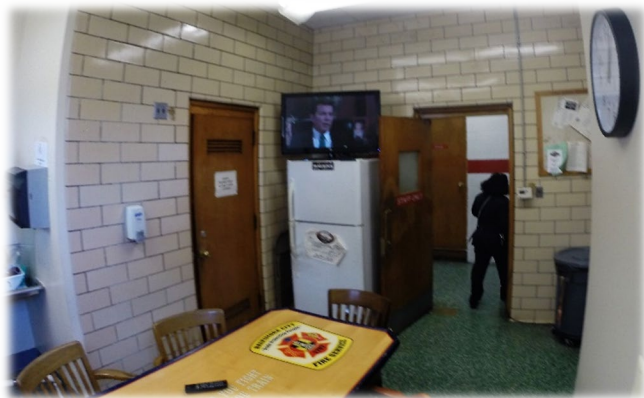
Dining area

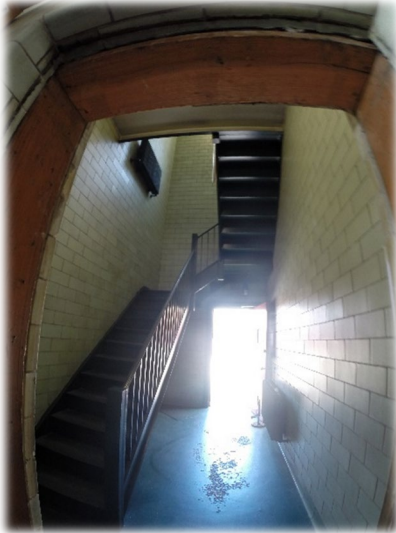
Staircase

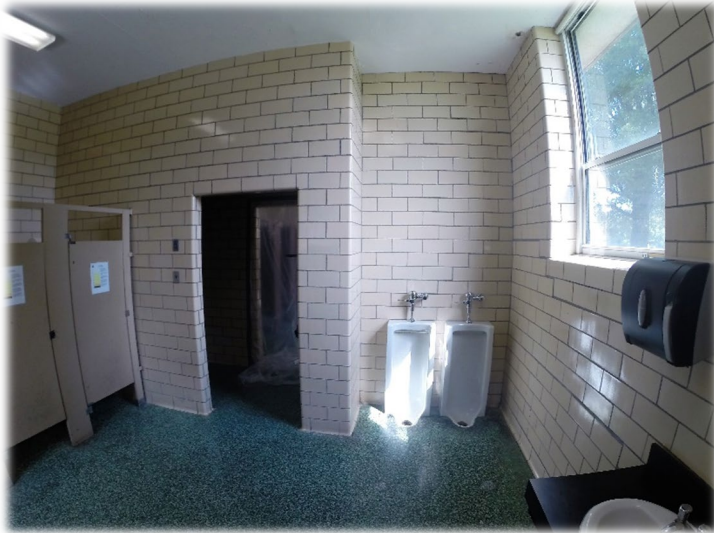
Restroom in auditorium building

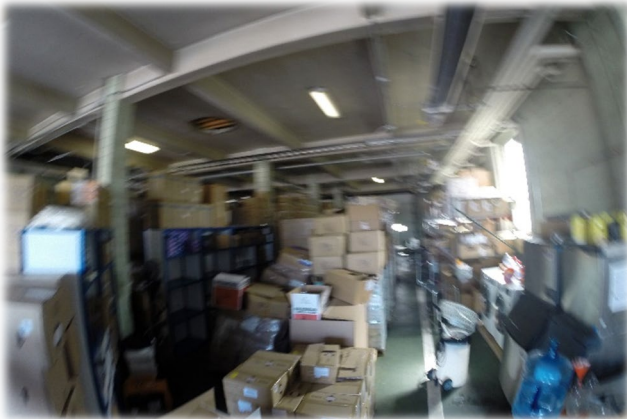
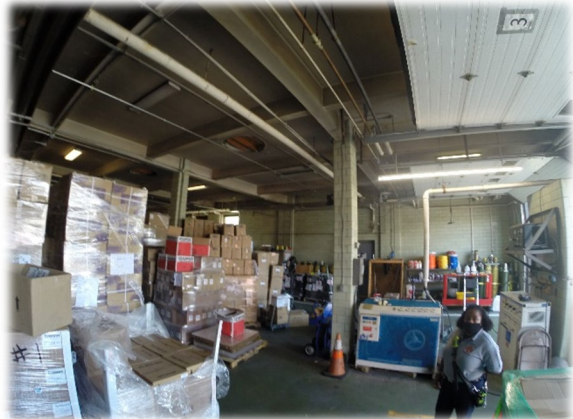
Bays are used for storage

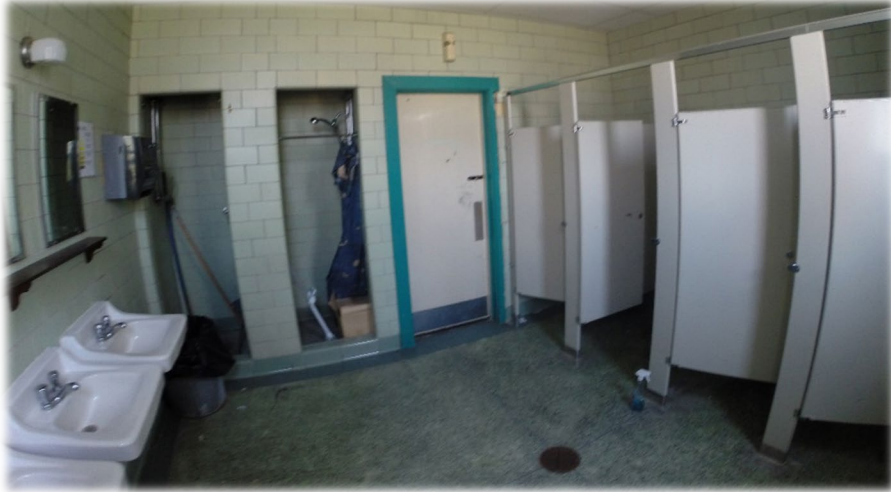
Restroom

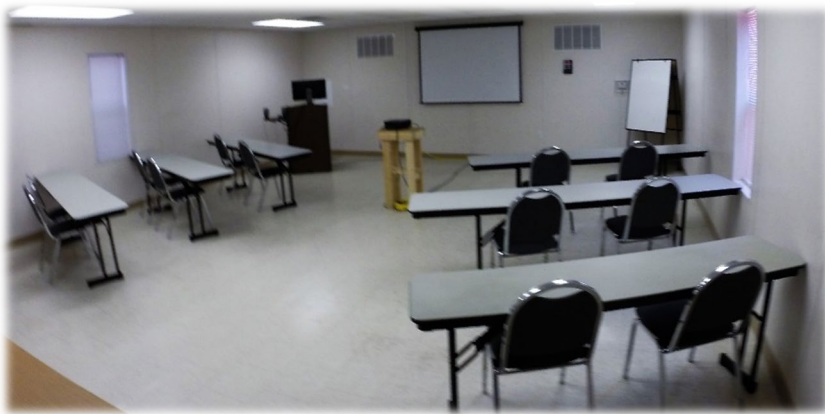
Classroom

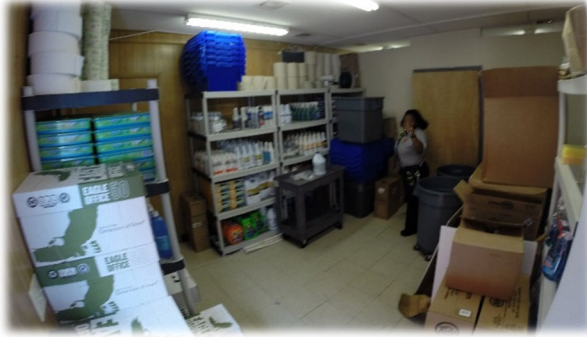
Storage

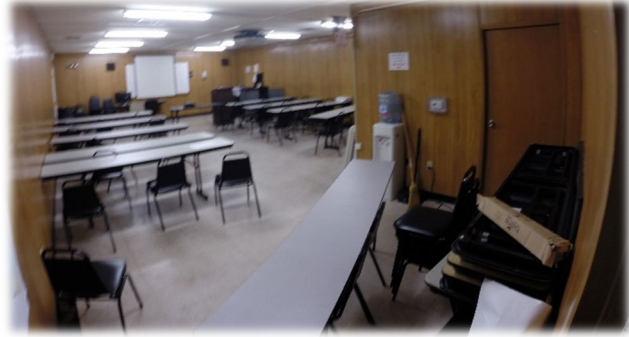
Classroom

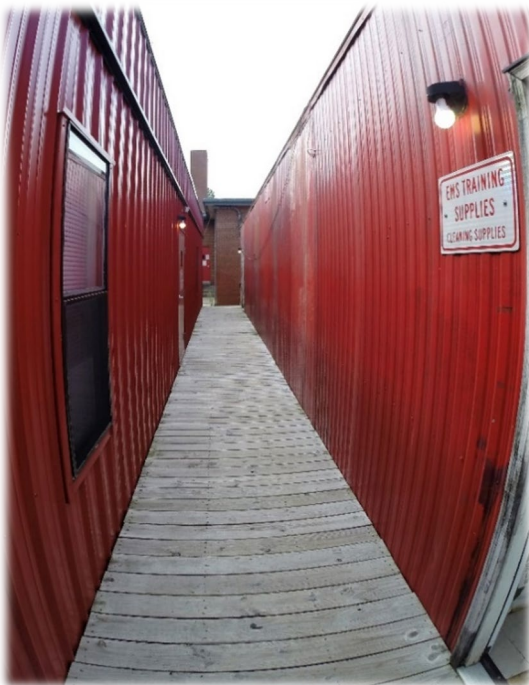
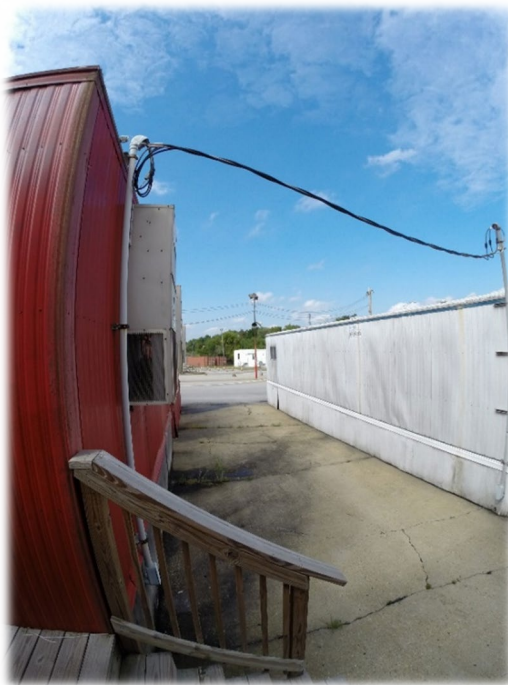
Space between modular buildings

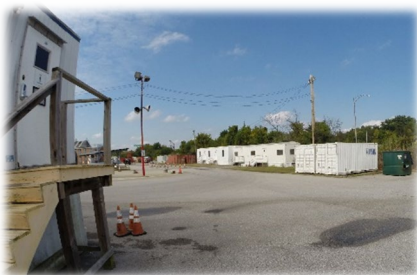
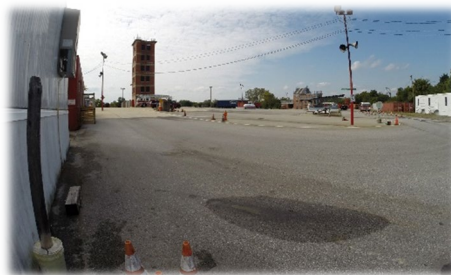
Additional modular and storage containers along north side of property

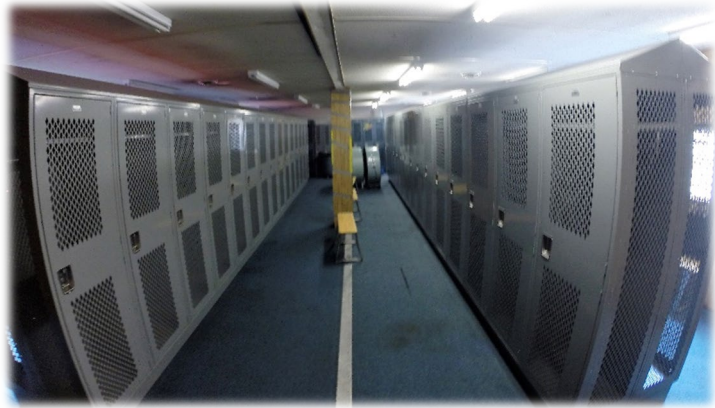
Recruit lockers

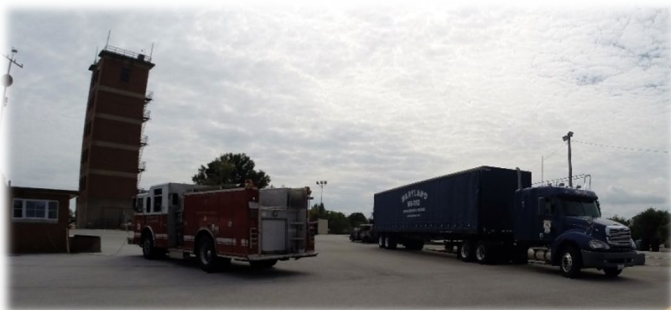
Burn tower in middle of drill field

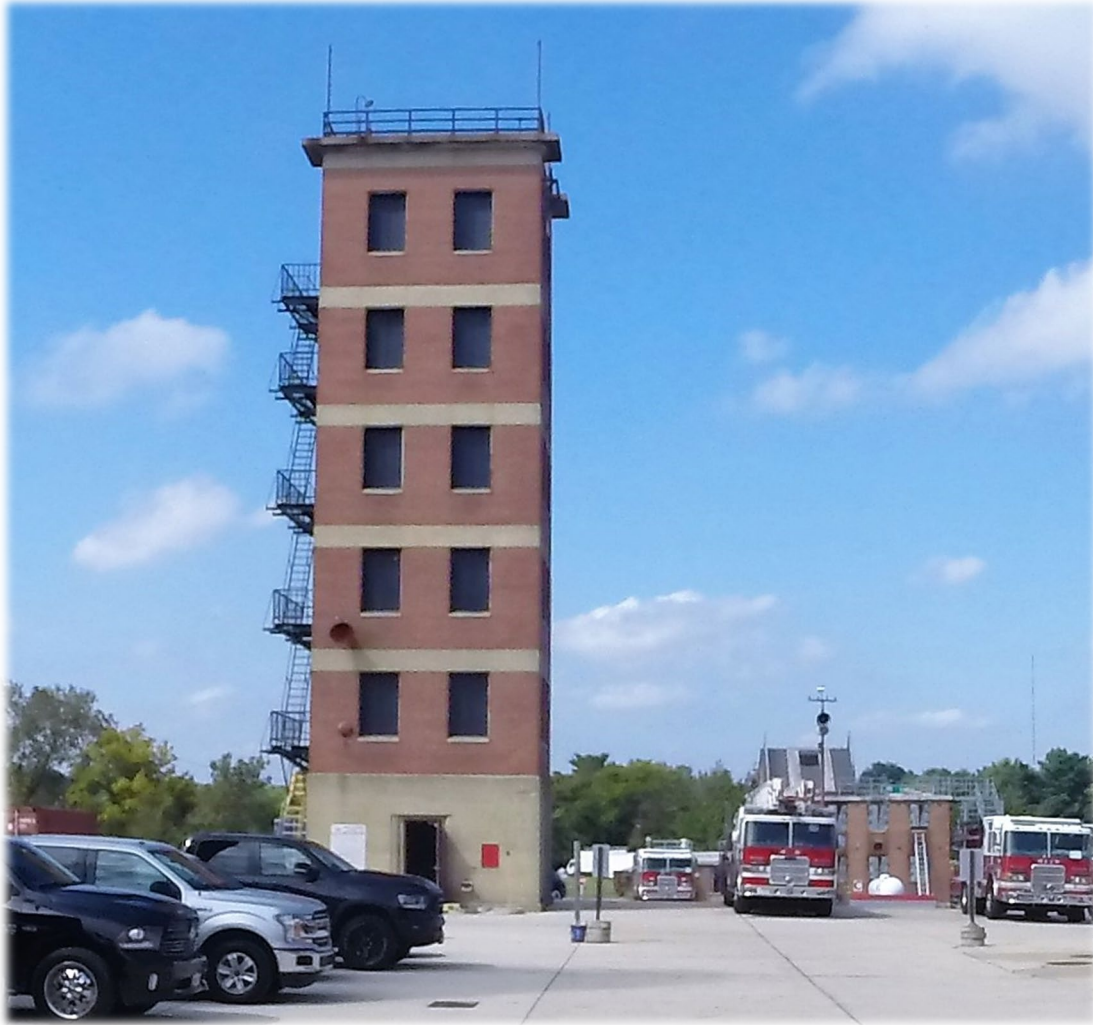
Burn tower
