### Home Inspection Report

8883 Sam Snead Hwy, Hot Springs, VA 24445

Thursday March 2, 2023

16-03-2023

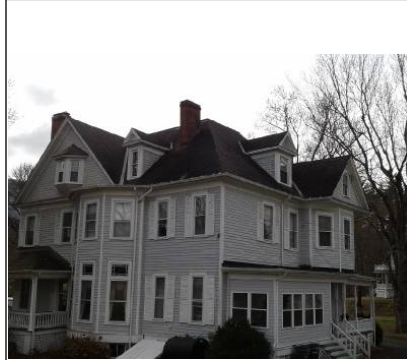
Missing shingles and moisture damage at roof and turret

- Missing/loose roof asphalt shingles. Missing damaged slate shingles. Recommend repair to reduce risk of moisture damage.
- Moisture damage to soffits and fascia. Recommend repair to reduce risk of moisture damage.

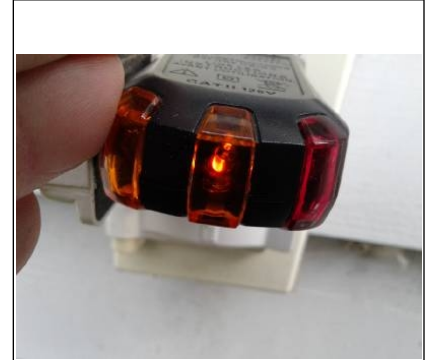
Open ground and not GFCI protected

- Exterior receptacle open ground and not GFCI protected. Receptacle not secured. Recommend repair
  - Kitchen and bathroom recepticals not GFCI protected. Recommend installing.

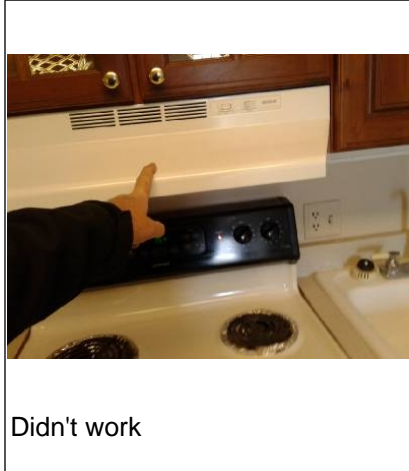
Didn't work

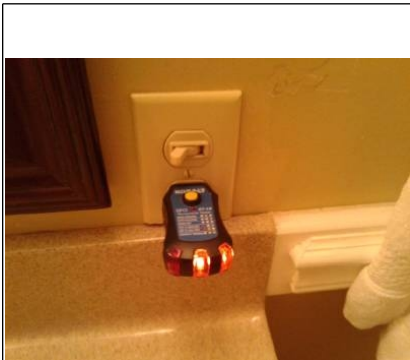
Not GFCI protected receptacle

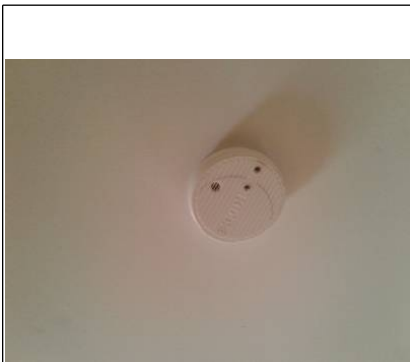
Didn't work when tested

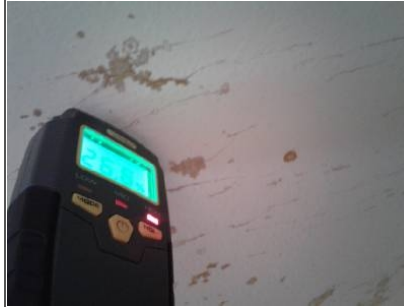
High moisture reading taken indicating active leak

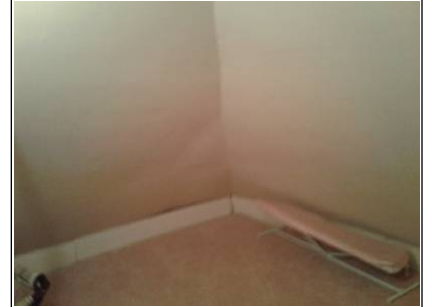
Moisture damage

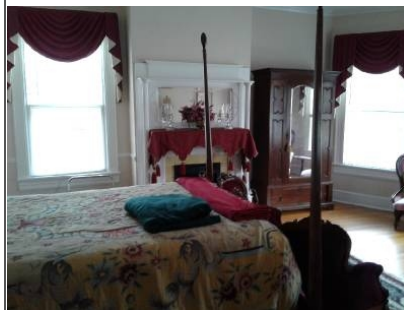
Patched ceiling

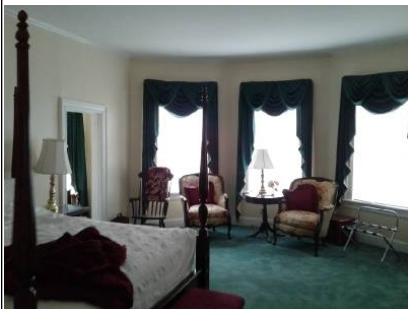
Moisture stains on ceilings

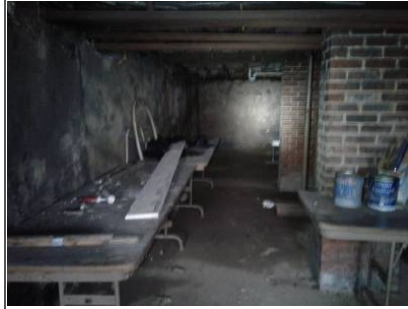
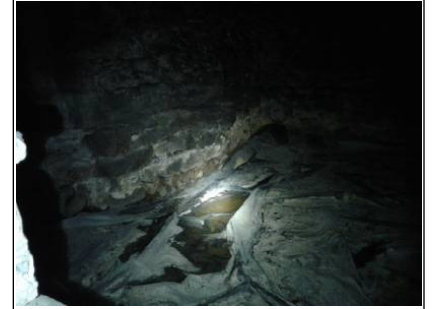
Standing water

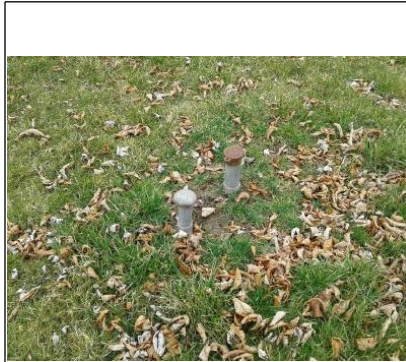
In ground fuel tank.

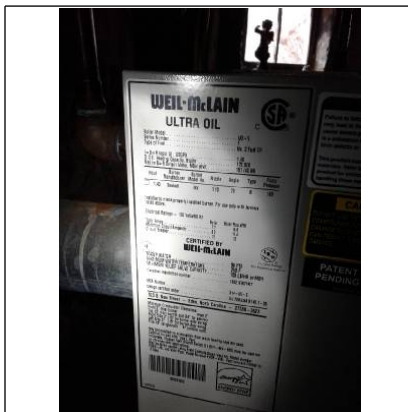
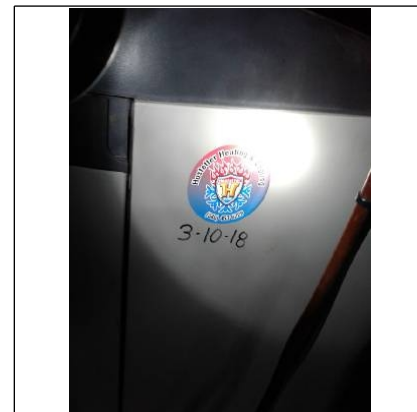
Expansion tank not supported

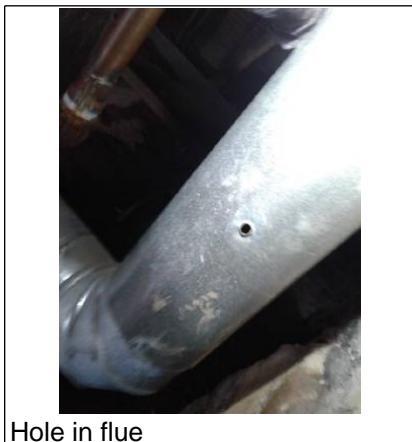
**Comments** Hole in boiling flue. Recommend repair

Hole in flue
