## PERFORMANCE ASSESSMENT REVIEW

<sup>3</sup>  
Delano Centre  
3024 West 4th Avenue, Vancouver, BC

**Project:** Delano Centre, 3023 West 4th Avenue, Vancouver

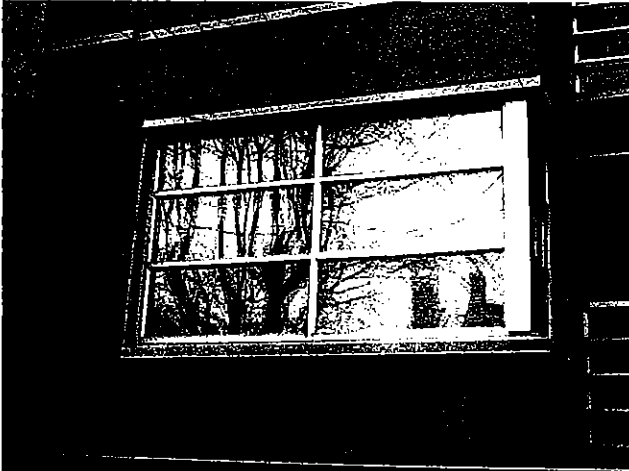
- 2.4 Windows** - See photos 1, 4, 5, 9, 11, 12, 12, 14, 18, 19, 24, 26, 27  
Windows were inspected from the exterior and from the interiors of Suites 409, 406 and 401. No signs of leaks, staining or damage from rain ingress or condensation were observed. Circular windows in exit stairs were also found to be free of leaks or condensation.

1. Typical window configuration
