**Cranor Inspection Services, LLC**

# Inspection Report

**8939 Cardiff Rd, Richmond, VA 23236**

Yr Blt:1987 Sq Ft: 3180

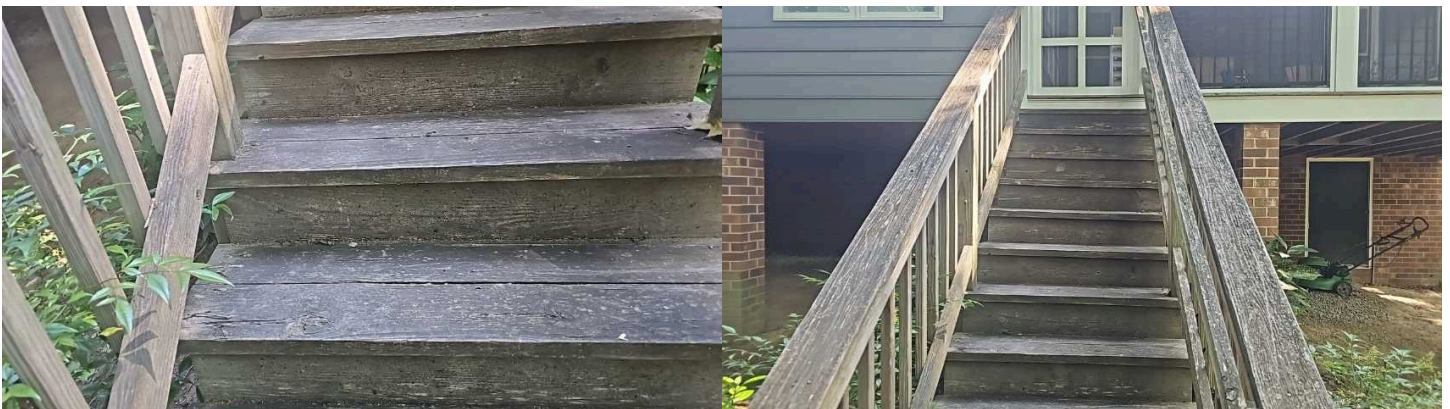
Weathered

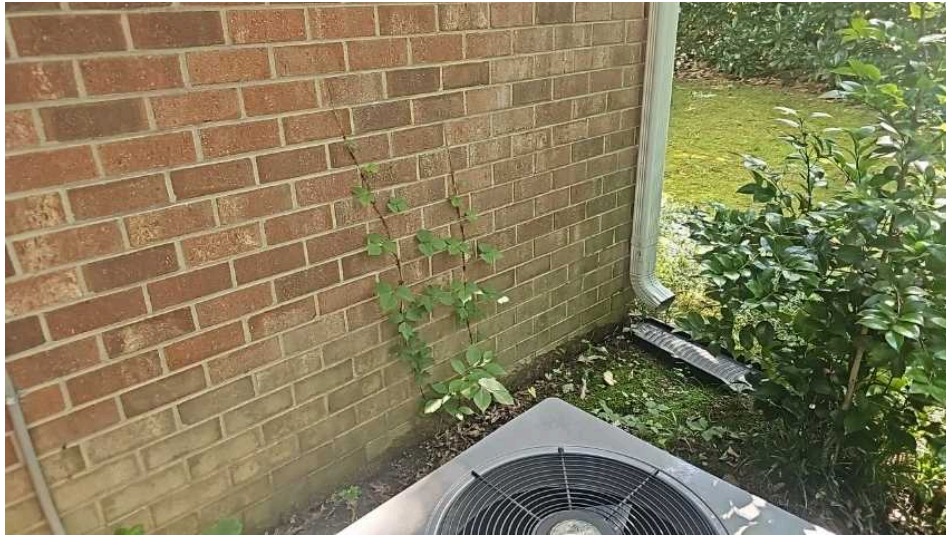
Page 17 Item: 13	Adjacent Vegetation	<b>13.1. Vegetation around the home is overgrown. There is Poison Ivy/ Poison Oak growing on home on rear left. There is thick vine growth in rear yard. Recommend trimming back / removing as necessary.</b>

Poison Ivy / oak growing on rear left

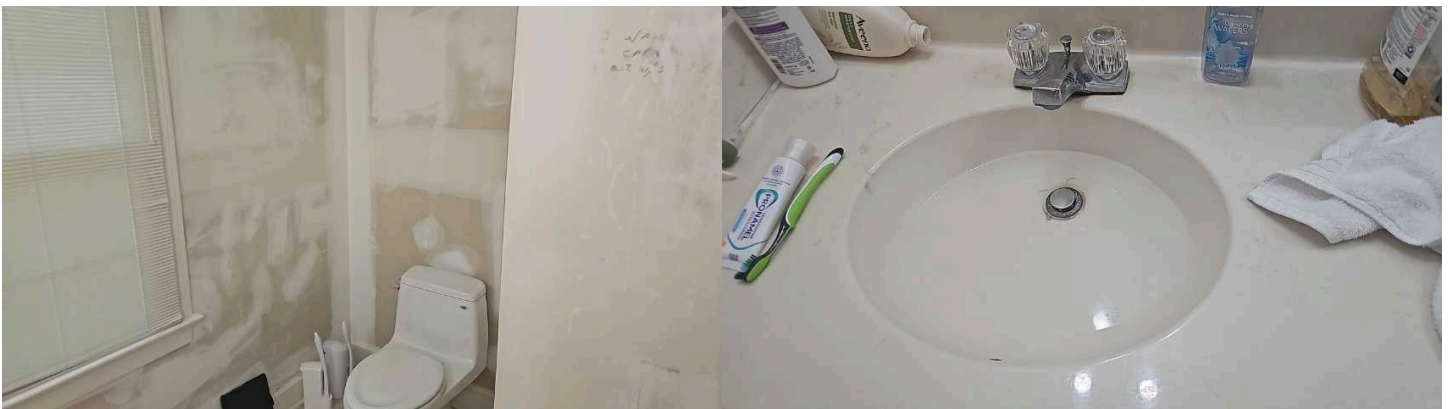
Left sink slow drain

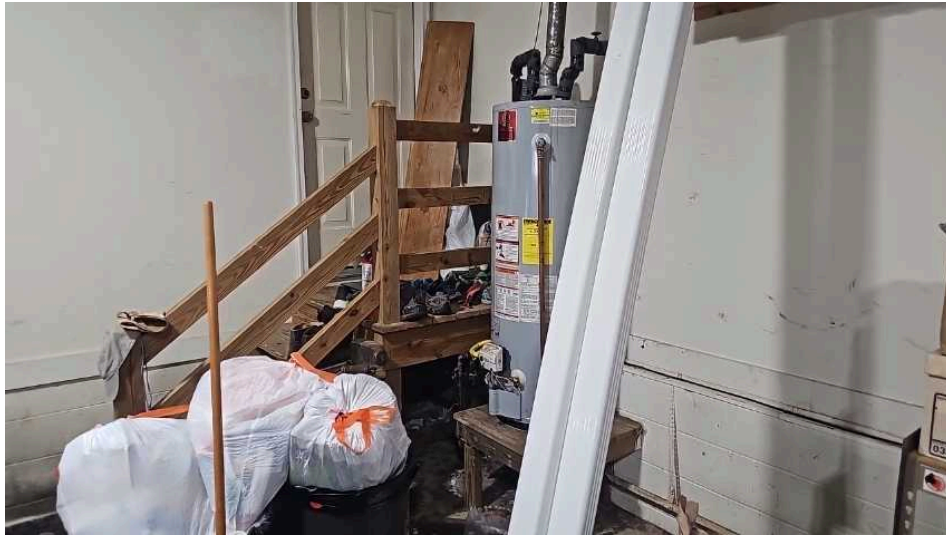
<i>Water Heater</i>		
Page 33 Item: 1	Water Heater	<p><b>1.3. The water heater located in the garage has no barrier to protect it from impact. The generally accepted construction practice as well as the gas company recommends that appliances in garages be protected from impact from automobiles.</b></p> <p><b>1.4. The metal flue vent sections serving the gas water heater are not secured together properly, there should 3 screws per joint. Recommend correction.</b></p>
<i>Attached Garage</i>		
Page 39 Item: 1	Garage Vehicle Door(s) & Openers	<b>1.1. The garage vehicle door opener photoelectric sensors that reverse the door are improperly installed too far off the floor which is unsafe. There is a serious risk of injury, particularly to children and pets, under this installation. The safety sensors should be installed within 4 to 6 six inches of the floor. Recommend having evaluated and corrected by a licensed garage door contractor.</b>

No impact barrier

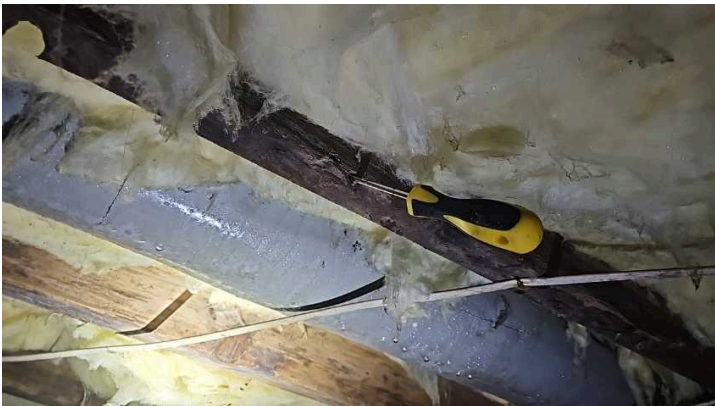
Page 44 Item: 3	Crawl Space Floor Structure	<b>3.1. The floor structure including the main support beam and joists have moisture related damage (rot). The floor structure is covered with a dark fungal like growth. Recommend having floor structure evaluated and repaired by a licensed contractor.</b>
Page 45 Item: 4	Crawl Space Ventilation, Moisture Control & Conditions	<b>4.1. The crawl space shows indications of chronic wet conditions and there is a visible surface discoloration or a suspected fungal like growth, such as mold or wood destroying fungi, on the floor structure. Fungal growth is the result of a water or high humidity problem. Addressing and alleviating the high humidity and wet conditions is critical in preventing the continuing development of the fungal growth. Fungal growth can result in deterioration of the floor structure, and in some cases affect indoor air quality. There is obvious damage on the wood floor structure. There are mushrooms growing in the crawl space. Recommend having evaluated and corrected as necessary by a qualified moisture control specialist.</b>

Black fungal like growth and rot on floor structure

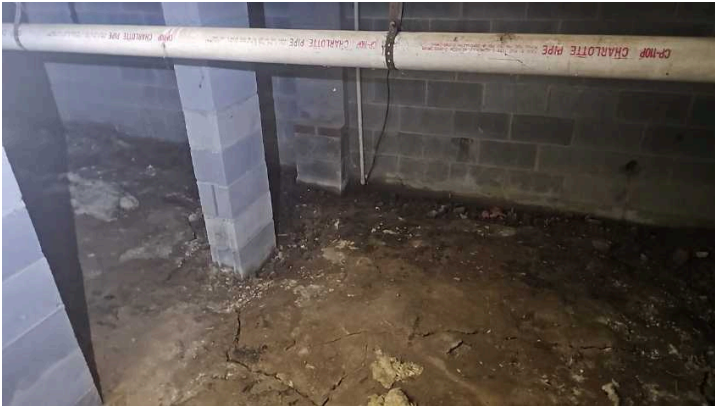
**4.1. The crawl space shows indications of chronic wet conditions and there is a visible surface discoloration or a suspected fungal like growth, such as mold or wood destroying fungi, on the floor structure. Fungal growth is the result of a water or high humidity problem. Addressing and alleviating the high humidity and wet conditions is critical in preventing the continuing development of the fungal growth. Fungal growth can result in deterioration of the floor structure, and in some cases affect indoor air quality. There is obvious damage on the wood floor structure. There are mushrooms growing in the crawl space. Recommend having evaluated and corrected as necessary by a qualified moisture control specialist.**

Wet
