INSPECTIONS FOR FALL HAZARDS AT BUILDING INTERIOR AND FACADE

Winter Hill Community Innovation School

3 October 2023

SGH Project 230889

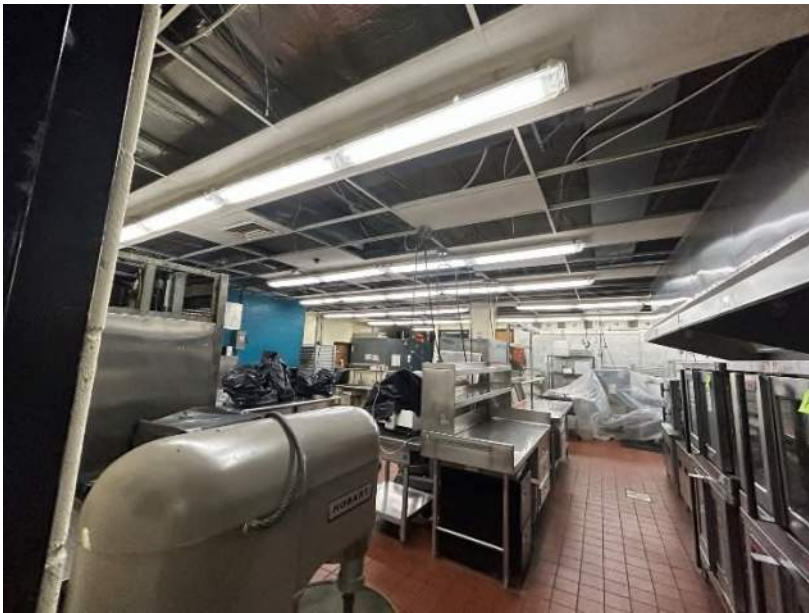
Photo 1

Overall view of a kitchen area after removal of ceiling tiles.

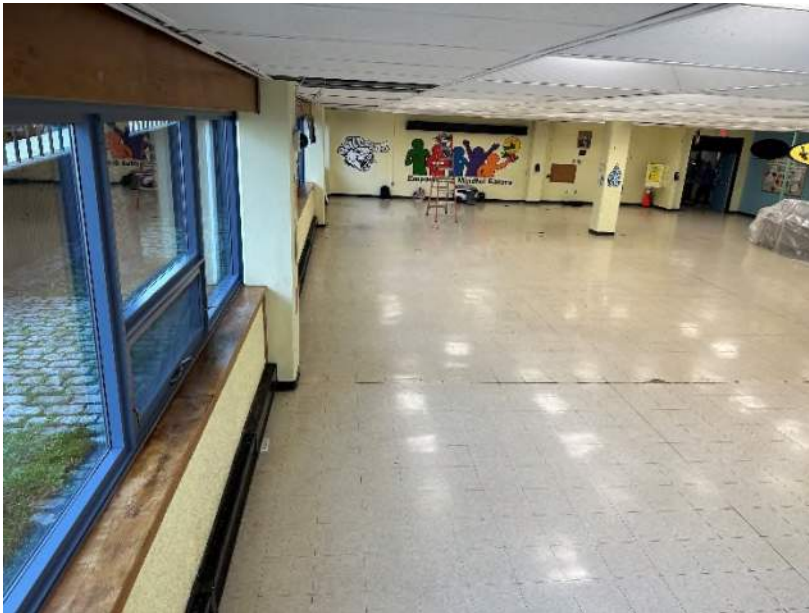
Photo 2

Overall view of a cafeteria area after removal of ceiling tiles.

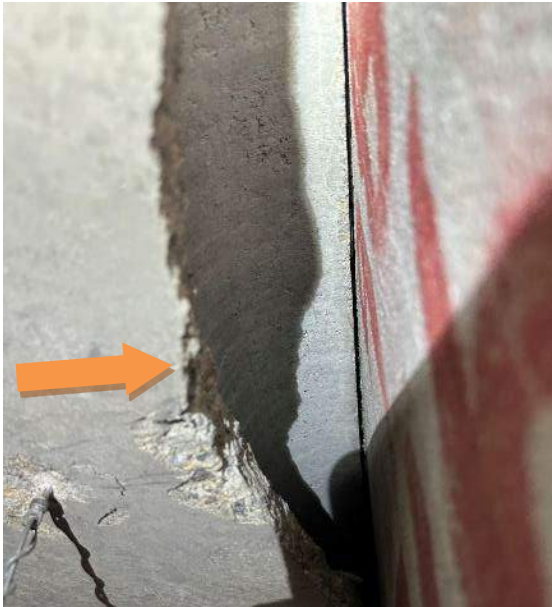
Photo 7

Existing spall at Stair 1 roof.

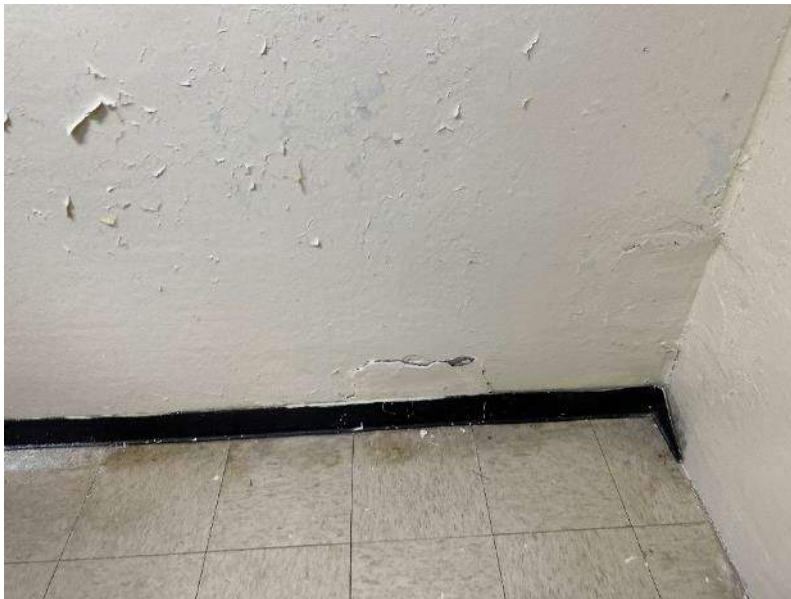
Photo 11

Peeling paint at Stair 3.

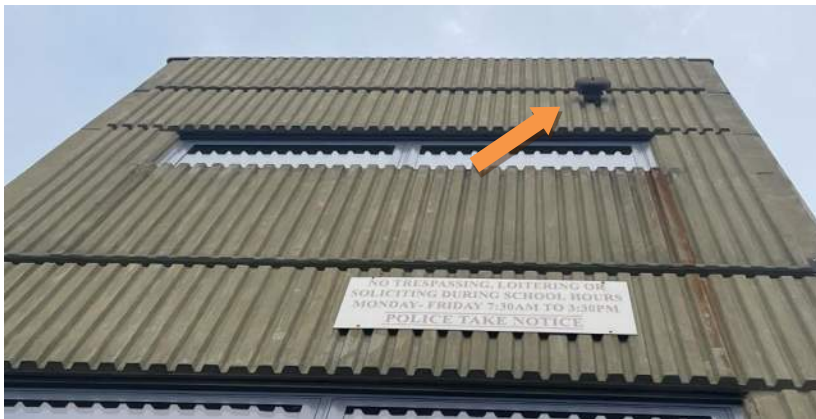
Photo 2

Potentially loose fixture at East facade.

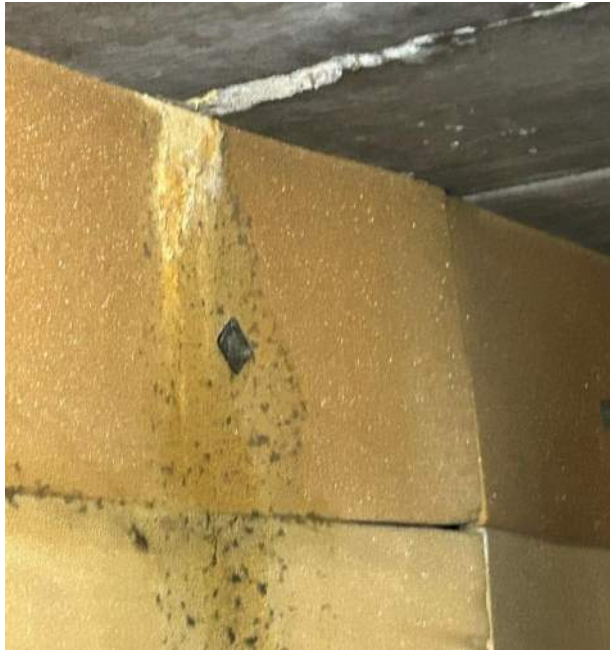
Photo 4

Mold along insulation at exterior wall.

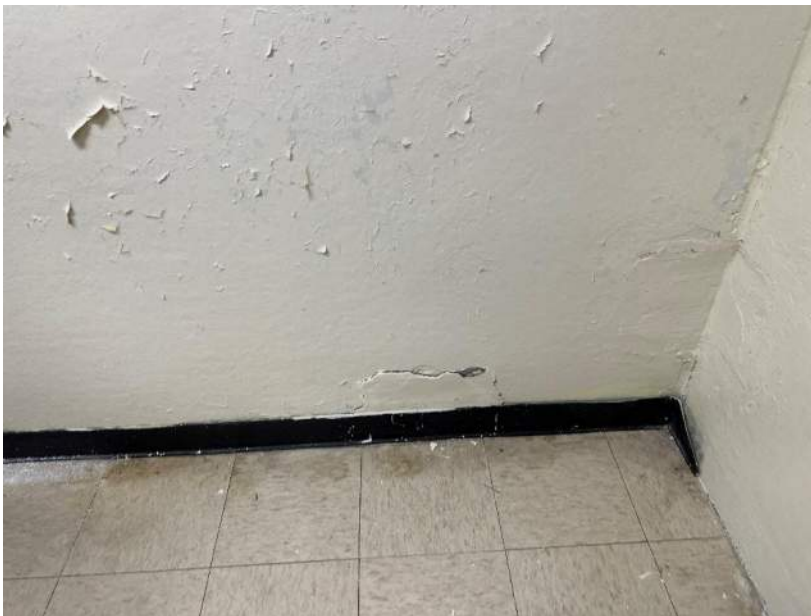
Photo 5

Peeling paint at Stair 3.

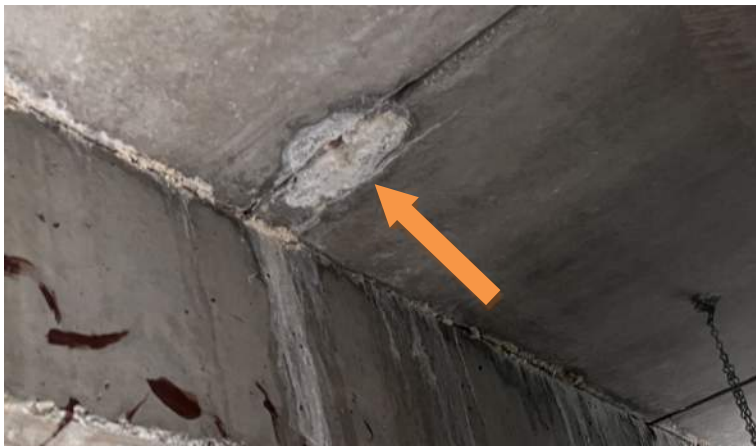
Photo 4

- There is an existing 3 in. by 6 in. spall along a panel joint in Room 103. The surrounding concrete is sound.
- Heavy efflorescence is present along a panel joint at a column in Room 104. Approximately 6 in. of joint sealant is missing between the column and panel (Photo 4).
- Custodial and Storage Rooms: there are three additional potential fall hazards at the additional locations that we inspected (four total, including those detailed in Field Report No. 2), as described below:
 - One potential fall hazard at a column in Room 108, measuring approximately 3 in. by 6 in. (Photo 5).
 - Two potential fall hazards on a column in Room ST-108, measuring approximately 2 in. by 3 in. and 2 in. by 6 in. (Photo 6).

Efflorescence at panel joint
in Room 104.

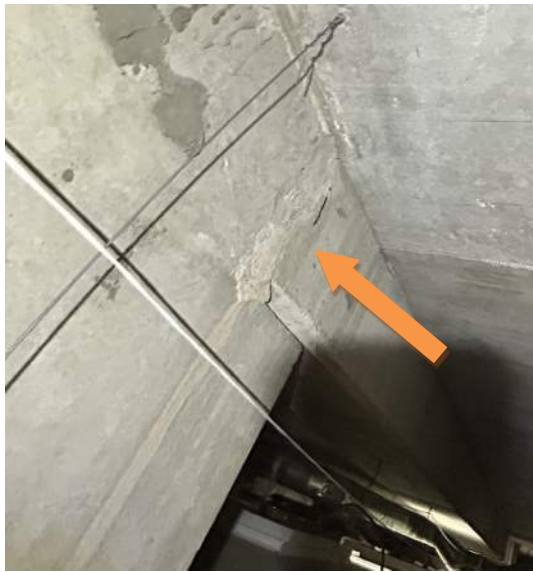
Photo 10

- One potential fall hazard at a column in Room ST-202, measuring approximately 6 in. by 12 in. (Photo 10).
 - One potential fall hazard around three sides of a column between Rooms 216 and 218, measuring approximately 2 in. wide (Photo 11). There is a previous repair in this column that is unsound.

Potential fall hazard at column in Room ST-202.

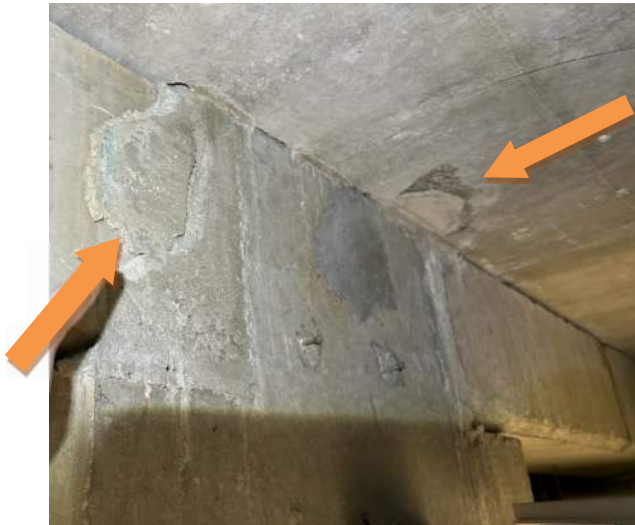
Photo 13

- One potential fall hazard at a column in Room ST-203, measuring approximately 12 in. by 12 in. (Photo 12).
 - Two potential fall hazards at a column and a beam between Rooms 215 and 217, measuring approximately 8 in. by 8 in. and 6 in. by 6 in., respectively (Photo 13).

Potential fall hazards between Rooms 215 and 217.

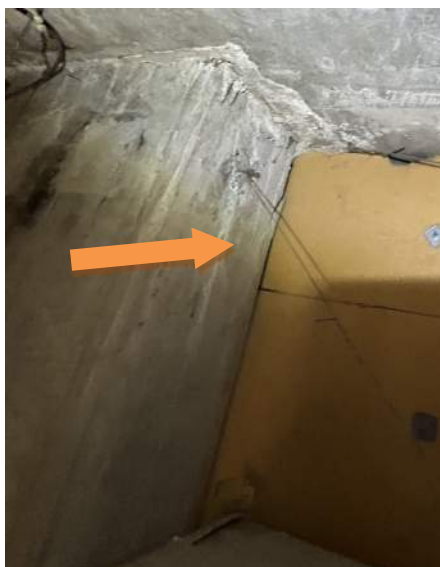
Photo 15

- One potential fall hazard at a previous repair next to a column in Room 215, measuring approximately 18 in. by 18 in. (Photo 14).
 - One potential fall hazard is adjacent to a column in Room 217, measuring approximately 3 in. by 10 in. (Photo 15).

Potential fall hazard at column in Room 217.

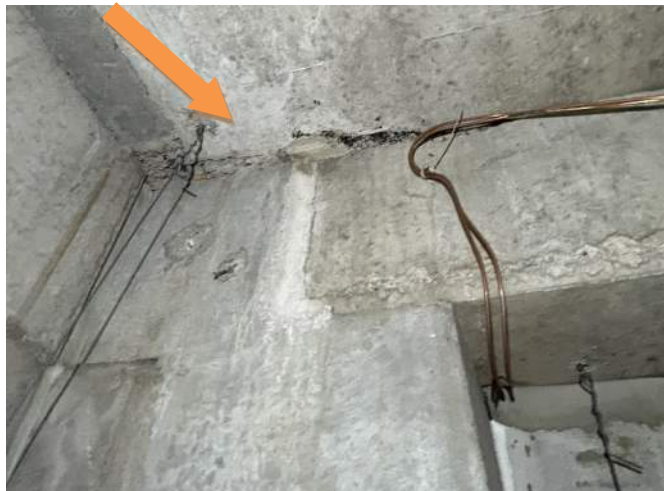
Photo 17

- There are two potential fall hazards at a column in Room 320, measuring approximately 2 in. by 3 in. and 1 in. by 4 in. (Photo 17).
 - One potential fall hazard is at a column in Room 320, measuring approximately 3 in. by 6 in. (Photo 18).

Potential fall hazards at column in Room 320.

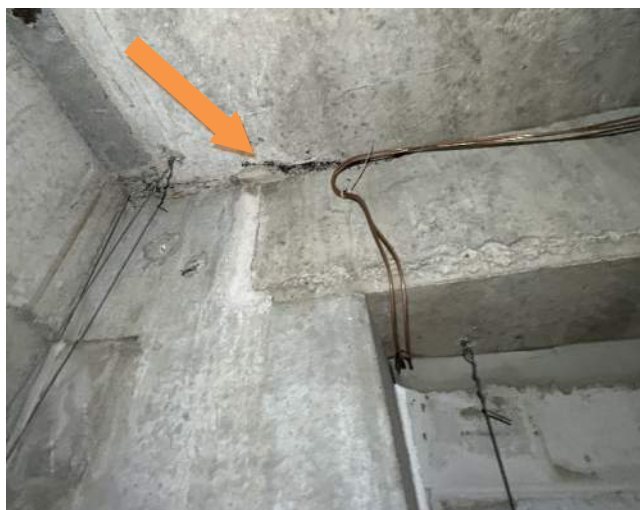
Photo 18

Potential fall hazard above column in Room 320.

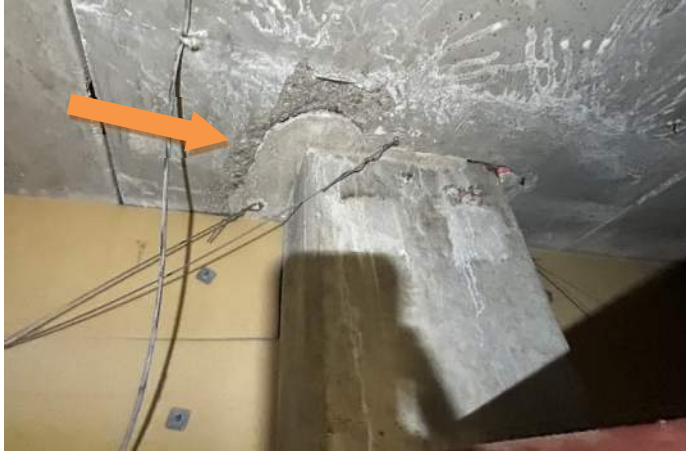
Photo 19

- There is one potential fall hazard at a previous repair between Rooms 317 and 319, measuring approximately 8 in. by 36 in. (Photo 19).
 - One potential fall hazard along a joint in Room 315 measures approximately 2 in. by 3 in. (Photo 20).

Potential fall hazard at previous repair between Rooms 317 and 319.

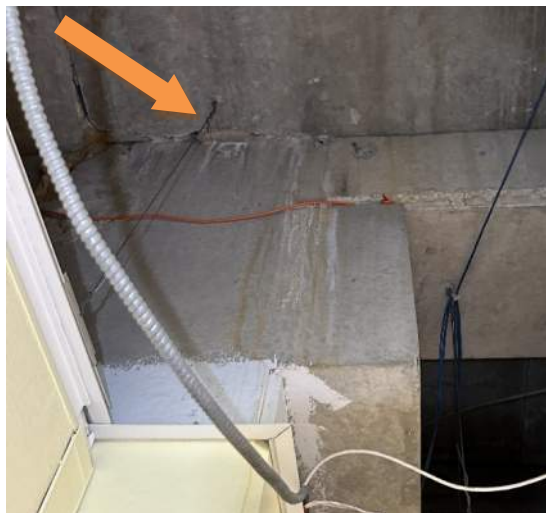
Photo 20

Potential fall hazard at a column joint in Room 315.

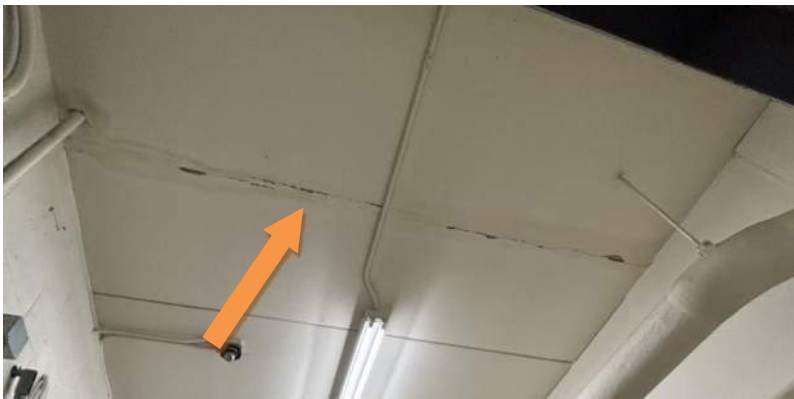
Photo 26

Potential fall hazards along a crack in Room ST-306.

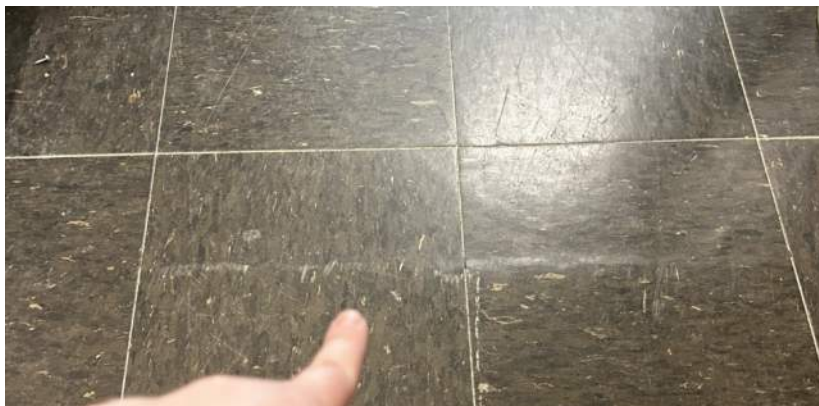
Photo 27

Raised floor above crack in Level 4 storage room.

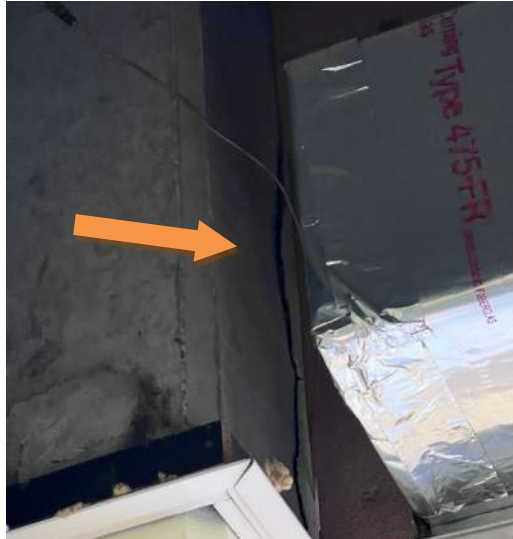
Photo 28

Potential fall hazard at column in Room 417.

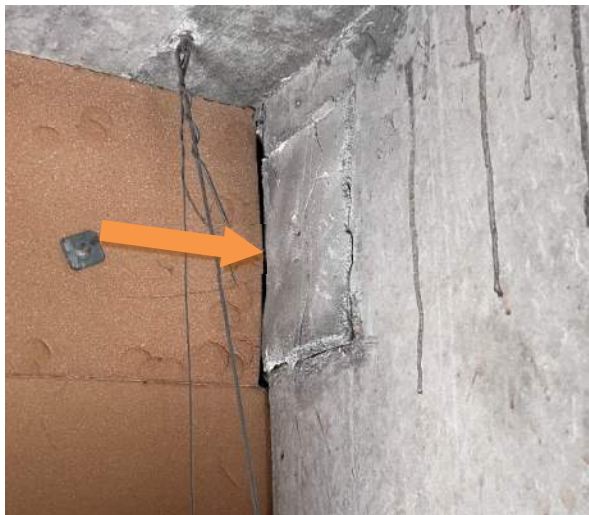
Photo 29

Potential fall hazard in Room 420.

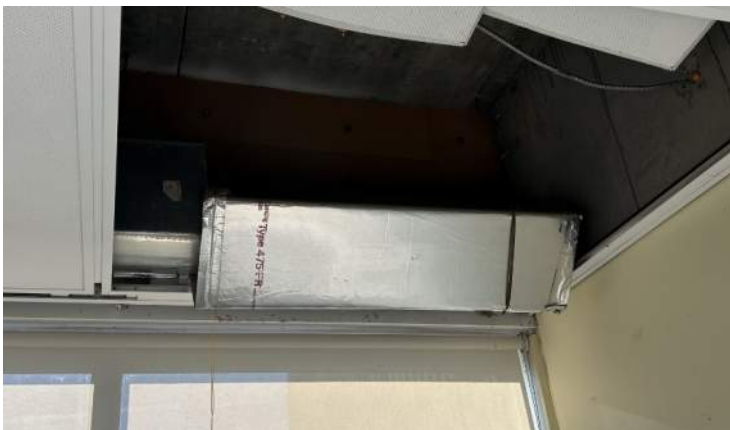
Photo 30

Loose ductwork in Room 420.
