MEMORANDUM

RE: Somerville IDDE Investigation – Permit Year 6 Catchment Inspection Memo

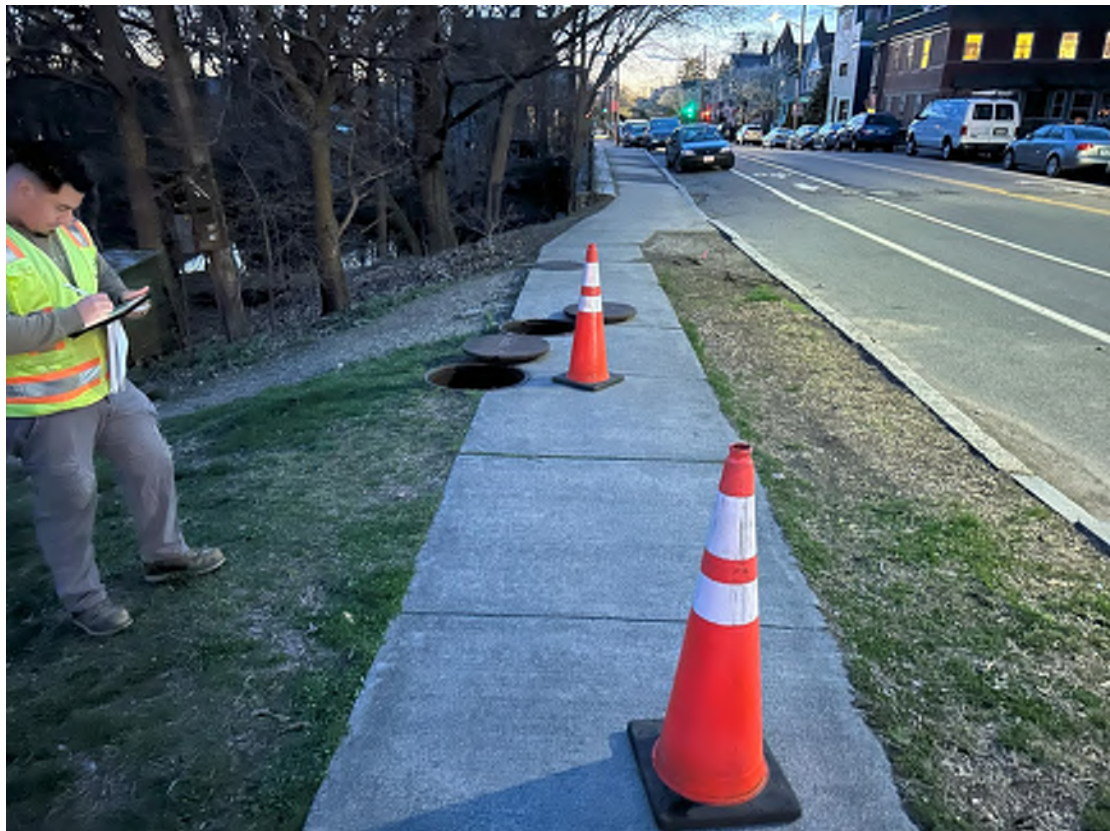
FIGURE 2: DRAINAGE MANHOLES ON BOSTON AVE

The two catch basins at the intersection of Irvington Road and Mystic Valley Parkway connect directly to drainage manhole (DMH) A-5947. Dye was added to DMH A-5947 and it was seen at the manhole at the intersection of Boston Ave and Mystic Valley Parkway followed by the downstream manholes on Boston Ave. There are four manholes in series on Boston Ave which act as a stormwater control measure. Drainages manholes 14-7002, 14-7003, and 14-7004 are shown in **Figure 2**.

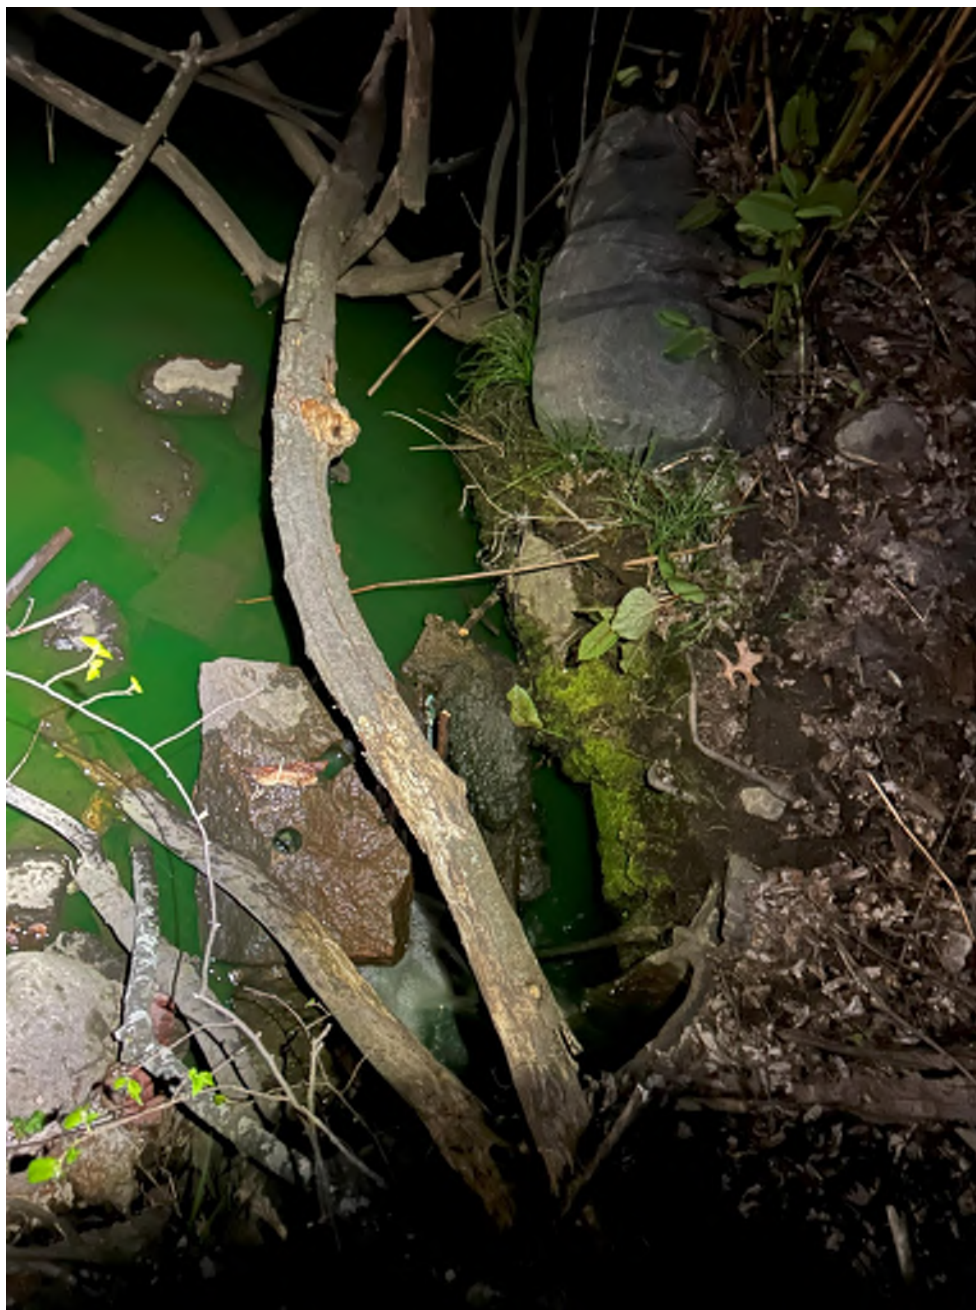
FIGURE 7: FAIRFAX STREET DYE IN ALEWIFE BROOK FROM OUTFALL 11

Following the SCM, the flow ends up at Outfall 11. The dye from Fairfax Street seen in Outfall 11 is shown in **Figure 7**. The confirmed Fairfax Street drainage configuration is shown in **Figure 8**.

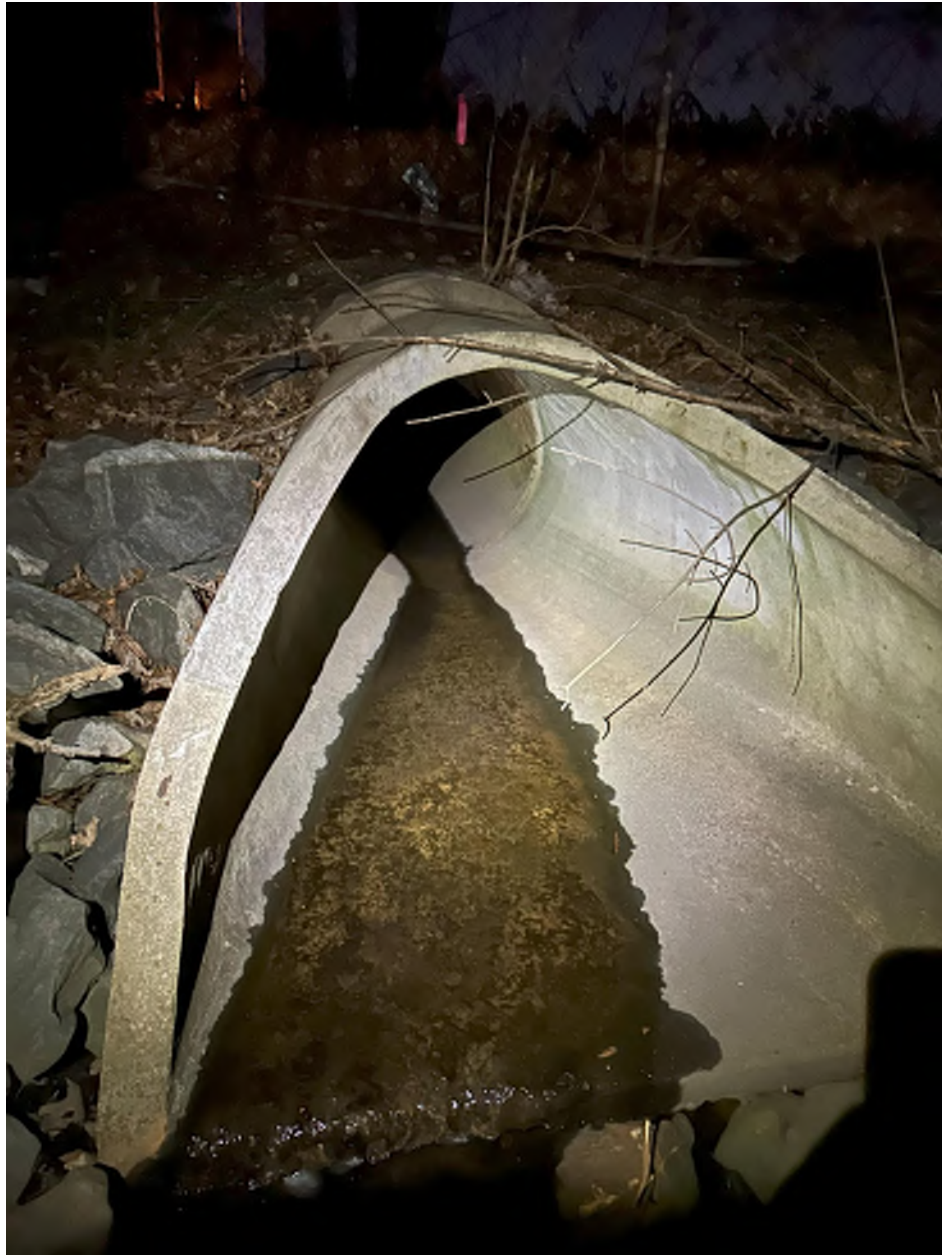
FIGURE 10: OUTFALL 10

Outfall 10 is shown in **Figure 10** and the confirmed drainage configuration for Sterling Street is shown in **Figure 11**.

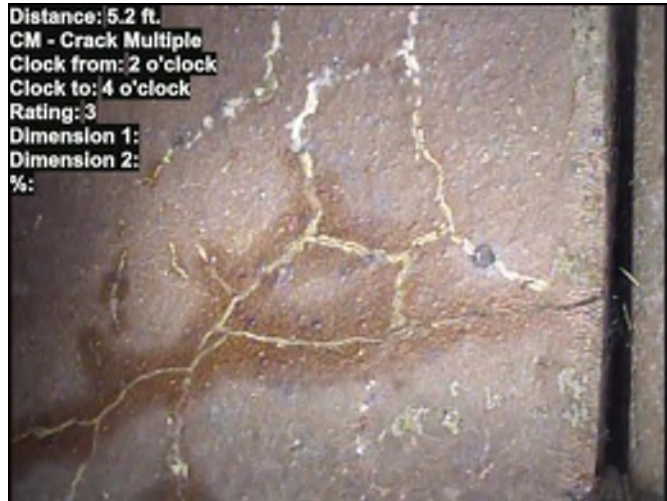
At: 5.2 ft. 2/4 CM - Crack Multiple

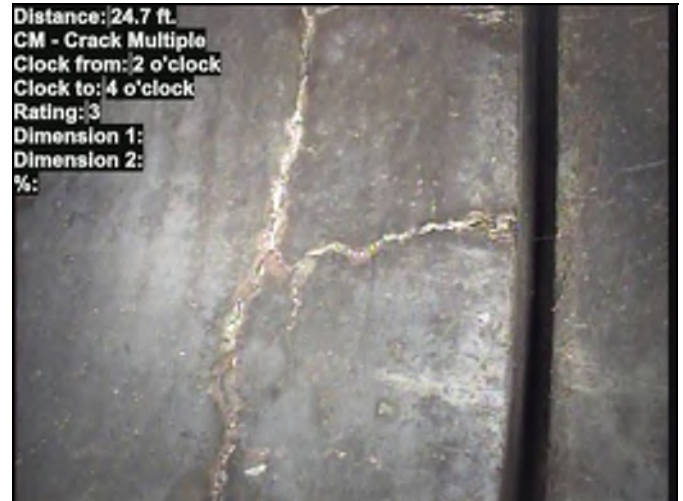
At: 24.7 ft. 2/4 CM - Crack Multiple

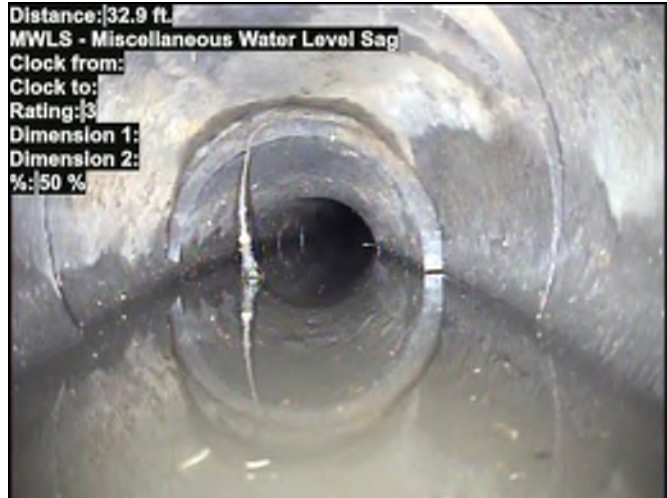
At: 32.9 ft. MWLS - Miscellaneous Water Level Sag

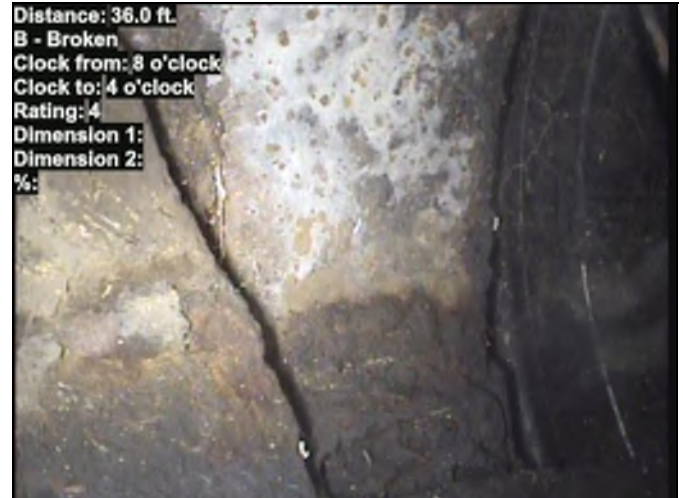
At: 36 ft. 8/4 B - Broken

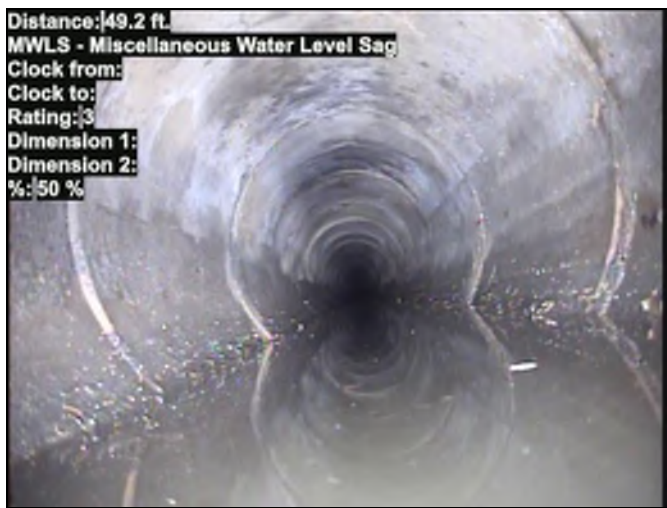
Distance: 49.2 ft.
MWLS - Miscellaneous Water Level Sag
Clock from:
Clock to:
Rating: 3
Dimension 1:
Dimension 2:
%: 50 %
Photo: 666667947.00-22084.00-20240421-205127-205641.JPG
At: 49.2 ft. MWLS - Miscellaneous Water Level Sag
Joint: No 50 %

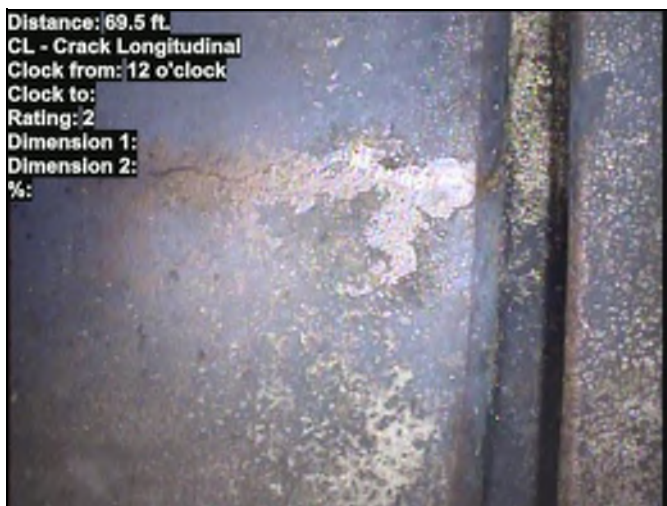
Distance: 69.5 ft.
CL - Crack Longitudinal
Clock from: 12 o'clock
Clock to:
Rating: 2
Dimension 1:
Dimension 2:
%:
Photo: 666667947.00-22084.00-20240421-205127-205743.JPG
At: 69.5 ft. 12/. CL - Crack Longitudinal
Joint: No

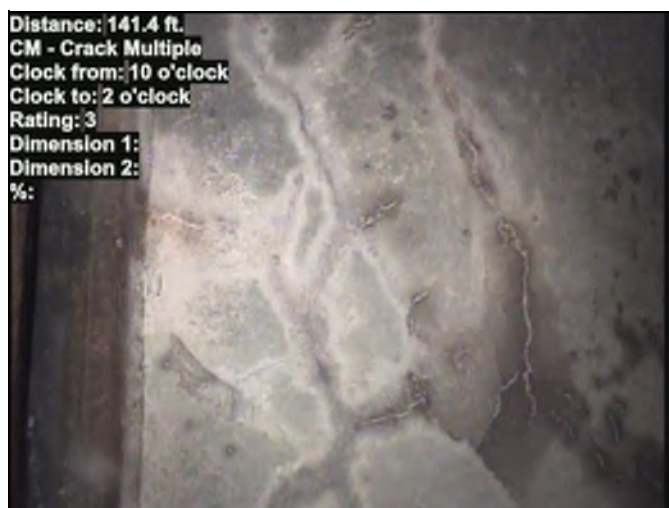
Distance: 141.4 ft.
 CM - Crack Multiple
 Clock from: 10 o'clock
 Clock to: 2 o'clock
 Rating: 3
 Dimension 1:
 Dimension 2:
 %:
 Photo: 666667947.00-22084.00-20240421-205127-210133.JPG
 At: 141.4 ft. CM - Crack Multiple
 10/2
 Joint: No

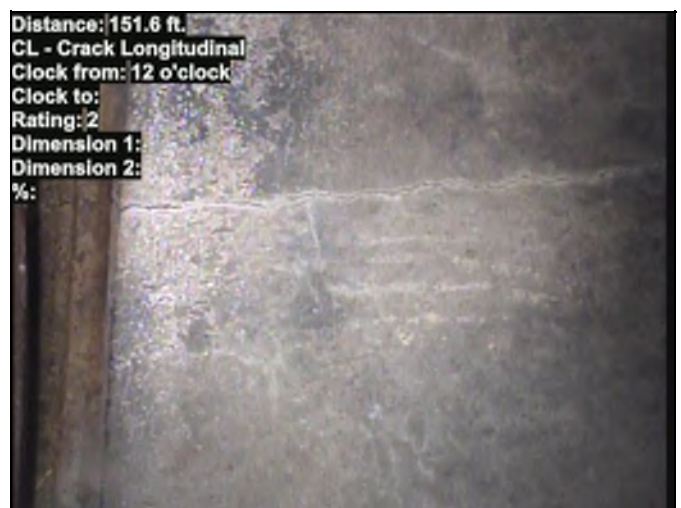
Distance: 151.6 ft.
 CL - Crack Longitudinal
 Clock from: 12 o'clock
 Clock to:
 Rating: 2
 Dimension 1:
 Dimension 2:
 %:
 Photo: 666667947.00-22084.00-20240421-205127-210208.JPG
 At: 151.6 ft. 12/. CL - Crack Longitudinal
 Joint: No

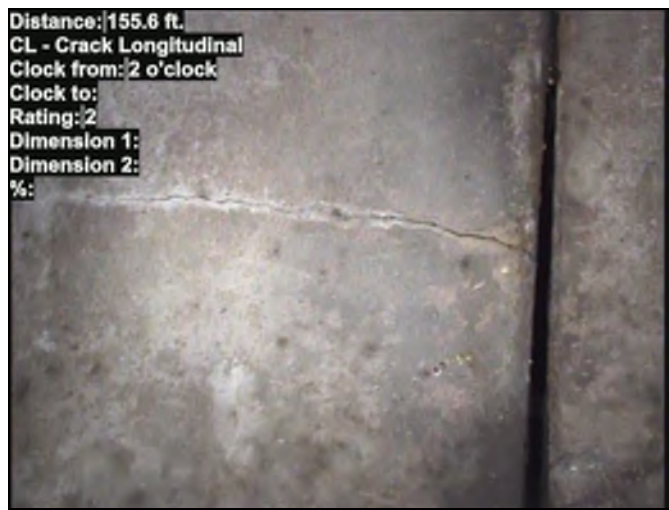
Distance: 155.6 ft.
CL - Crack Longitudinal
Clock from: 2 o'clock
Clock to:
Rating: 2
Dimension 1:
Dimension 2:
%:

At: 155.6 ft. 2/. CL - Crack Longitudinal

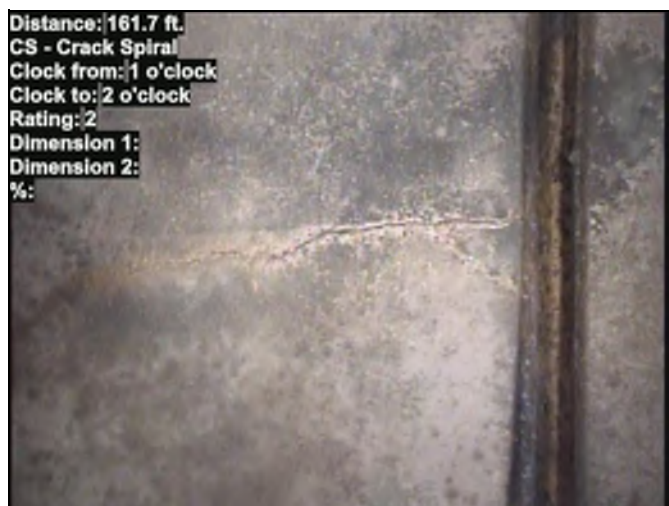
Distance: 161.7 ft.
CS - Crack Spiral
Clock from: 1 o'clock
Clock to: 2 o'clock
Rating: 2
Dimension 1:
Dimension 2:
%:

At: 161.7 ft. 1/2 CS - Crack Spiral

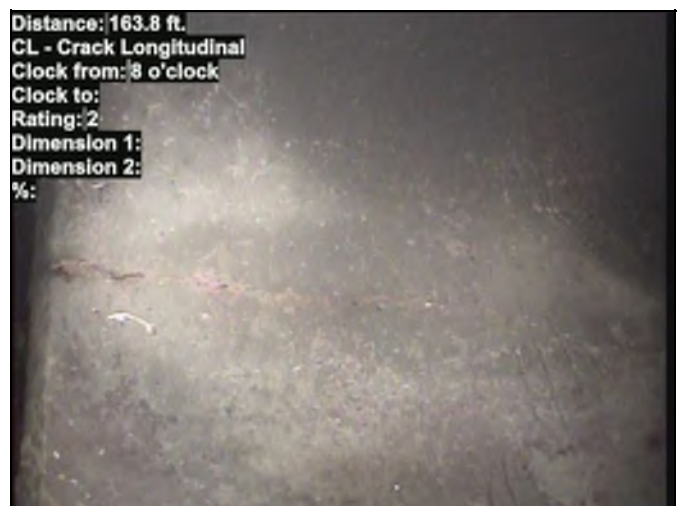
Distance: 163.8 ft.
CL - Crack Longitudinal
Clock from: 8 o'clock
Clock to:
Rating: 2
Dimension 1:
Dimension 2:
%:

At: 163.8 ft. 8/. CL - Crack Longitudinal

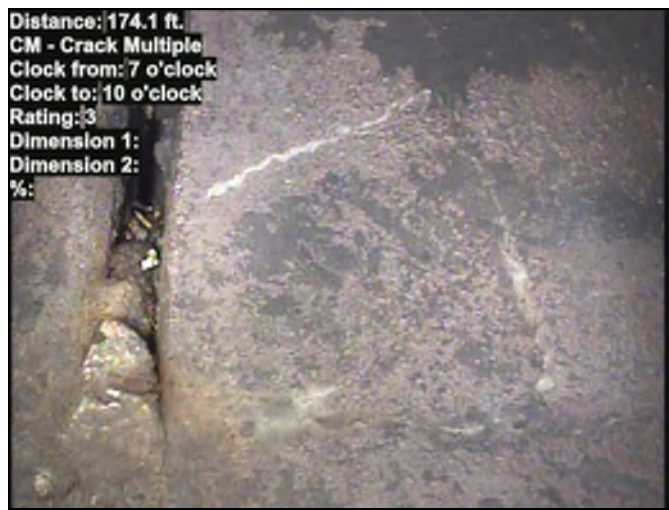
At: 174.1 ft. CM - Crack Multiple
7/10

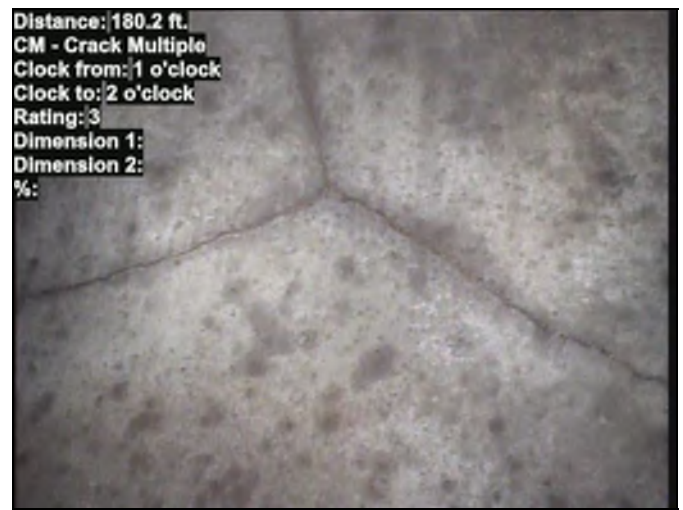
At: 180.2 ft. 1/2 CM - Crack Multiple
Joint: No

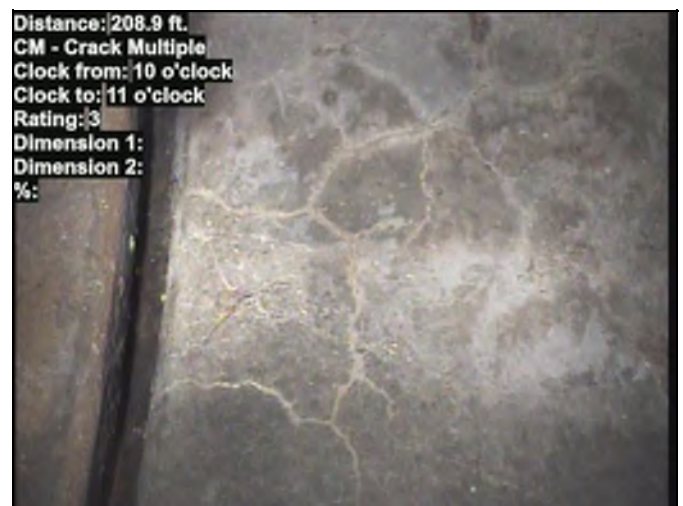
At: 208.9 ft. CM - Crack Multiple
10/11
Joint: No

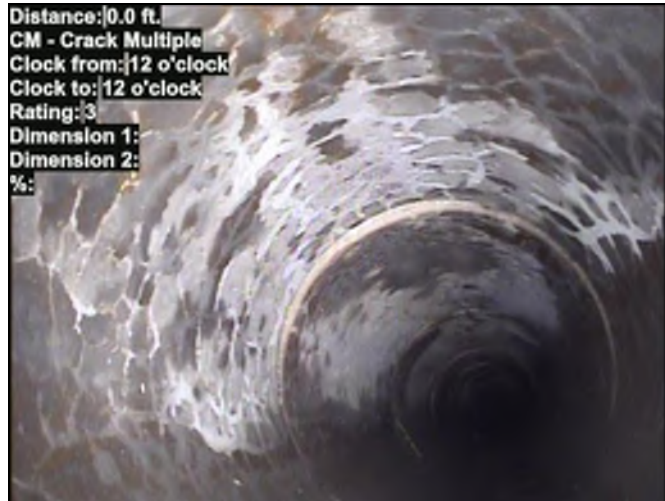
Photo: 666667947.00-2282.00-20240421-211333-211946.JPG

At: 0 ft. 12/12 CM - Crack Multiple

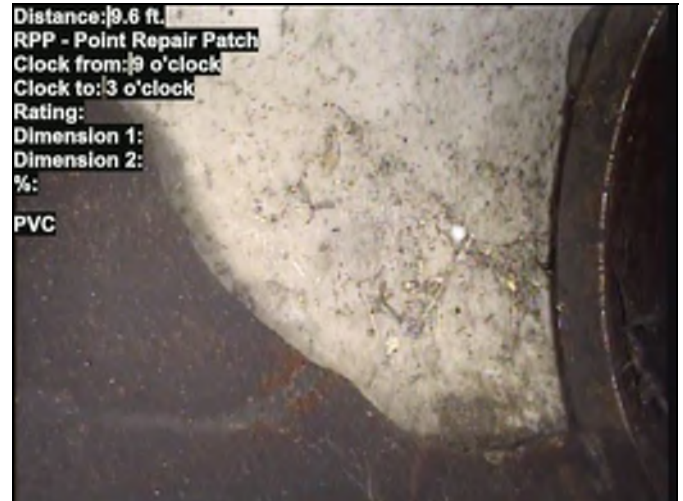
Photo: 666667947.00-2282.00-20240421-211333-212035.JPG

At: 9.6 ft. 9/3 RPP - Point Repair Patch

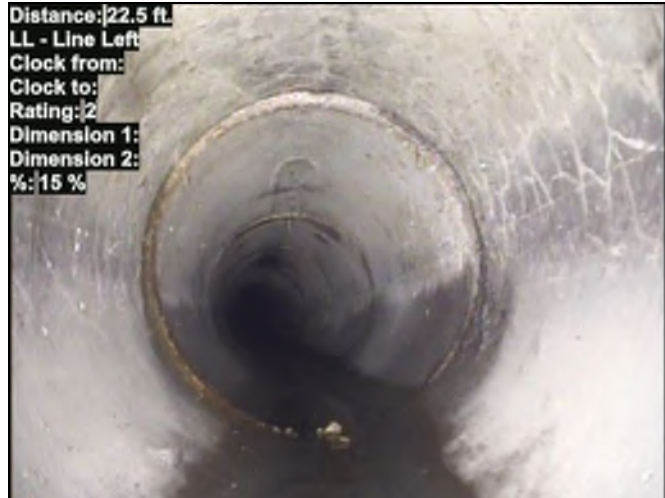
Photo: 666667947.00-2282.00-20240421-211333-212144.JPG

At: 22.5 ft. LL - Line Left

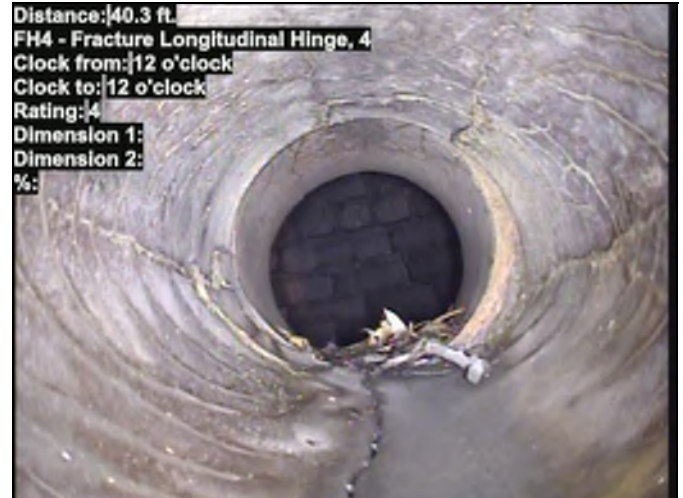
Photo: 666667947.00-2282.00-20240421-211333-212245.JPG

At: 40.3 ft. FH4 - Fracture Longitudinal Hinge, 4
12/12

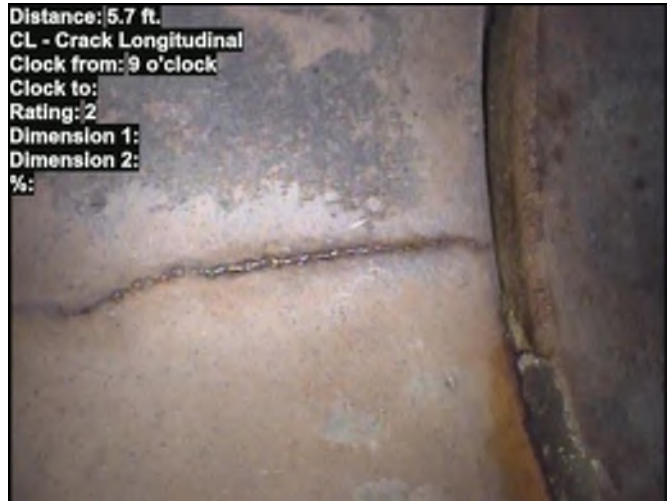
Photo: 22084.00-22283.00-20240421-222809-222859.JPG

At: 5.7 ft. 9/. CL - Crack Longitudinal

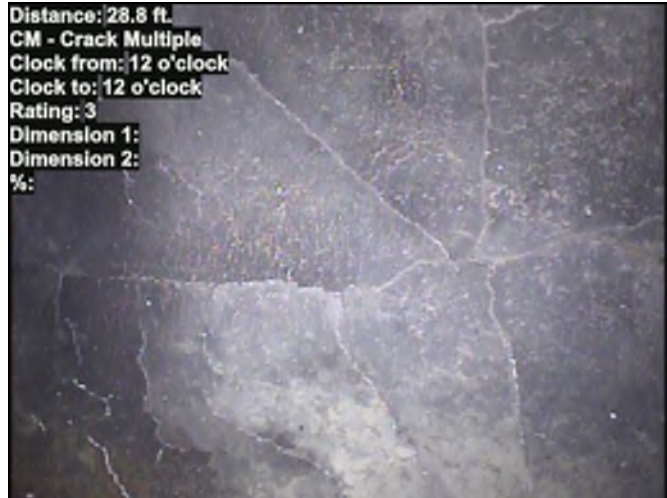
Photo: 22084.00-22283.00-20240421-222809-223012.JPG

At: 28.8 ft. CM - Crack Multiple

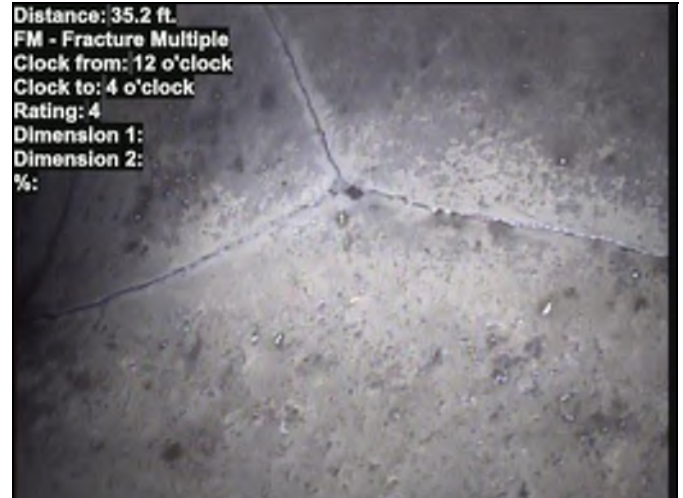
Photo: 22084.00-22283.00-20240421-222809-223039.JPG

At: 35.2 ft. 12/4 FM - Fracture Multiple

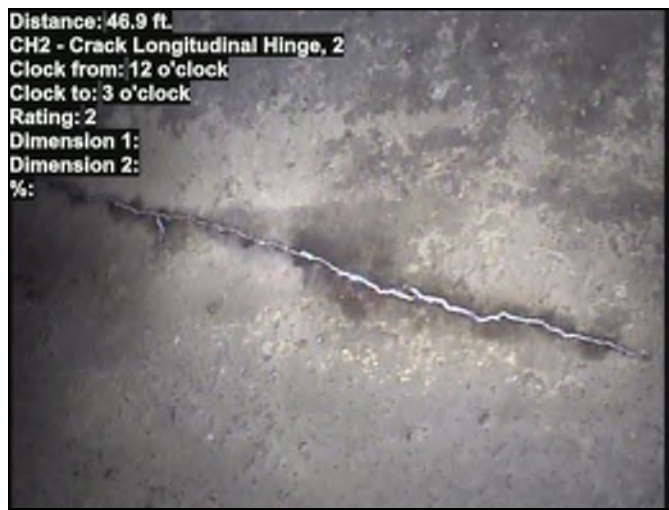
Photo: 22084.00-22283.00-20240421-222809-223140.JPG
At: 46.9 ft. 12/3 CH2 - Crack Longitudinal Hinge, 2
Joint: No

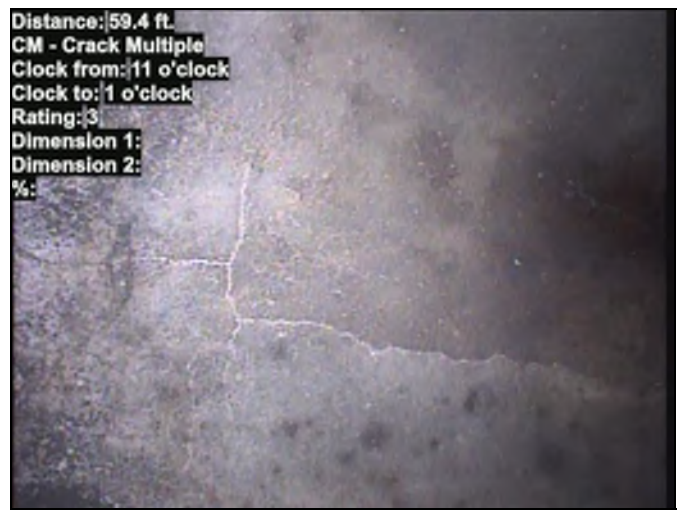
Photo: 22084.00-22283.00-20240421-222809-223210.JPG
At: 59.4 ft. 11/1 CM - Crack Multiple
Joint: No

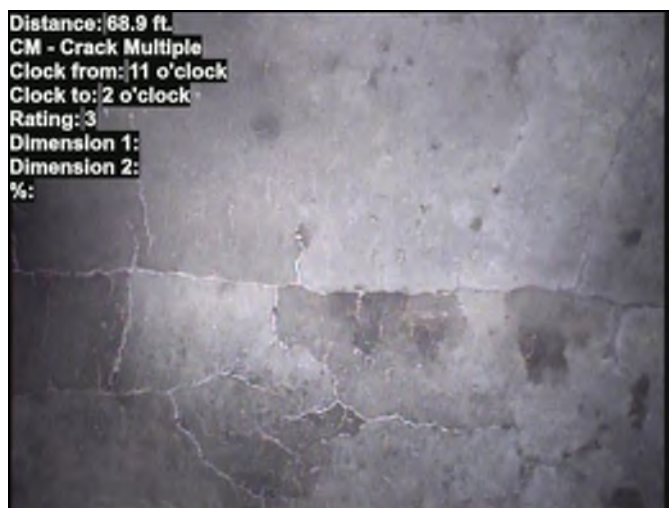
Photo: 22084.00-22283.00-20240421-222809-223236.JPG
At: 68.9 ft. 11/2 CM - Crack Multiple
Joint: No

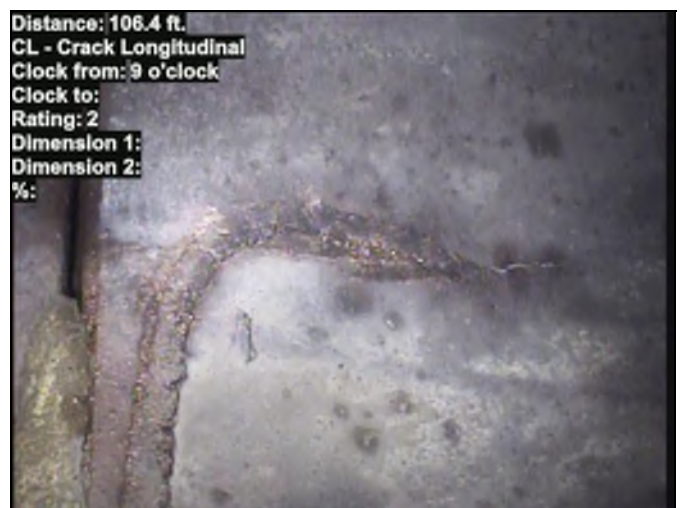
Photo: 22084.00-22283.00-20240421-222809-223403.JPG
At: 106.4 ft. 9/. CL - Crack Longitudinal
Joint: No

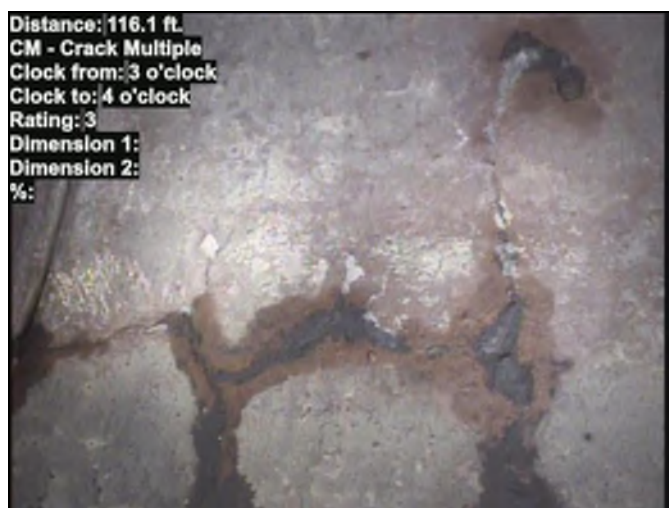
Photo: 22084.00-22283.00-20240421-222809-223430.JPG
At: 116.1 ft. 3/4 CM - Crack Multiple
Joint: No

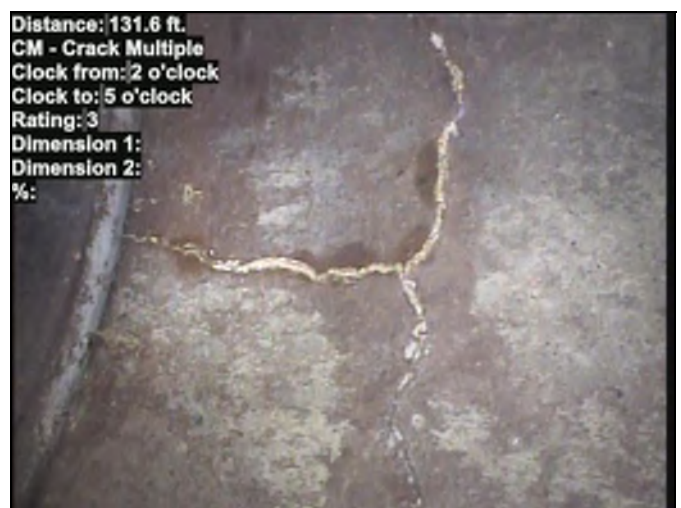
Photo: 22084.00-22283.00-20240421-222809-223504.JPG
At: 131.6 ft. 2/5 CM - Crack Multiple
Joint: No

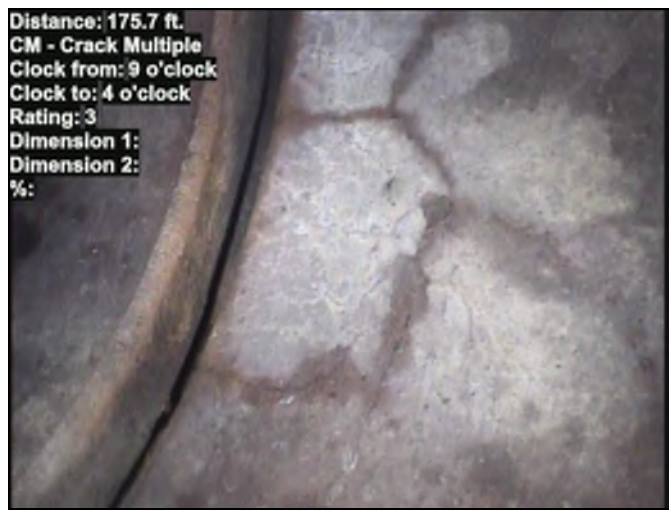
Photo: 22084.00-22283.00-20240421-222809-223625.JPG

At: 175.7 ft. 9/4 CM - Crack Multiple

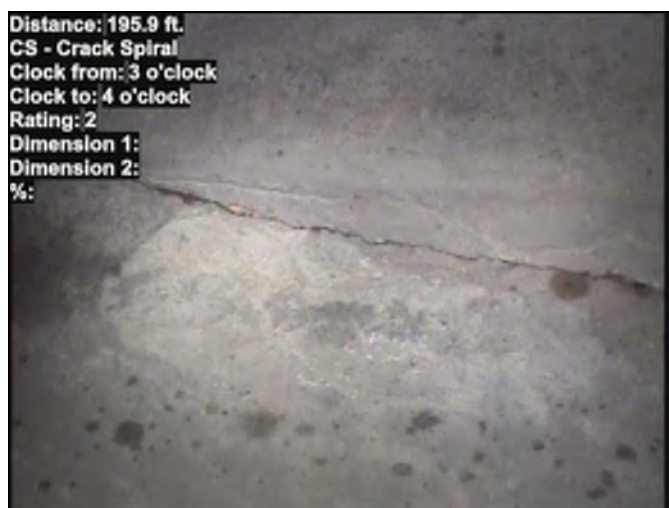
Photo: 22084.00-22283.00-20240421-222809-223743.JPG

At: 195.9 ft. 3/4 CS - Crack Spiral

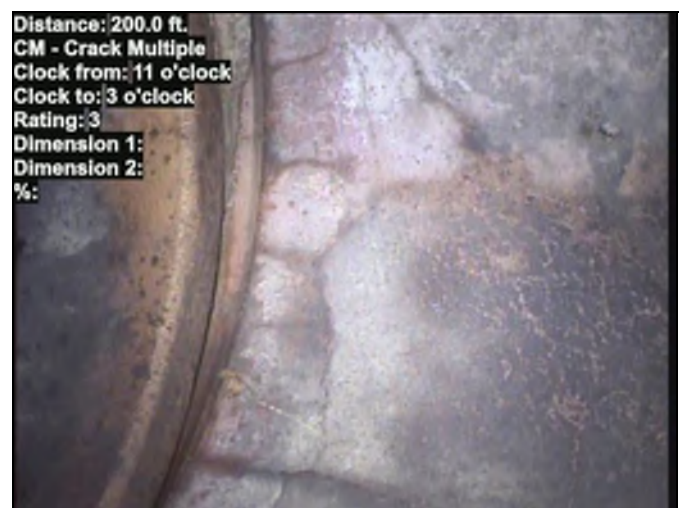
Photo: 22084.00-22283.00-20240421-222809-223801.JPG

At: 200 ft. 11/3 CM - Crack Multiple

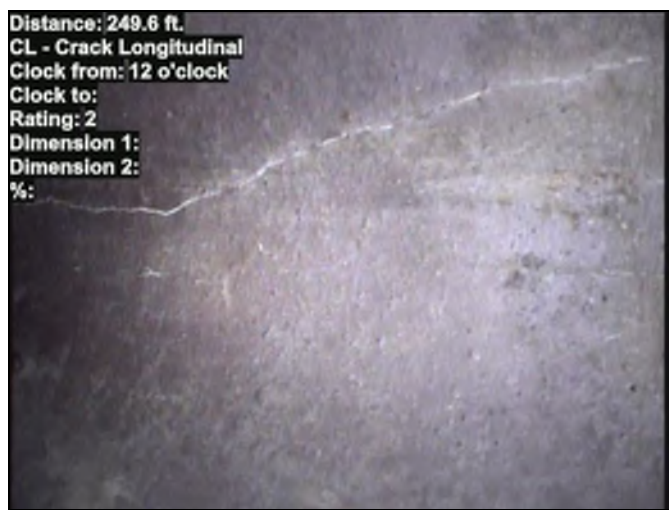
Distance: 249.6 ft.
CL - Crack Longitudinal
Clock from: 12 o'clock
Clock to:
Rating: 2
Dimension 1:
Dimension 2:
%:
Photo: 22084.00-22283.00-20240421-222809-223944.JPG
At: 249.6 ft. 12/. CL - Crack Longitudinal
Joint: No

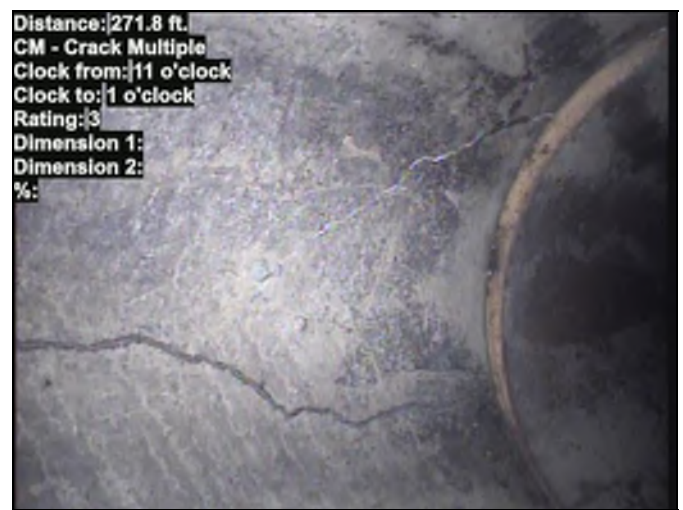
Distance: 271.8 ft.
CM - Crack Multiple
Clock from: 11 o'clock
Clock to: 1 o'clock
Rating: 3
Dimension 1:
Dimension 2:
%:
Photo: 22084.00-22283.00-20240421-222809-224031.JPG
At: 271.8 ft. CM - Crack Multiple
11/1
Joint: No

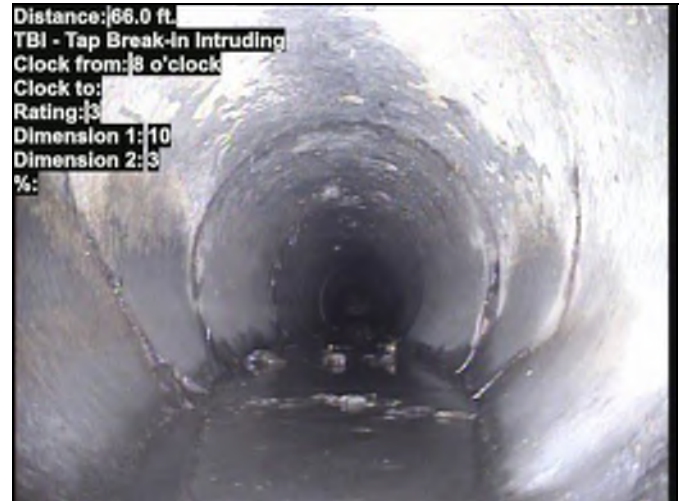
Photo: 22280.00-22283.00-20240421-224929-225154.JPG

At: 66 ft. 8/. TBI - Tap Break-in Intruding

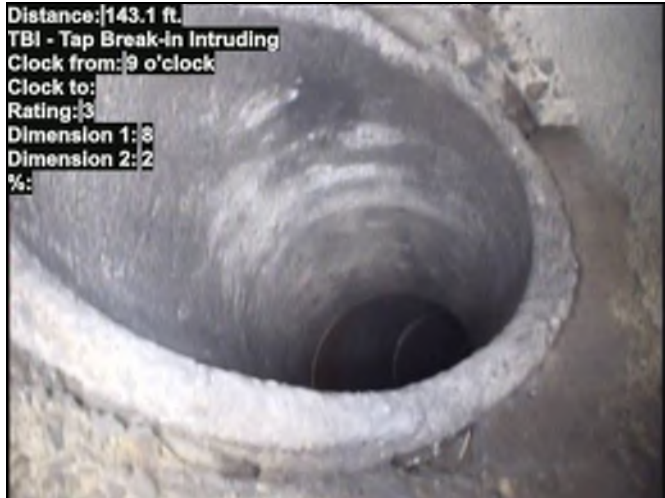
Photo: 22280.00-22283.00-20240421-224929-225341.JPG

At: 143.1 ft. 9/. TBI - Tap Break-in Intruding

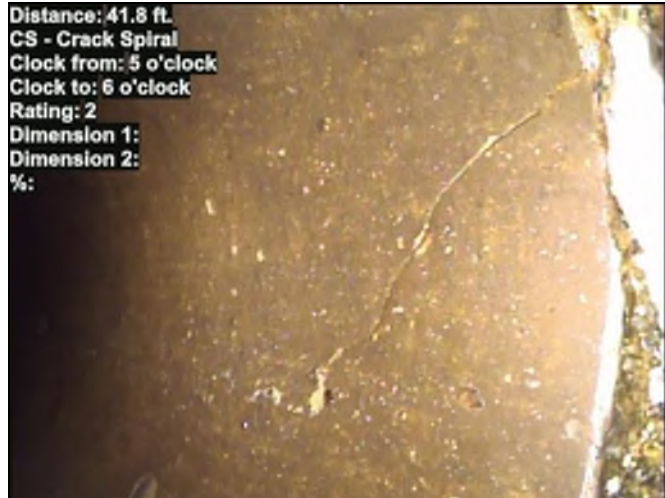
Distance: 41.8 ft.
CS - Crack Spiral
Clock from: 5 o'clock
Clock to: 6 o'clock
Rating: 2
Dimension 1:
Dimension 2:
%:
Photo: 666667978.00-30328.00-20240422-010742-011148.JPG
At: 41.8 ft. 5/6 CS - Crack Spiral
Joint: No

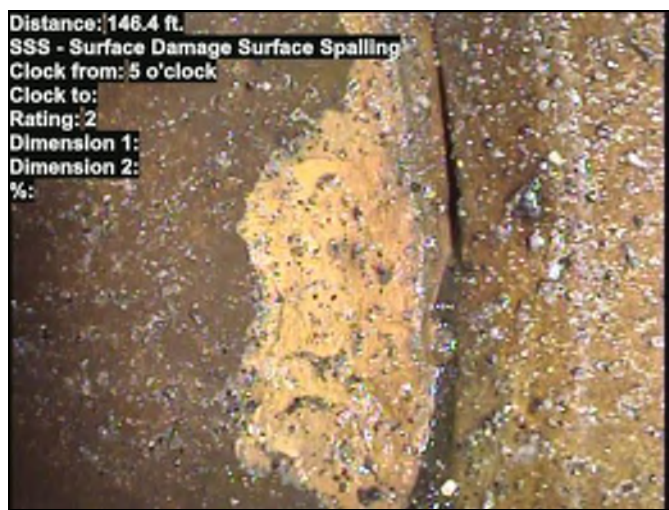
Distance: 146.4 ft.
SSS - Surface Damage Surface Spalling
Clock from: 5 o'clock
Clock to:
Rating: 2
Dimension 1:
Dimension 2:
%:
Photo: 666667978.00-30328.00-20240422-010742-011853.JPG
At: 146.4 ft. 5/. SSS - Surface Damage Surface Spalling
Joint: No

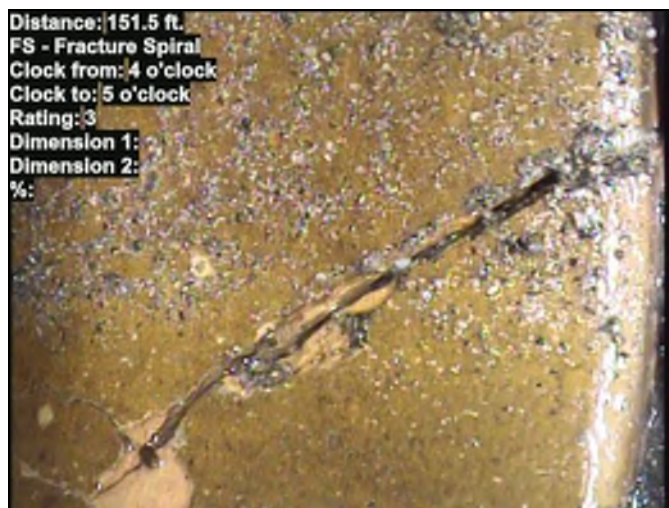
Distance: 151.5 ft.
FS - Fracture Spiral
Clock from: 4 o'clock
Clock to: 5 o'clock
Rating: 3
Dimension 1:
Dimension 2:
%:
Photo: 666667978.00-30328.00-20240422-010742-011932.JPG
At: 151.5 ft. 4/5 FS - Fracture Spiral
Joint: No

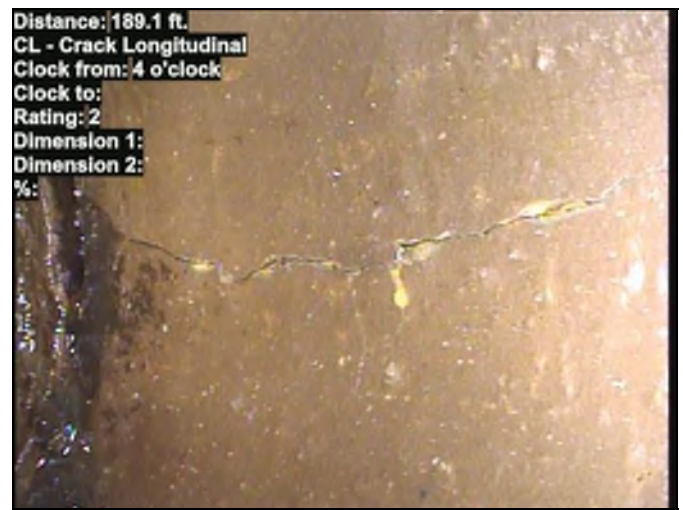
Distance: 189.1 ft.
 CL - Crack Longitudinal
 Clock from: 4 o'clock
 Clock to:
 Rating: 2
 Dimension 1:
 Dimension 2:
 %:
 Photo: 666667978.00-30328.00-20240422-010742-012141.JPG
 At: 189.1 ft. 4/. CL - Crack Longitudinal
 Joint: No

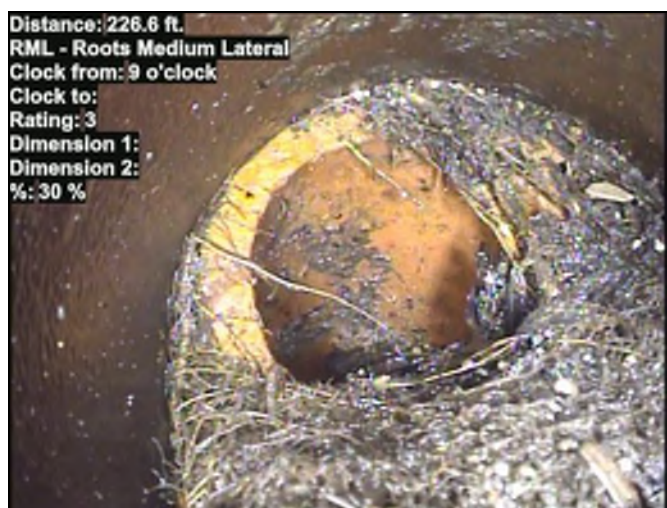
Distance: 226.6 ft.
 RML - Roots Medium Lateral
 Clock from: 9 o'clock
 Clock to:
 Rating: 3
 Dimension 1:
 Dimension 2:
 %: 30 %
 Photo: 666667978.00-30328.00-20240422-010742-012341.JPG
 At: 226.6 ft. 9/. RML - Roots Medium Lateral
 Joint: No 30 %

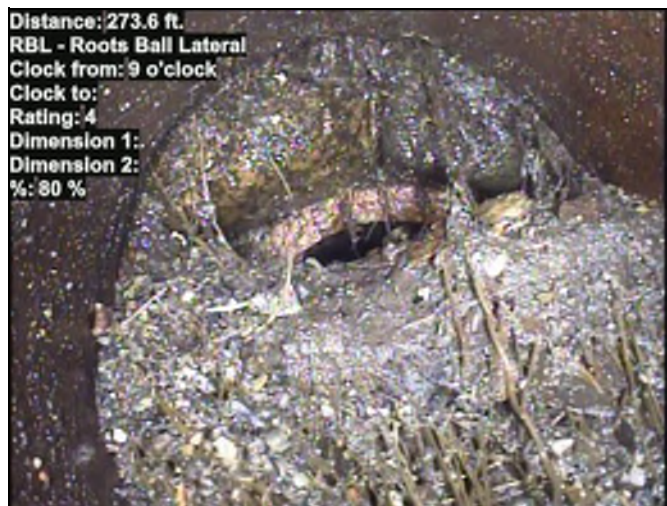
Distance: 273.6 ft.
RBL - Roots Ball Lateral
Clock from: 9 o'clock
Clock to:
Rating: 4
Dimension 1:
Dimension 2:
%: 80 %
Photo: 666667978.00-30328.00-20240422-010742-012623.JPG
At: 273.6 ft. 9/. RBL - Roots Ball Lateral
Joint: No 80 %

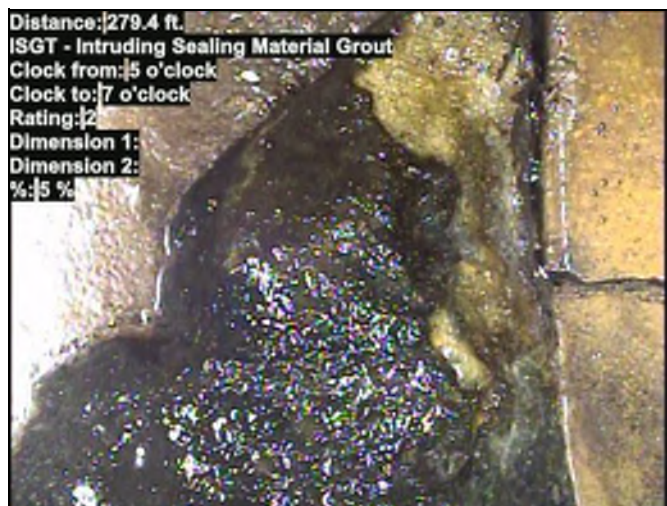
Distance: 279.4 ft.
ISGT - Intruding Sealing Material Grout
Clock from: 5 o'clock
Clock to: 7 o'clock
Rating: 2
Dimension 1:
Dimension 2:
%: 5 %
Photo: 666667978.00-30328.00-20240422-010742-012724.JPG
At: 279.4 ft. 5/7 ISGT - Intruding Sealing Material Grout
Joint: No 5 %

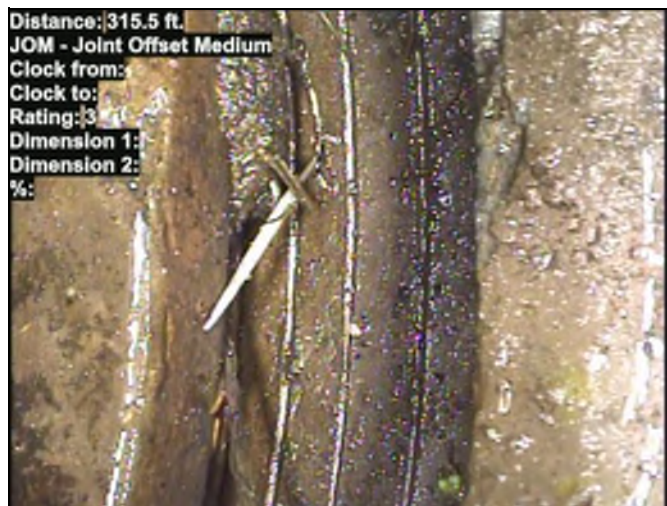
At: 315.5 ft. JOM - Joint Offset Medium

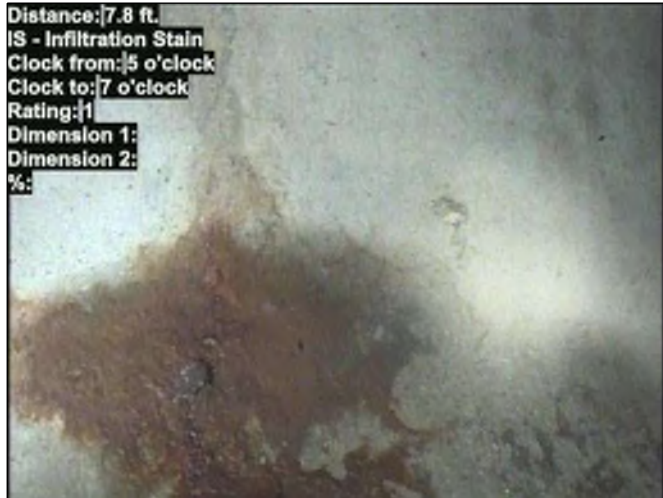
Photo: 32-6421-32-6424-20230905-075303.JPG
At: 7.8 ft. 5/7 IS - Infiltration Stain
Joint: No

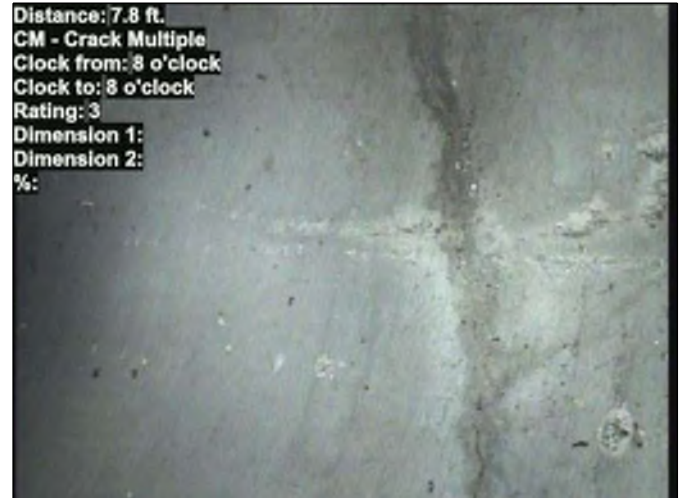
Photo: 32-6421-32-6424-20230905-075244.JPG
At: 7.8 ft. 8/8 CM - Crack Multiple
Joint: No

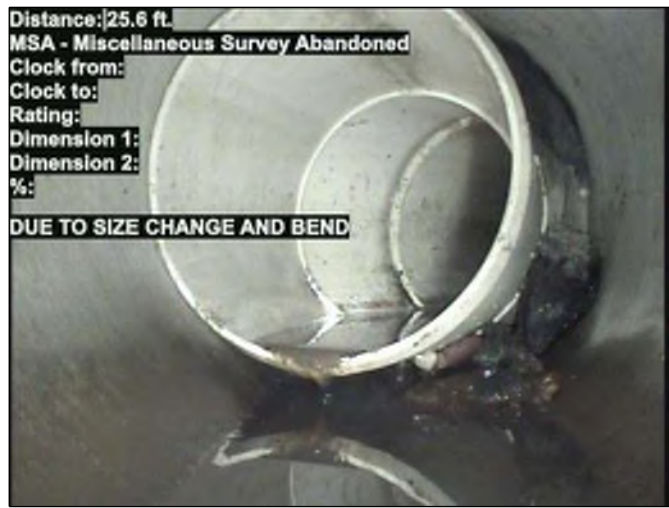
Photo: 32-6421-32-6424-20230905-080056.JPG
At: 25.6 ft. MSA - Miscellaneous Survey Abandoned
Joint: No DUE TO SIZE CHANGE AND BEND

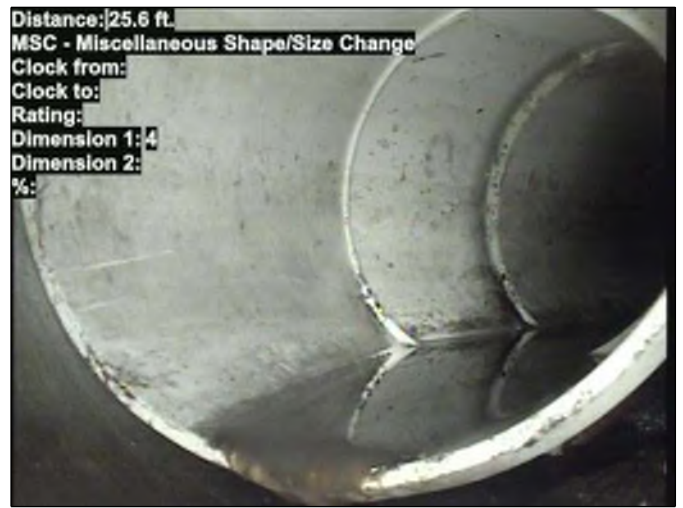
Photo: 32-6421-32-6424-20230905-075823.JPG
At: 25.6 ft. MSC - Miscellaneous Shape/Size Change
Joint: No

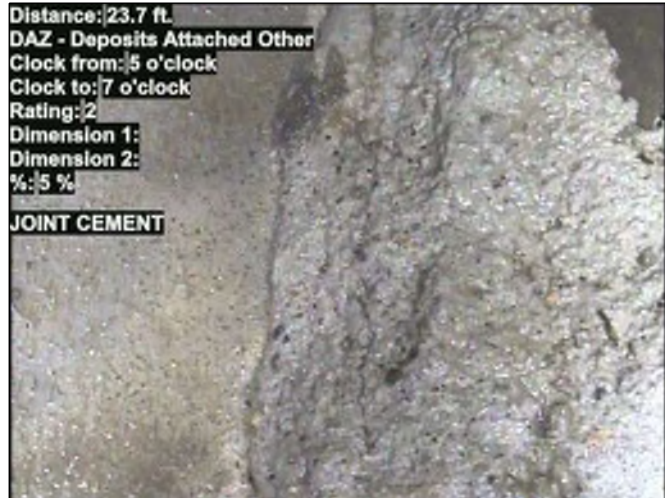
At: 23.7 ft. 5/7 DAZ - Deposits Attached Other

Joint: No 5 % JOINT CEMENT

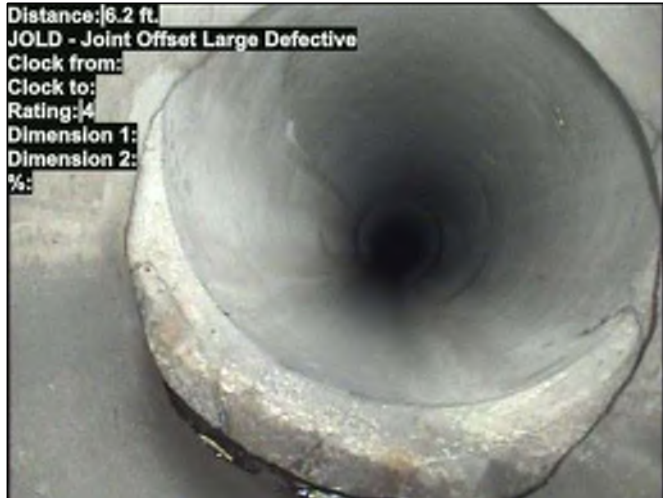
At: 6.2 ft. JOLD - Joint Offset Large Defective

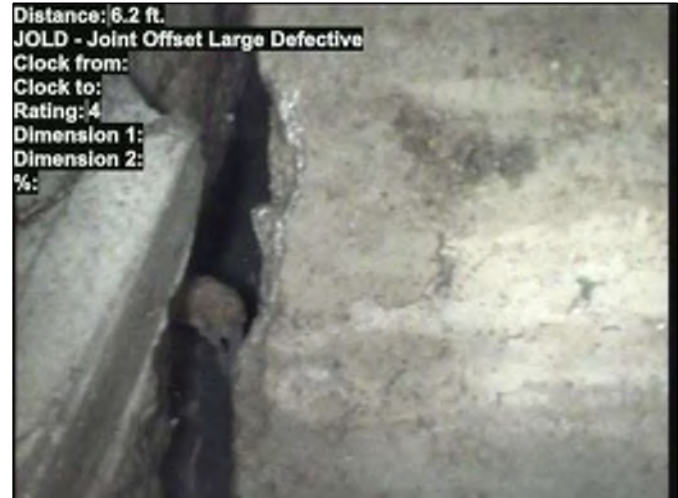
At: 6.2 ft. JOLD - Joint Offset Large Defective

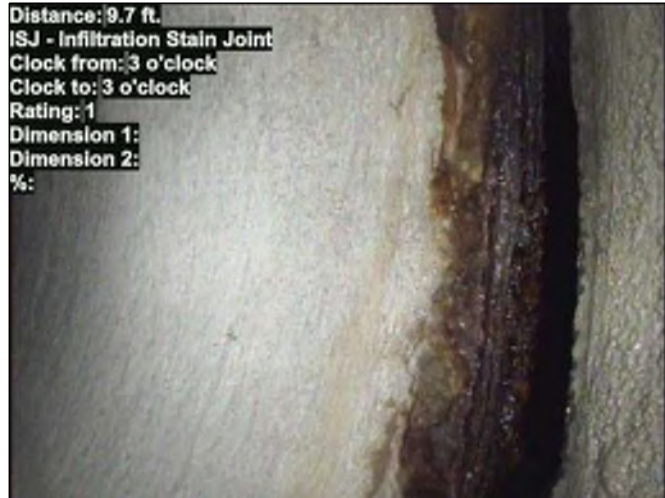
Photo: 32-6444-32-6443-20230905-105823.JPG
At: 9.7 ft. 3/3 ISJ - Infiltration Stain Joint
Joint: Yes

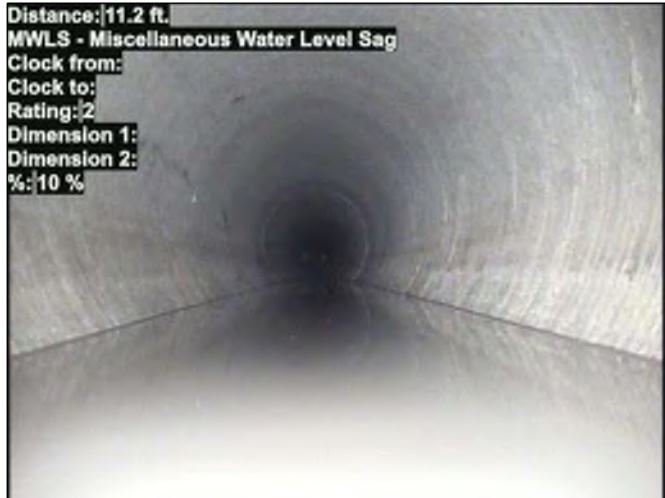
Legend

At: 11.2 ft. MWLS - Miscellaneous Water Level Sag

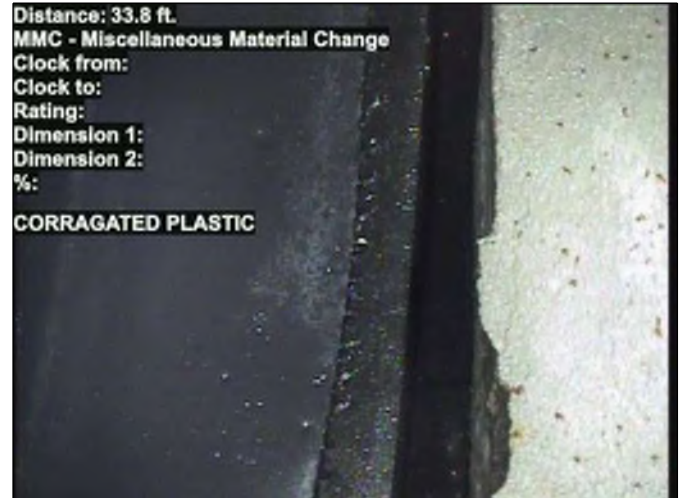
Photo: FIT-7003-32-6426-20230905-094848.JPG

At: 33.8 ft. MMC - Miscellaneous Material Change

Joint: No CORRUGATED PLASTIC
