MEMORANDUM

RE: Somerville IDDE Investigation – Permit Year 6 Catchment Inspection Memo

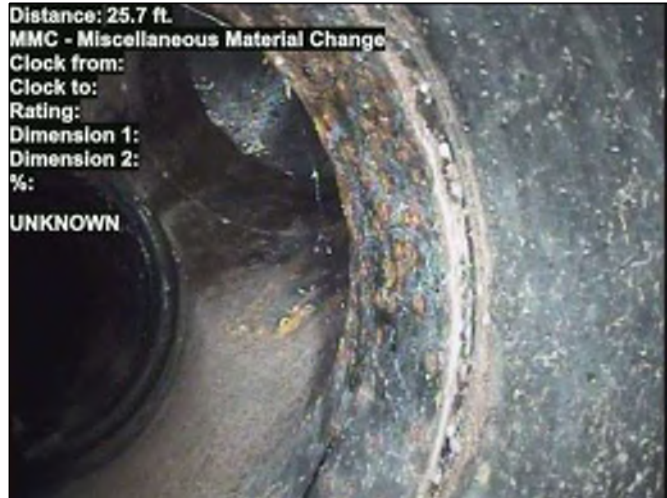
Photo: UNKNOWN-32-6442-20230905-115342.JPG

At: 25.7 ft. MMC - Miscellaneous Material Change

Joint: No UNKNOWN

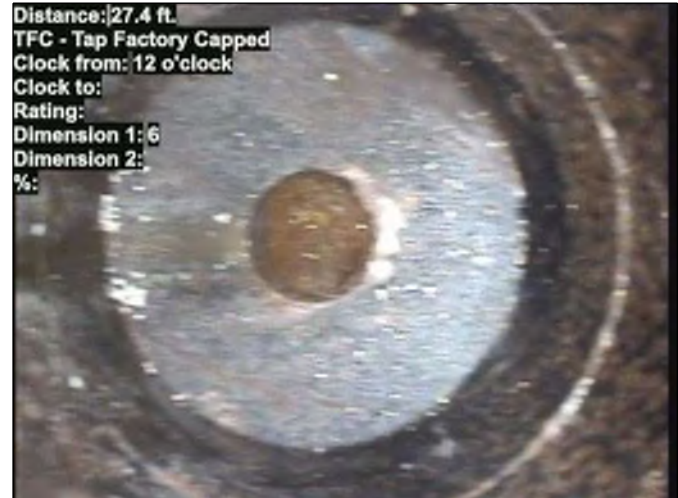
Photo: UNKNOWN-32-6442-20230905-115442.JPG

At: 27.4 ft. 12/. TFC - Tap Factory Capped

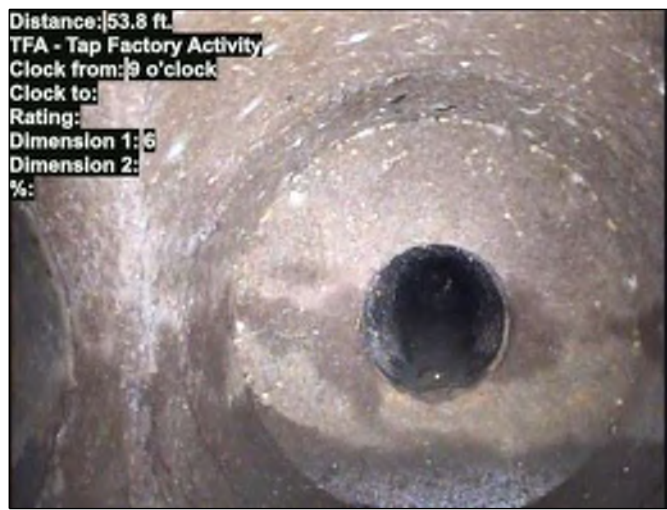
Photo: UNKNOWN-32-6442-20230905-115626.JPG
At: 53.8 ft. 9/. TFA - Tap Factory Activity
Joint: No

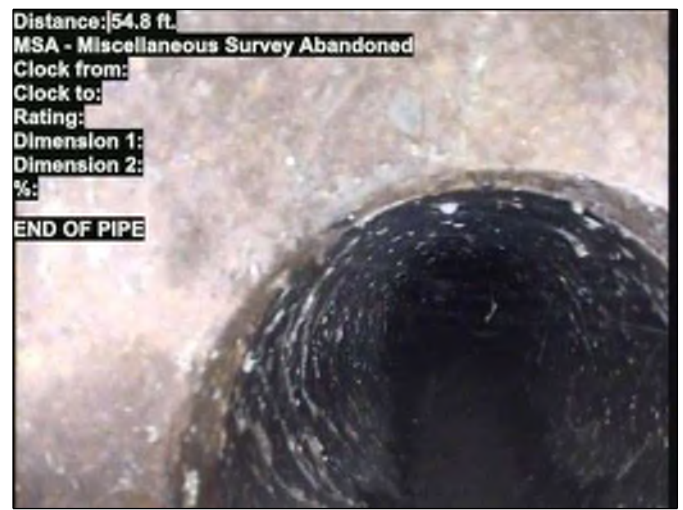
Photo: UNKNOWN-32-6442-20230905-115633.JPG
At: 54.8 ft. MSA - Miscellaneous Survey Abandoned
Joint: No END OF PIPE

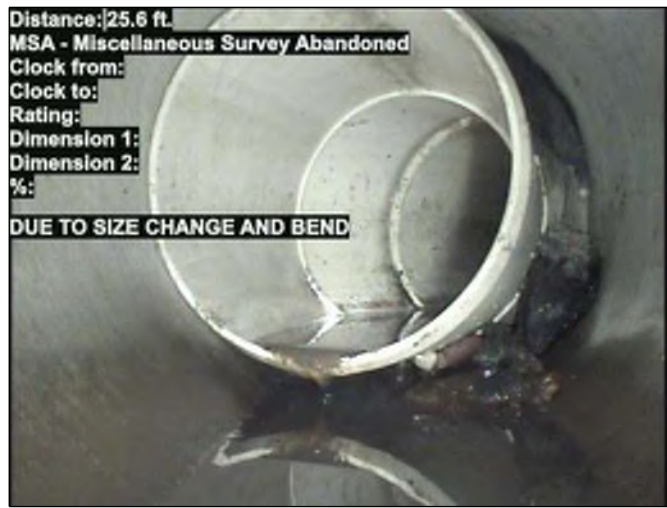
Photo: 32-6421-32-6424-20230905-080056.JPG
At: 25.6 ft. MSA - Miscellaneous Survey Abandoned
Joint: No DUE TO SIZE CHANGE AND BEND

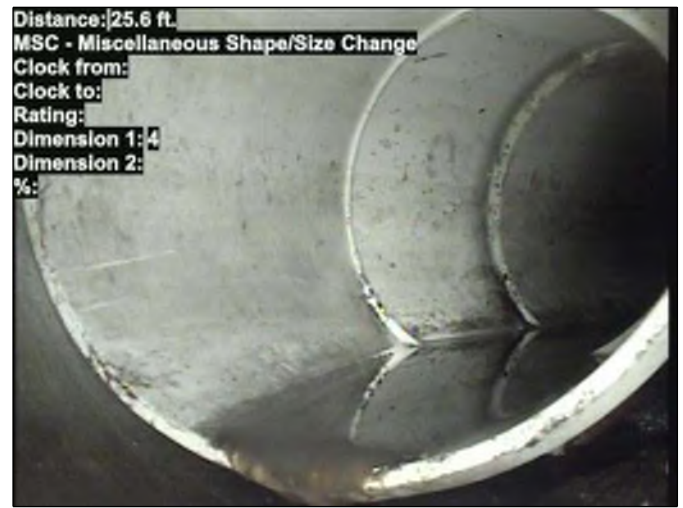
Photo: 32-6421-32-6424-20230905-075823.JPG
At: 25.6 ft. MSC - Miscellaneous Shape/Size Change
Joint: No

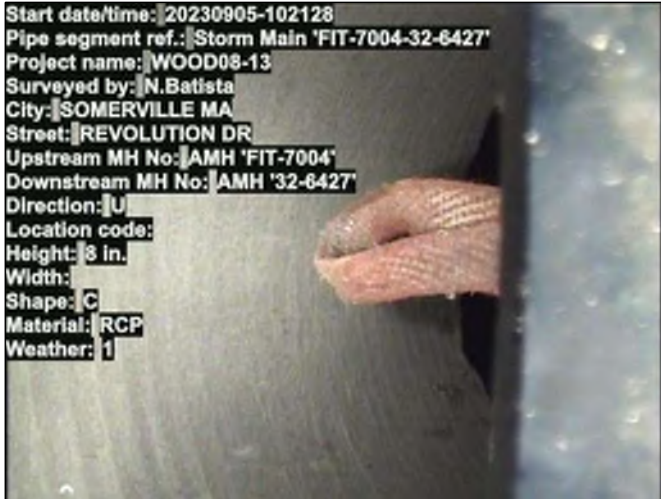
Photo: FIT-7004-32-6427-20230905-102128.JPG

At: 0 ft. AMH - Manhole

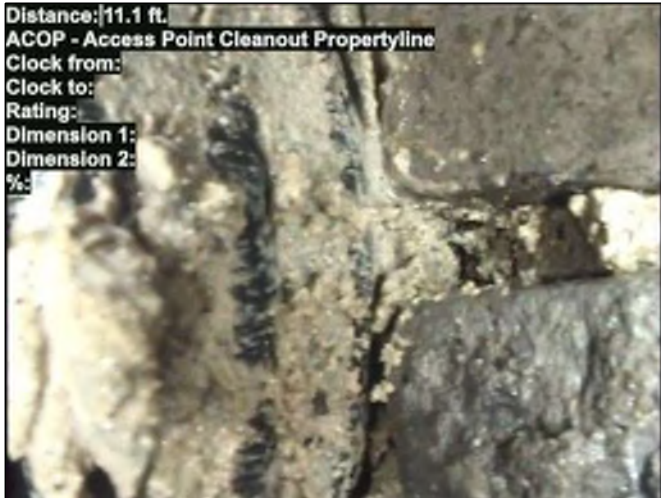
Photo: FIT-7004-32-6427-20230905-102243.JPG

At: 11.1 ft. ACOP - Access Point Cleanout Propertyline
